Bothin Marsh Geomorphology, Ecology, And Conservation Options

Marin County Open Space District

January 2018

This report was produced on behalf of the Marin County Parks based on review of the science related to restoration and protection of tidal marshes in upper Richardson Bay, Marin County, California.

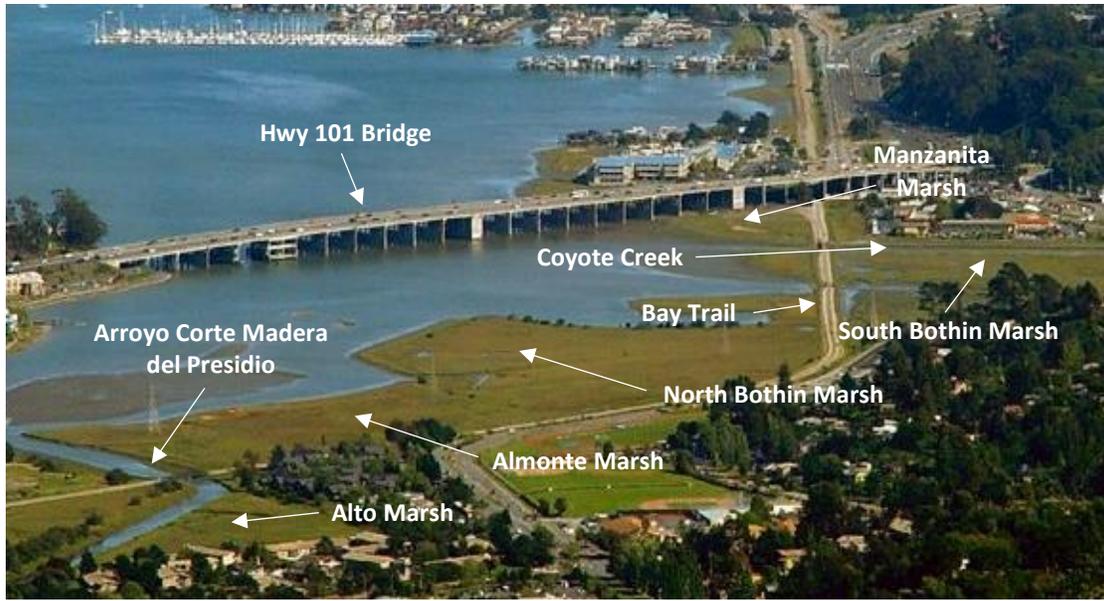
Eastward aerial view of upper Richardson Bay and the Bothin Marsh Complex. Wikimedia Commons (By Bento00 (Own work) [Public domain], via Wikimedia Commons).

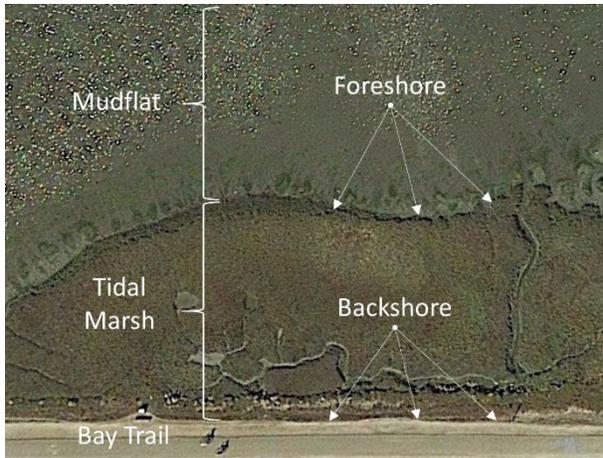
Figure 1.1. Aerial view of portion of Bothin Marsh showing relative positions of mudflat bayward of the marsh, foreshore between the marsh and mudflat, and backshore between the marsh and uplands, formed here by the Bay Trail.

Marshes do not have to drown to erode. Wind-generated waves and tidal currents can erode the bayward margins of the marshes, here called the foreshore (see Figure 1.1 below), such that the marshes will become narrower. The marsh foreshore tends to be unstable, eroding when the waves are strong and the

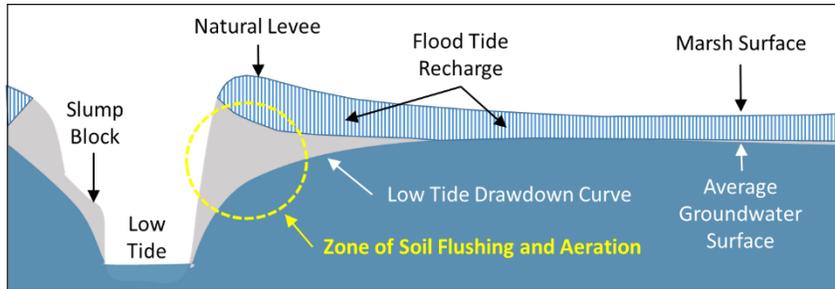
Figure 1.4. Diagram of the channel zone of a mature tidal marsh channel, showing characteristics processes and features (after Balling and Resh 1982).

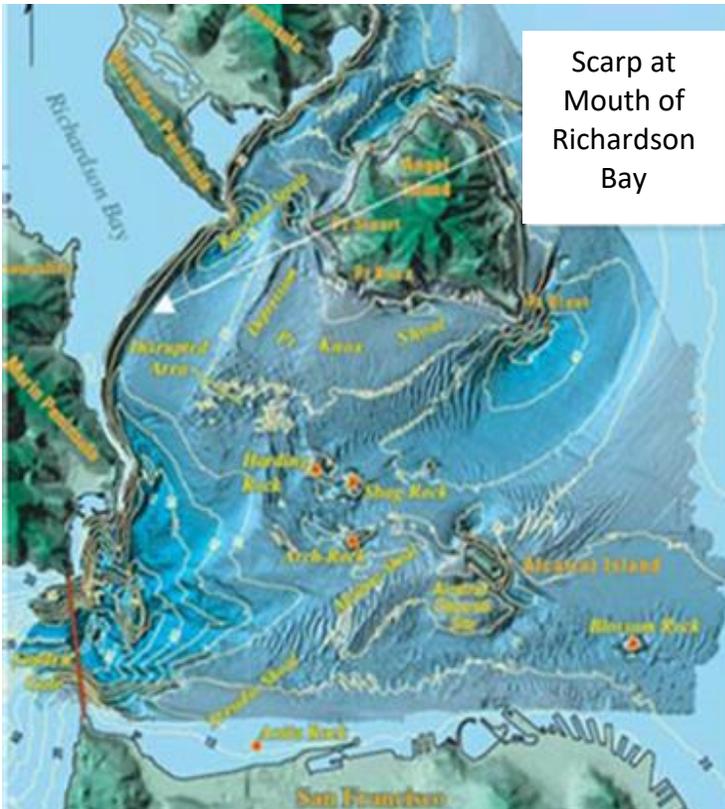
Figure 1.5 showing scarp at the mouth of Richardson Bay and adjoining deep subtidal area directing the flow of tidal waters through Raccoon Strait (see Figure 1.6) (from Means 1965).

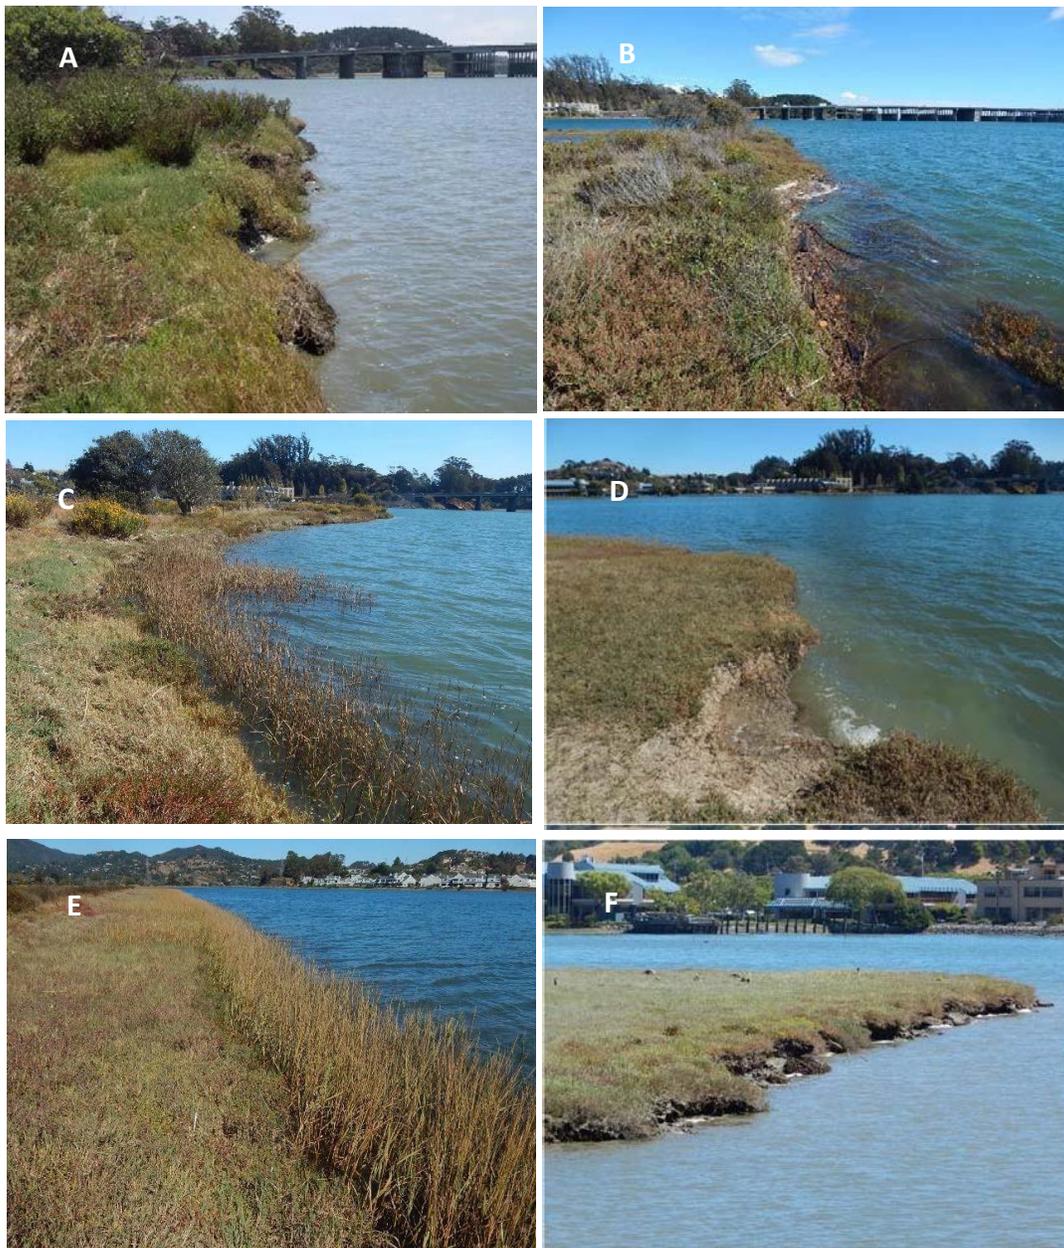
Figure 1.7. Caption next page.

1.7. Wave-cut salt marsh scarps at Bothin Marsh. (A) Active scarp at east end “headland” of south-facing levee, North Bothin Marsh. Note collapsing, undercut salt marsh sod and canopy. (B) Detached rotational slump block (tops still near horizontal) below scarp, submerged at high tide. (C) Cordgrass colonized a narrow zone of slump blocks (submerged at high tide). Pickleweed and other high marsh plants “drown” on blocks rotated to low marsh tidal elevations with excessive duration of daily tidal submergence; cordgrass seedlings colonize the sheltered, stable substrate of blocks and dead/dying high marsh vegetation. (D) Active cliff in compacted, cohesive levee at North Bothin Marsh “headland” at south end. Waves generate visible suspended fine sediment plume from eroding levee scarp. Trampling (public access) compacts soil and waves shear vegetation, producing a prostrate saltgrass turf on levee substrate, in contrast with high pickleweed salt marsh. (E) Abrupt zonation between fringing high salt marsh bayward of North Bothin Marsh east-facing levee north of “headland” (pickleweed, saltgrass, alkali-heath and *Jaumea* dominants) and uniform narrow cordgrass marsh belt below relict scarp (abrupt change in slope). Vegetation and topographic structure results from post- erosion scarp recovery phase. (F) Progressive active erosion of south-facing bay fringing marsh north of Coyote Creek mouth, with undercut sod and topping failures rapidly disintegrating from erosion by frequent wind-waves (from long fetch towards Golden Gate). Little or no persistent cordgrass colonization occurs in highly exposed scarp segment. (Photo dates: A – June 2012; B – Oct 2015; C-E Oct 2017; F – June 2016)

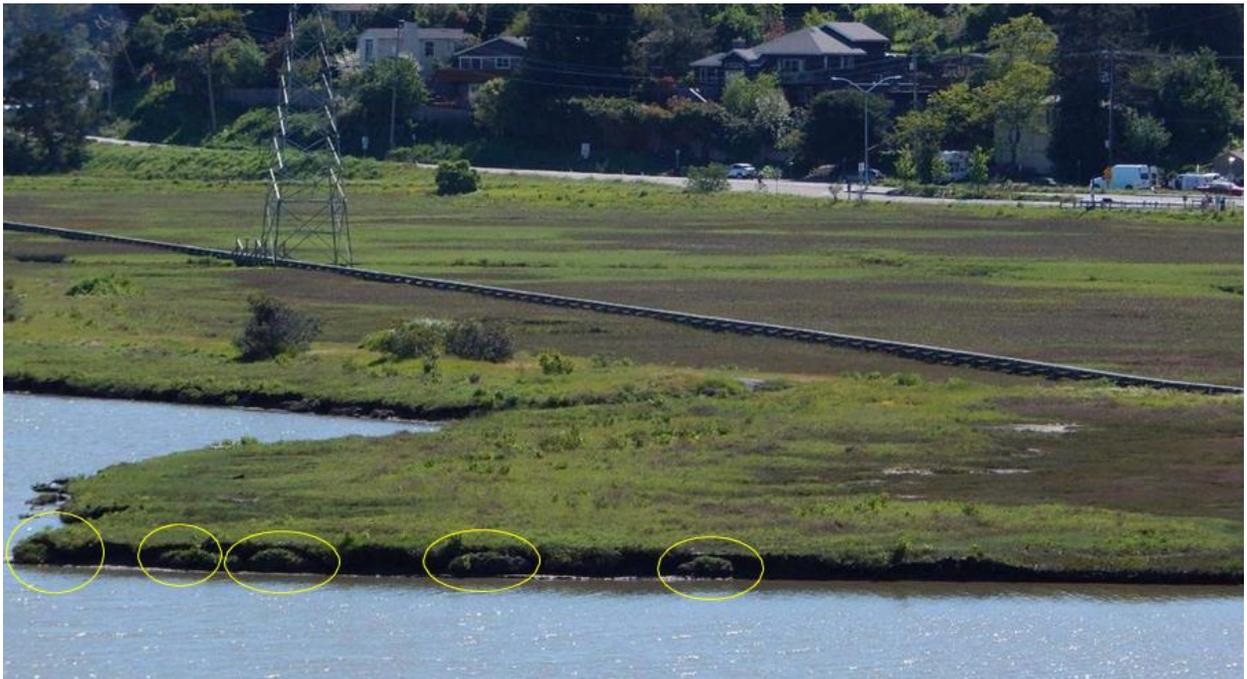
Figure 1.8. Oblique view of North Bothin Marsh bay-edge salt marsh scarp shows active erosion and retreat indicators. Topping and rotational failures of recent slump blocks at north end are circled. Recent failure is indicated by persistence of high marsh vegetation at top of slump block. April 2017.

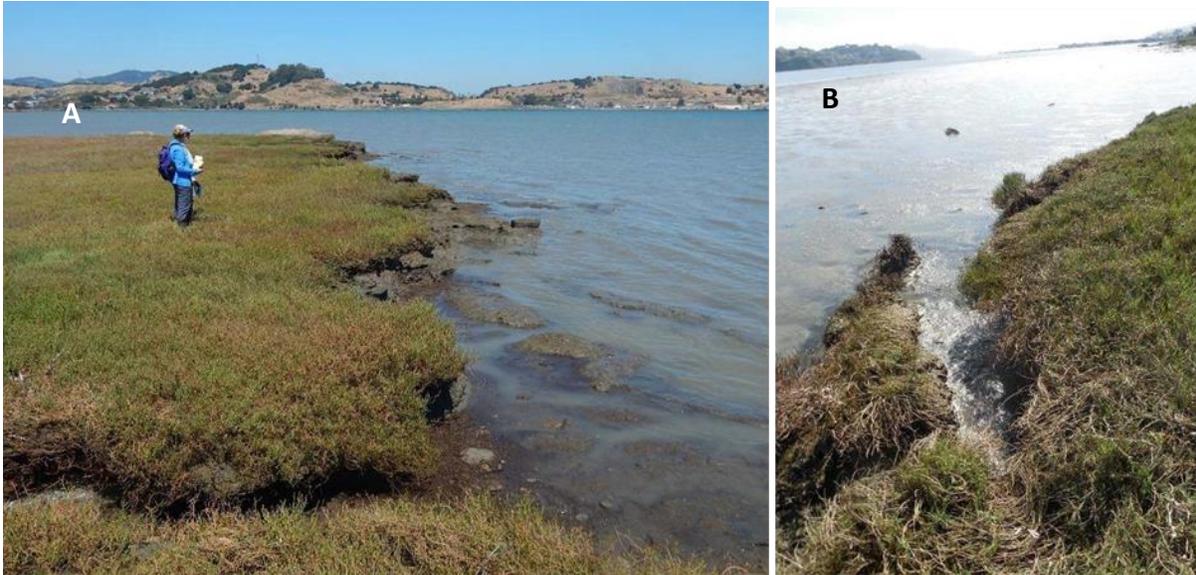
Figure 1.9. Areas of low and high wind-wave settings of salt marsh show erosional scarps. (A) Muzzi Marsh bay edge is exposed to chronic ferry wakes at higher tide stages and long wind-wave fetch to south. The old levee has eroded, exposing dredged bay mud fill on which restored tidal salt marsh forms a “crust” over low-strength consolidated mud with no root mats. Slump blocks rapidly deteriorate before cordgrass can establish well-anchored seedlings or clones. August 2017. (B) Manzanita Marsh (south) toppling slump block failure formed during wave erosion phase, followed by mudflat accretion. This cycle establishes sheltered microsites for potential cordgrass recolonization by seedling establishment and spread of clones. April 2013.

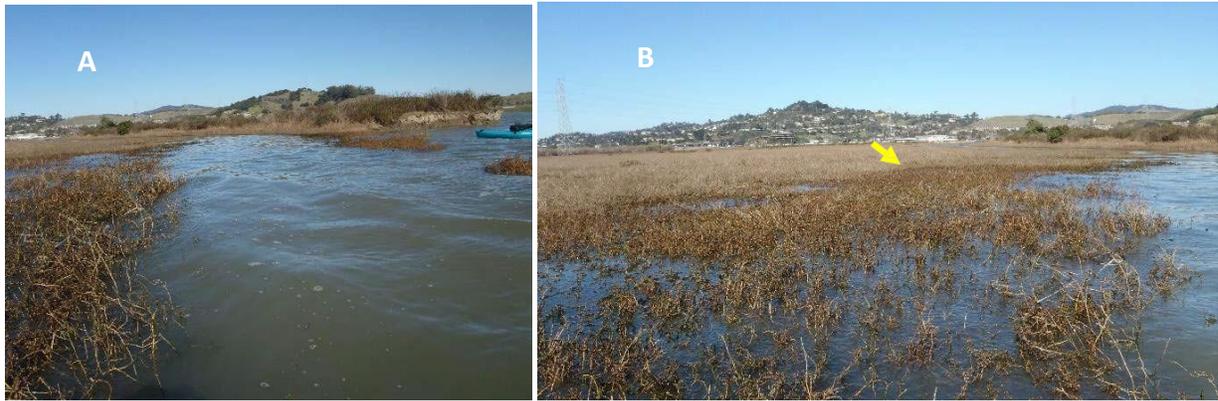
Figure 1.10. Wave damping at the bay edge of north Muzzi Marsh in low wave energy conditions during high spring tide, January 2011. (A) Waves intercepted by leading edge of pickleweed vegetation. Wave height approximately 10 feet, meeting or exceeding height of pickleweed canopy top. (B) Wave damping zone marked by wave-wetted (darker) pickleweed shoots contrasting with dry (lighter) shoots where waves are damped to height less than pickleweed shoot canopy above still water level. Wave-wetted (wave damping) zones are less than 30 feet-wide.

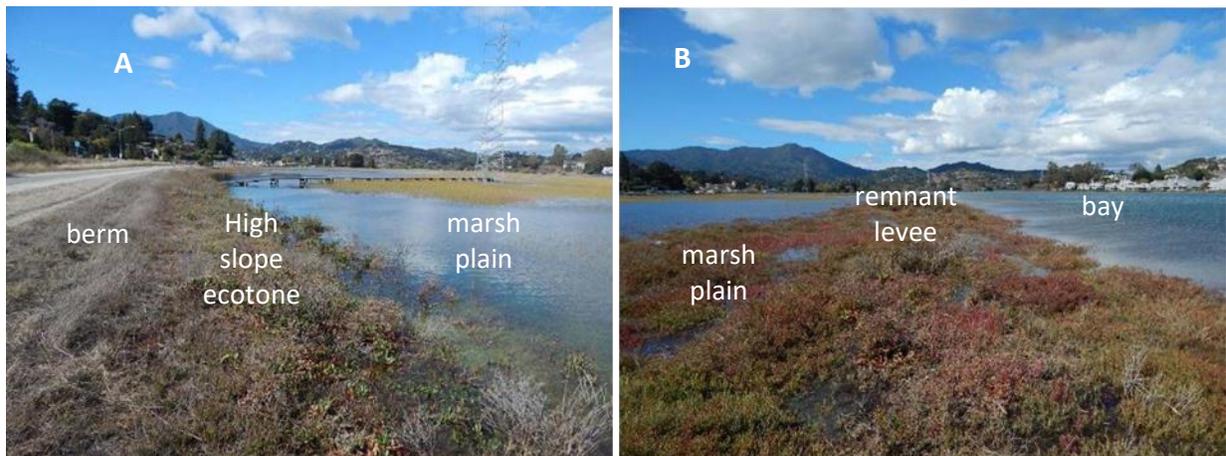
Figure 1.11. Canopy of emergent marsh vegetation is shown during calm-weather spring high tide submergence of (A) the North Bothin Marsh plain and (B) levee crest. Vegetation roughness provides wind-wave attenuation during storm conditions. October 2015.

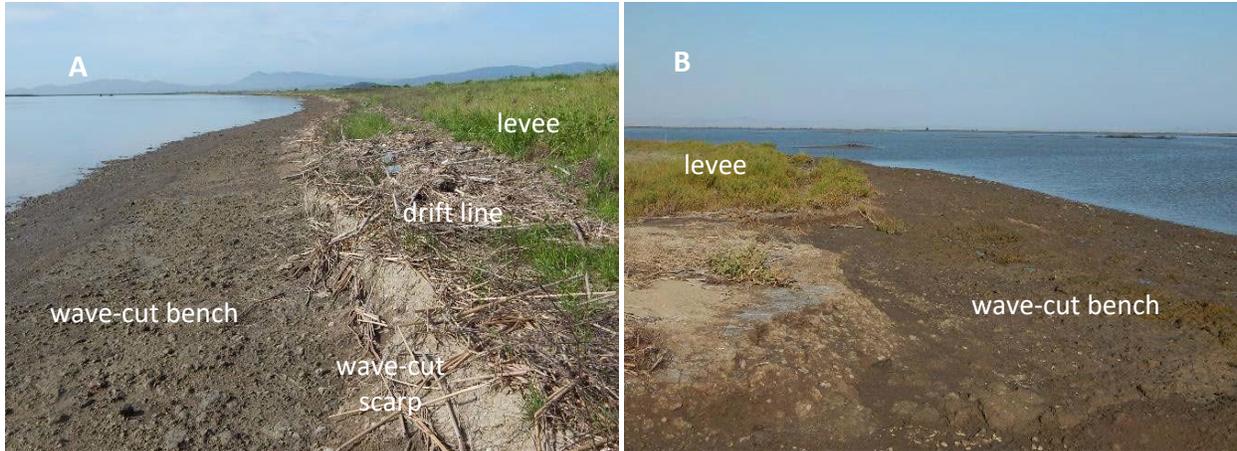
Figure 1.12. An example of wave erosion is shown on salt marsh restoration shorelines that do not have wave-damping intertidal vegetation. Low-gradient “horizontal levee” of new tidal marsh restoration site (Sears Point, Petaluma) in the bare, graded intertidal flats. Rapid, significant erosion of gentle gradient designed for 10:1-20:1 (south-facing levee) in a single year indicates the essential contribution of wave attenuation by marsh vegetation to the stability of low-angle slopes. Steeper slopes (less than 10:1) are most vulnerable to wave erosion unprotected by fringing salt marsh. (A) About 1 to 1.7 feet of high erosion scarp has formed in the levee facing away from dominant westerly winds, and a wide scour zone has removed approximately 1 foot of fill from the south-facing levee (B) one year after tidal breaching. Negative feedback processes (wave-cut bench flattens slope with increased exposure of more cohesive, higher-strength compacted mud with high roughness to trap seeds and shelter seedlings) eventually shifts intertidal profile to frequent seedling colonization phase and marsh shoreline stabilization. August 2017.

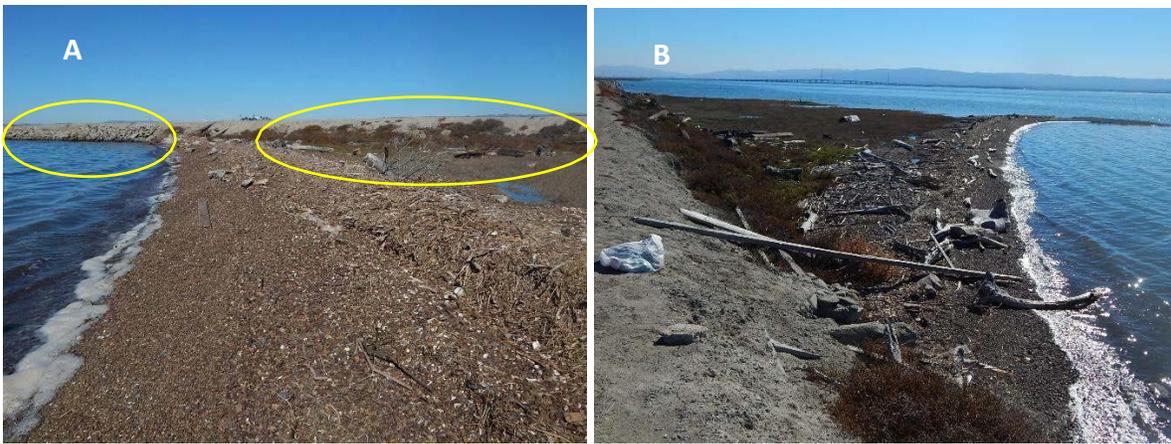
Figure 1.13. Gravel bay barrier beach formed from erosion of historic landing fill is shown at Newark salt ponds west of Coyote Hills, San Francisco Bay. (A) Unvegetated levee exposed to waves is armored with concrete slabs and rubble. (B) Salt pond levee in lee of barrier beach supports salt marsh and a vegetated levee slope. October 2014

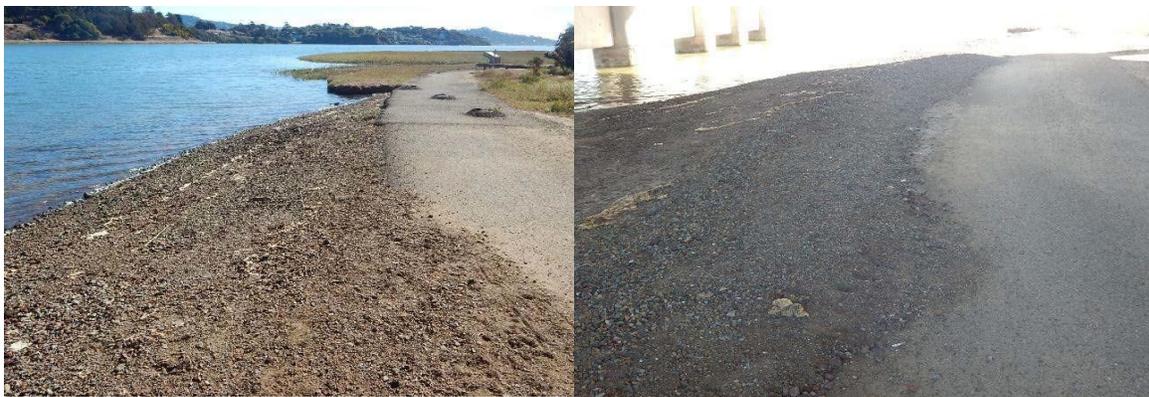
Figure 1.14. Gravel and sand berm accretion by wind-waves in Richardson Bay under the 101 Highway, south of Bothin Marsh. Local shoreline erosion of fill supplies the coarse sediment. Waves deposit a swash bar over the edge of the paved path. September 2017.

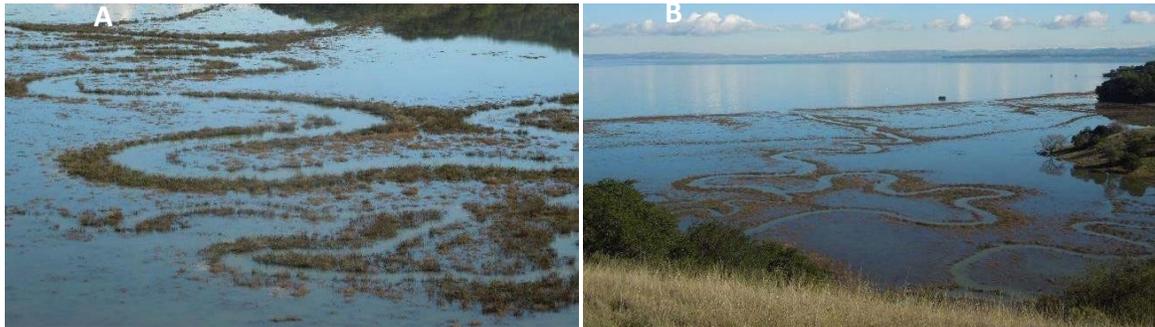
Figure 1.17. Tidal creek bank patterning of high marsh showing (A) sinuous zones of dense gumplant, interior prehistoric salt marsh plain, China Camp Marsh, San Rafael; (B) continuous high tide refuge cover from front to back of same marsh; and (D) well-developed creek banks (natural levees in ancient tidal marsh plain) support steep tidal drainage gradients with tall gumplant and pickleweed as refuge; December 2012, and December 2008).

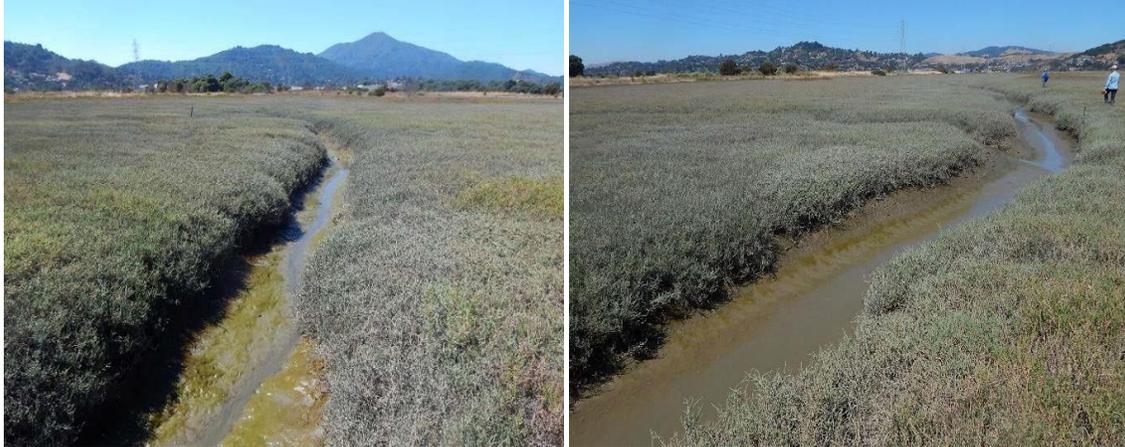
Figure 1.18. Interior Muzzi Marsh tidal channel, after over 40 years of tidal restoration, still lacks sufficient topographic and tidal creek drainage gradients along creek banks to support tall-form pickleweed or gumplant. Olive-green diatom films on channel muds indicate their immobility. The interior marsh plain formed on dredged sediment fill and was ditched to initiate channels and improve internal tidal drainage. It remains continuous monotypic pickleweed marsh with minimal high tide refuge (compared to interior North Bothin Marsh). August 2017.

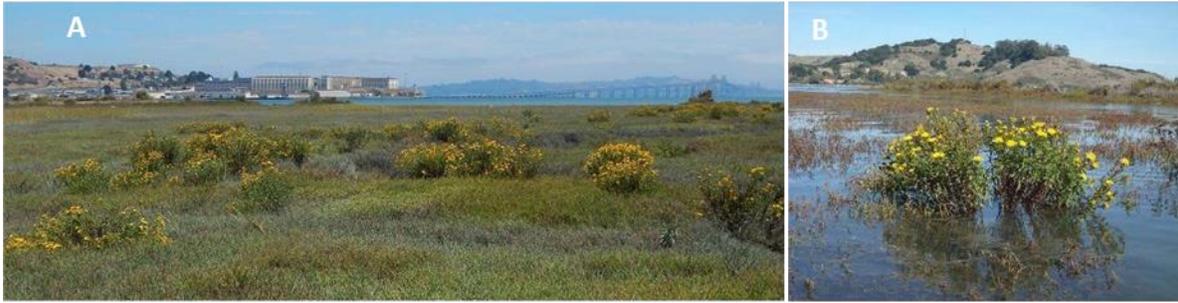
Figure 19. Bayward Muzzi Marsh tidal creek with mouth directly connected to San Rafael Bay (wave-exposed mudflat with high suspended sediment supply) has developed natural steep banks with high salt marsh levee topography and tidal drainage, supporting dense gumplant and tall-form pickleweed, with local high tide refuge cover. Gumplant delineates banks. (A) August 2017; (B) October 2011.

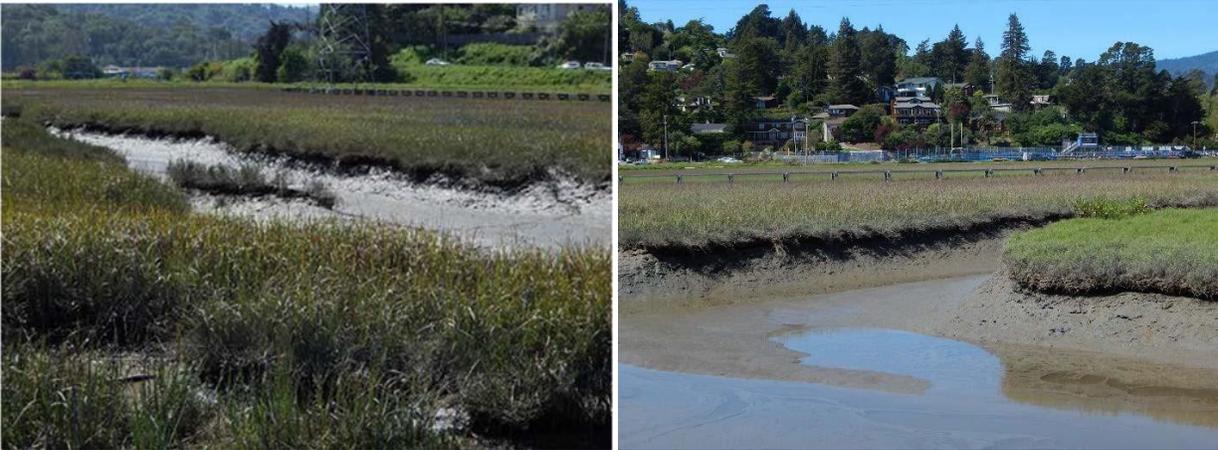
Figure 1.21. Main trunk channels branched near the levee breach, close to tidal sediment sources in Richardson Bay, also lack natural levee. Most of the marsh plain is dominated by intermediate low and middle marsh vegetation. A saltgrass meadow occurs locally along banks closest to the tidal breach, with only scattered individual gumplant. The creek banks are steep, cohesive, and support overhanging root mats – all indicators of normal bank processes, although slump blocks rare. Development of natural levees is still lagging after several decades of tidal action.

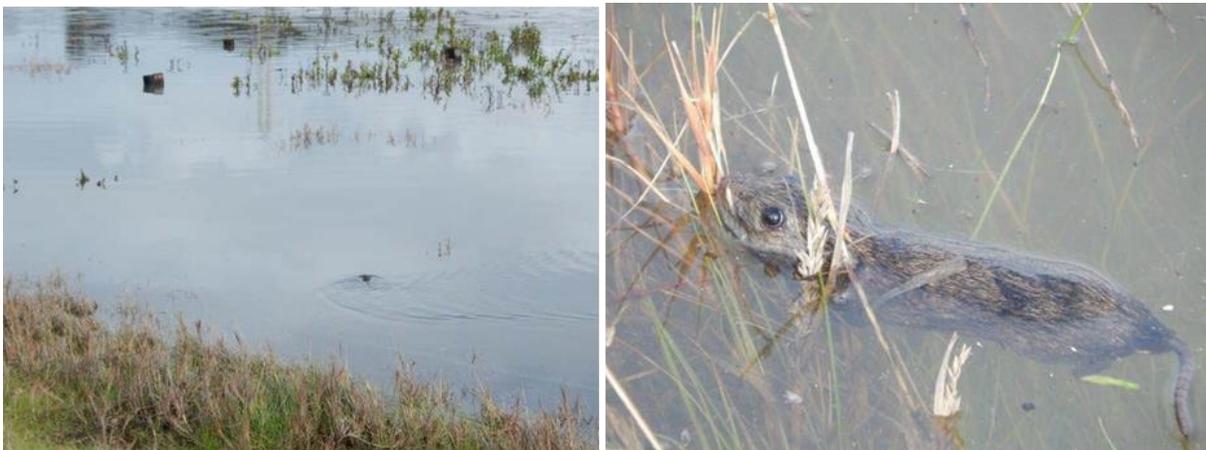
Figure 1.22. Small mammals, including voles capable of diving and swimming, are forced to cross open water to reach the nearest emergent cover along the terrestrial edge of North Bothin Marsh, where internal tidal creek banks have not developed high salt marsh vegetation that would provide flood refuge at short distance from, or within, the home ranges of salt marsh wildlife. Like California rails, small mammals are vulnerable to avian predators (egrets, herons, harriers) during daytime marsh submergence. January 2017.

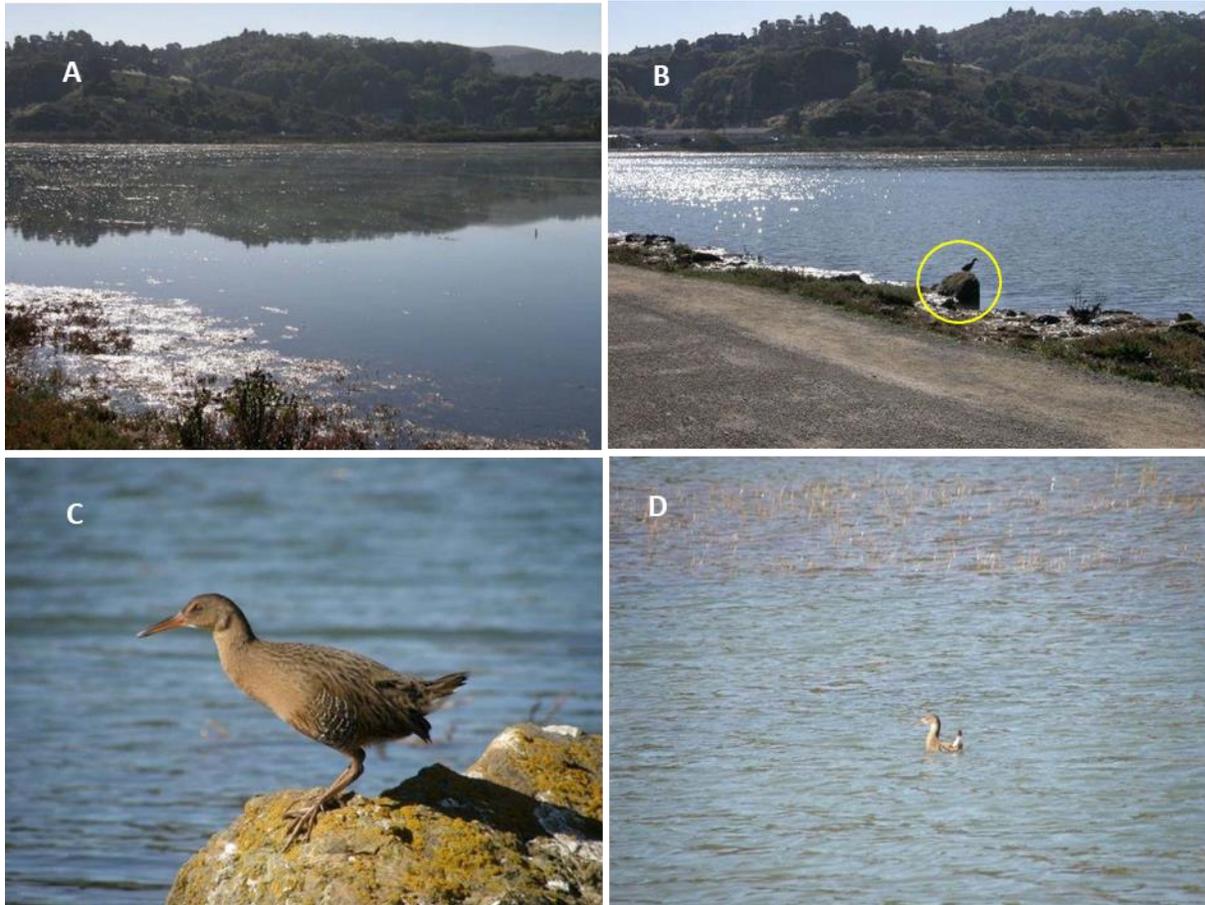
Figure 1.23. Ecological consequences of undeveloped internal high marsh creek banks: The failure to develop internal high marsh along creek banks as the first line of high tide refuge cover in South Bothin Marsh, combined with scarcity or absence of high tide refuge cover along the shoreline, strands vulnerable marsh wildlife during extreme high tides that submerge the marsh. Without internal high tide refuge cover along tidal creeks, extreme high tide marsh submergence has forced California rails to shorelines lacking cover for protection. This deficiency in salt marsh internal and edge structure exposes rails to detection by avian predators during marsh-submerging daytime high spring tides. The following example is indicative of a recurrent ecogeomorphic constraint. (A) All marsh vegetation is completely submerged in South Bothin Marsh in fall of a non-El Niño year (November 2008). (B) California rail displaced from flooded marsh reaches nearest emergent surface: interior berm slope (compacted fill and rock) with prostrate high salt marsh vegetation providing negligible terrestrial ecotone cover. Terrestrial ecotone cover is an alternative to creek bank high marsh refuge. (B-C) California rail remains exposed and highly vigilant, with no available escape routes leading to cover. (D) Rail swims to the first cordgrass cover visibly emergent above the water surface as the tide levels in the basin slowly fall, lagging behind open bay marshes. Duration of rail high tide exposure: over 45 minutes. November 13, 2008.

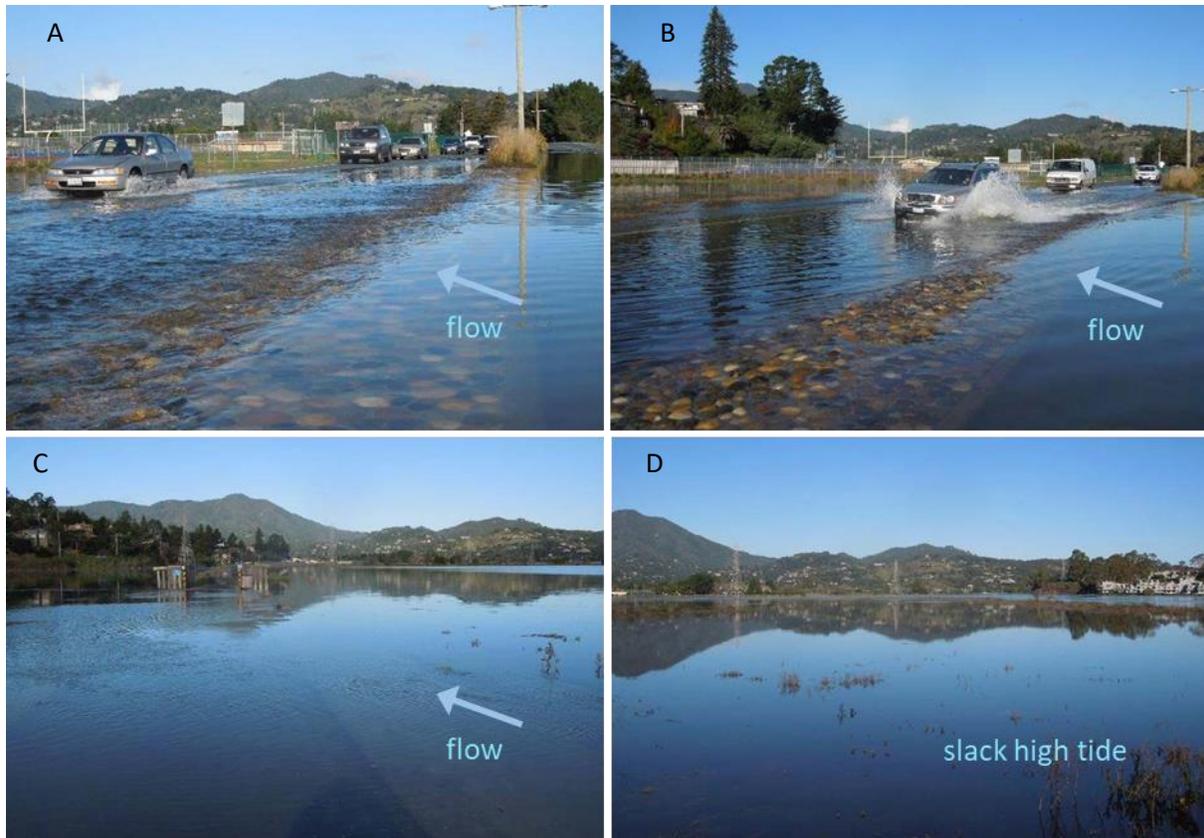
Figure 1.24. Local Bothin Marsh flood tide during anomalously high local sea level event (higher than astronomic predicted tide) during calm weather in a non-El Niño year, before the winter solstice. The median strip of Almonte Boulevard (A, B) became an floodway for the bay, with road is submerged by up to 2 feet of tidal water, and with (C) submerging South Bothin Marsh, (D) North Bothin Marshes and the Bay Trail during slack high tide, December 12, 2012.

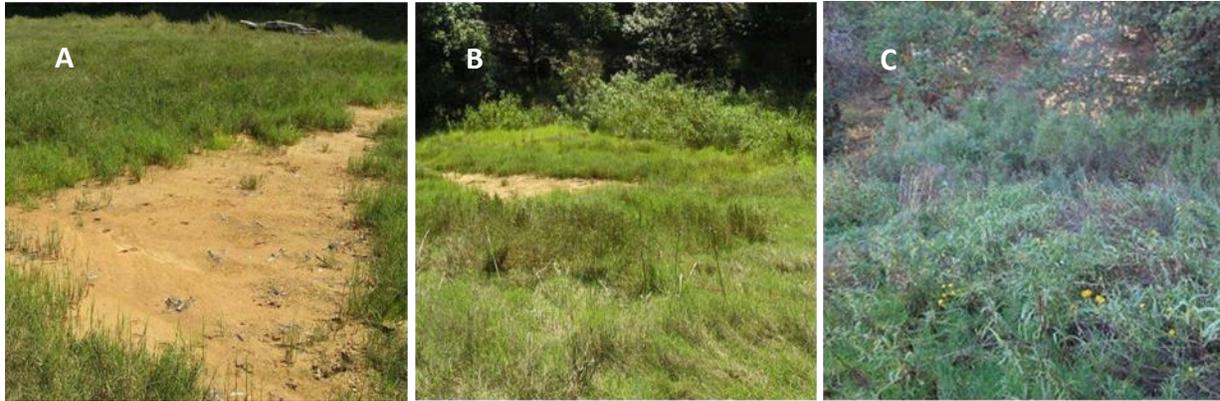
Figure 1.26 China Camp Marsh (A, B) alluvial fan over tidal marsh almost completely recolonized by high salt marsh vegetation after two years, leaving only small bare patches of coarse sediment. April 2008, and (B) the head of the fan dominated by tall gumplant vegetation below upland coyote-brush, providing terrestrial-edge high tide refuge.

lateral spread from contiguous salt marsh. The alluvial fan regenerated high salt marsh gradients, with wider, gently sloping zones in the spring high tide elevation range. By 2012, the fan supported a new salt marsh-terrestrial ecotone including gumplant (Baye, personal observation, 2006- 2012; see Figures 1.25 and 1.26 below). This alluvial fan-tidal marsh depositional process, though extinct at Bothin Marsh, remains relevant because artificial surrogate processes simulate functionally equivalent landforms at restored tidal marsh edges.

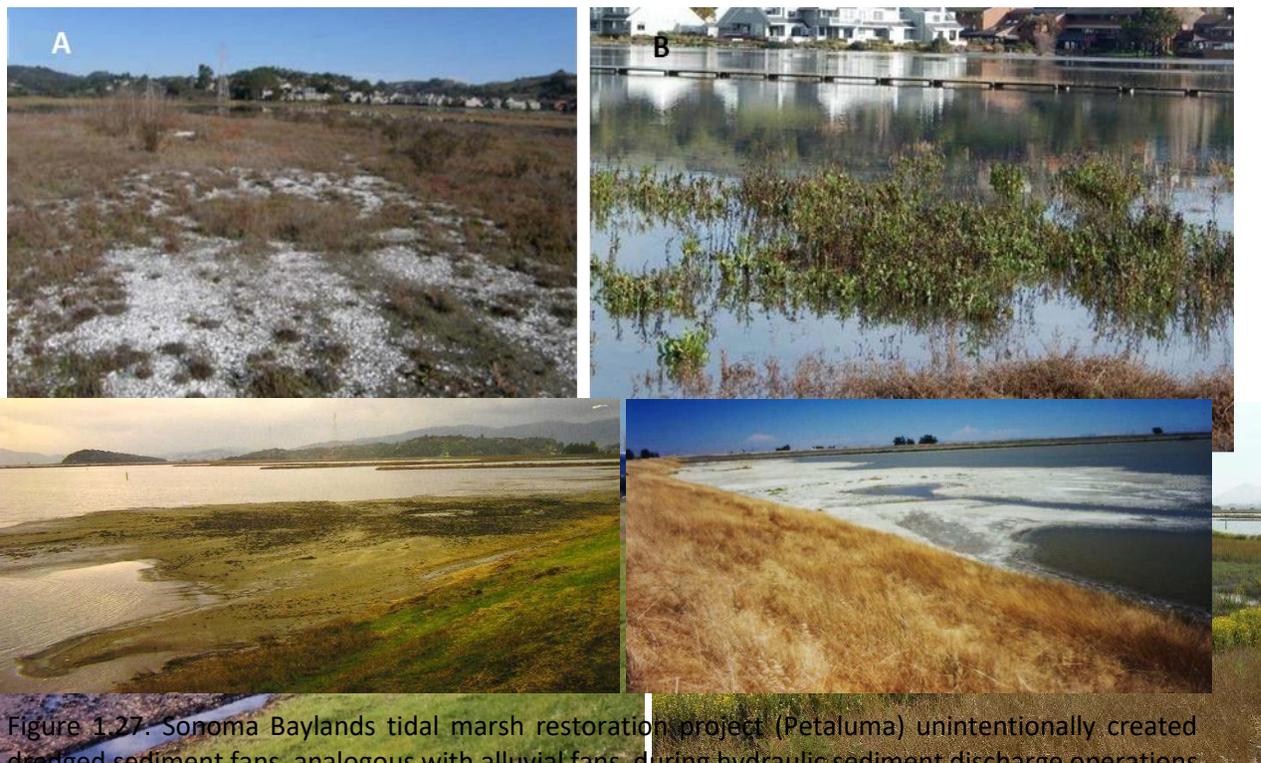
Figure 1.27. Sonoma Baylands tidal marsh restoration project (Petaluma) unintentionally created dredged sediment fans, analogous with alluvial fans, during hydraulic sediment discharge operations for raising 28 islands. Baylands elevation fans supported vegetation established in 1996, primarily dominated by tall pickleweed. Winter and summer 1996. The artificial alluvial fans stabilized high salt marsh vegetation dominated by gumplant and tall pickleweed, similar to natural alluvial fan-high salt marsh succession event at China Camp, 2006-2012. (A) Winter 1996; (B) summer 2006.

At Sonoma Baylands, Petaluma (U.S. Army Corps of Engineers and California Coastal Conservancy tidal marsh restoration project), dredge sediment including sand and shell was deposited hydraulically in diked baylands to raise subsided elevations (Figures 1.27-1.28). The dredge discharge points along the landward levee were moved intermittently, forming a series of sediment splays (dredge sediment fans or mounds, analogous with alluvial fans) around the discharge point in 1995. The fans were stratified with layers of coarser and finer sediment, distributed in variable sediment lobes that established variable soil textures for tidal marsh plant growth. This “constructed” feature (partially removed by subsequent grading) subsequently formed the only high salt marsh vegetation gradients with high tide refuge cover (abundant tall gumplant) in the project’s restored tidal marsh plain by 2000. They remain the only wide, gently sloped high salt marsh gradients at Sonoma Bayland.

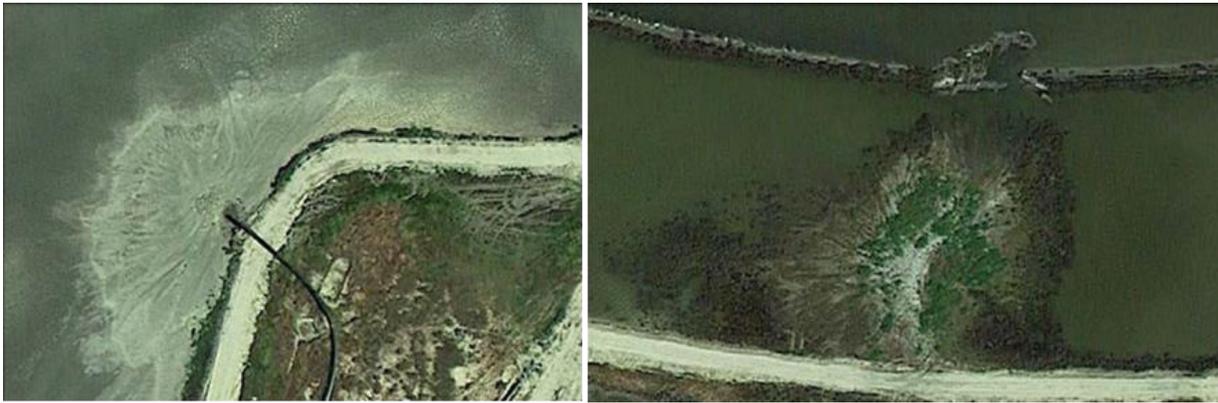
Figure 1.29. Montezuma Wetlands tidal marsh restoration project (Suisun Marsh) unintentionally created dredged sediment fans during filling of subsided diked baylands. Fans became vegetated with salt marsh vegetation prior to tidal restoration. April 2013 (Google Earth imagery).

At Montezuma Wetlands Project (Suisun Marsh), similar hydraulic dredge sediment fans analogous with alluvial fans nearly identical with those of Sonoma Baylands (20 years earlier) were deposited during dredge sediment filling operations. These artificial sediment fans became vegetated with non-tidal salt marsh in various stages of succession (see Figure 1.29). At North Bothin Marsh, shell fragment-rich, sandy to silty old dredge sediment mounds or fans (Chapter 4) persist along its landward edge, bordering the historic railroad berm (Figure 1.30). These historic relict features now support large colonies of the rare salt marsh bird’s-beak and most of the tall gumplant colonies that provide high tide refuge cover internal to the marsh (not located on levee and berm slopes).

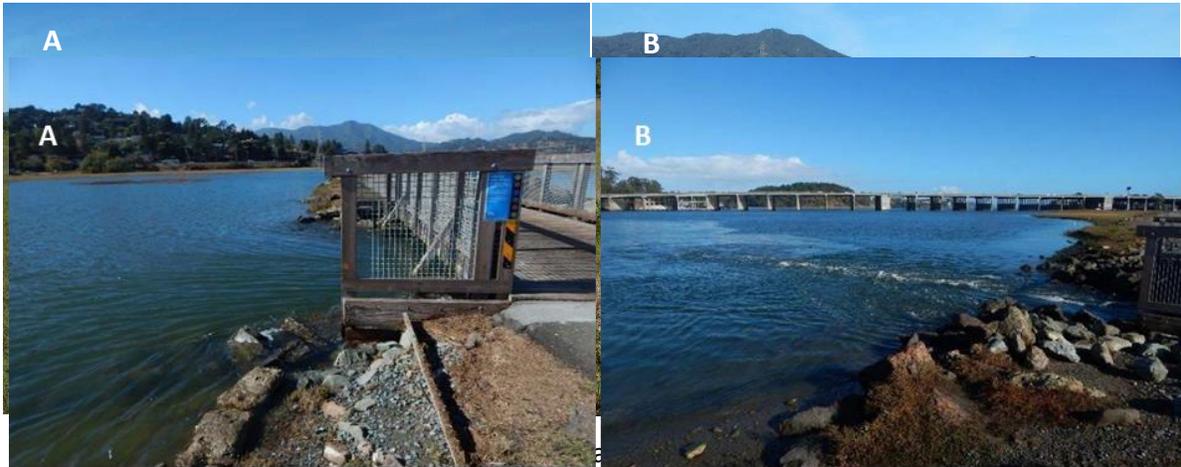
Figure 1.33. Historic infrastructure influences modern tidal hydrology of South Bothin Marsh. The under-sized tidal inlet (see Chapter 3) is a rock-armored breach in the historic railroad berm under the Bay Trail Bridge 2. The tides ebb faster from Richardson Bay than the marsh can drain. As a result, the water level of the Bay drops faster than the water level in the marsh. The difference in water levels can result in very high velocities of ebb flow from the marsh, causing a scour pool on the bay side of the inlet. (A) water streams from the marsh at high velocity, creating (B) turbulent flow through the inlet, creating standing waves in the Bay. Slow drainage of the marsh increases its duration of submergence, relative to fully tidal bay salt marshes.

At the extreme end of the spectrum of channel erosion resistance, the quarry rock-stabilized tidal inlet of South Bothin Marsh appears to significantly choke tidal flows between the bay and tidal basin enclosed by the historical berm and the Coyote Creek high marsh (fill) bank. Significant tidal choking (undersized tidal inlet cross-section relative to tidal prism) is indicated by the lag in tide levels between the tidal basin and the bay, made visible by steep, turbulent water slopes across the inlet throat, and an ebb tide jet (plume of turbulent water, sometimes with standing waves and foam) discharging to the Bay. The tidal asymmetry between the basin and the bay, and the slow, prolonged residual ebb tide in the basin, is a chronic tidal restriction. Restriction of tidal flows through bridges and culverts is a widespread hydrological and ecological impairment of tidal salt marshes of the Atlantic Coast (Tiner 2013), where it has been the primary focus of many tidal restoration projects (Roman and Burdick 2012). The ecological consequences of significant tidal choking at South Bothin Marsh probably include the very slow succession of low cordgrass marsh and cordgrass-pickleweed marsh ecotones, and failure to develop any significant internal high marsh banks along creeks. The choked tidal asymmetry between the South Bothin Marsh basin and fully tidal Coyote Creek may be responsible for the recent scouring of the former high marsh on the northern artificial levee bank of Coyote Creek: during the ebb phase after extreme high tides, the basin drains by turbulent over-marsh flow across the bank to the lower tide level of Coyote Creek. This process scours runnels that have not yet incised to intertidal depths because concentrated rocky lag from artificial fill impedes erosion. This may change as sea level rise continues.

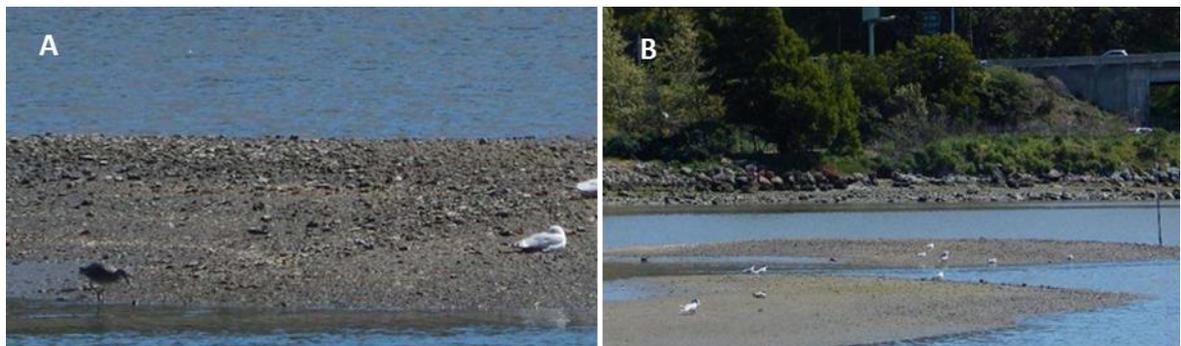
Figure 1.32. Coarse, gravelly sediments form a convex, armored surface on relict old dredge sediments that comprise Richardson Bay tidal flats. The coarse material is concentrated at the surface after wind-wave erosion and tidal currents remove the finer sediment from around the larger particles. The armoring limits resuspension of fines and thus limits their availability to the marshes. April 2017.

Effects of erosional resistance of artificial surfaces are evident in some other shorelines of Bothin Marsh, and in adjacent tidal flats. In tidal flat areas subject to dredging in the 1960s and 1970s (Chapter 3), concentration of lag armored surfaces have formed. These appear to develop from wind-wave erosion of gravel-contaminated flats: where gravels are mechanically mixed with bay mud by past dredging, wind-wave and current erosion has winnowed out more mobile fine sediment, concentrating heavier gravel at the surface, where it locks down fine sediment beneath it. Tidal flats composed of naturally well-sorted silt-clay (typical bay mud) are subject to wind-wave erosion and resuspension of fine sediment, which can supply adjacent tidal marshes with suspended tidal sediments supporting marsh accretion (Allen and Pye 2002, Pethick 2002). Lag surfaces stabilize the mudflat surface, locally inhibiting mudflat-marsh sediment exchange. The bay shoreline at the historical railroad berm is a steep, impermeable surface composed of boulder-sized riprap and compacted stony fill that inhibits rooting and anchoring of salt marsh vegetation. It appears to act as a wave-reflective seawall, scouring fine sediment and inhibiting marsh initiation and accretion where rock outcrops are prevalent and a soil or mud veneer (root zone) has been lost to erosion.

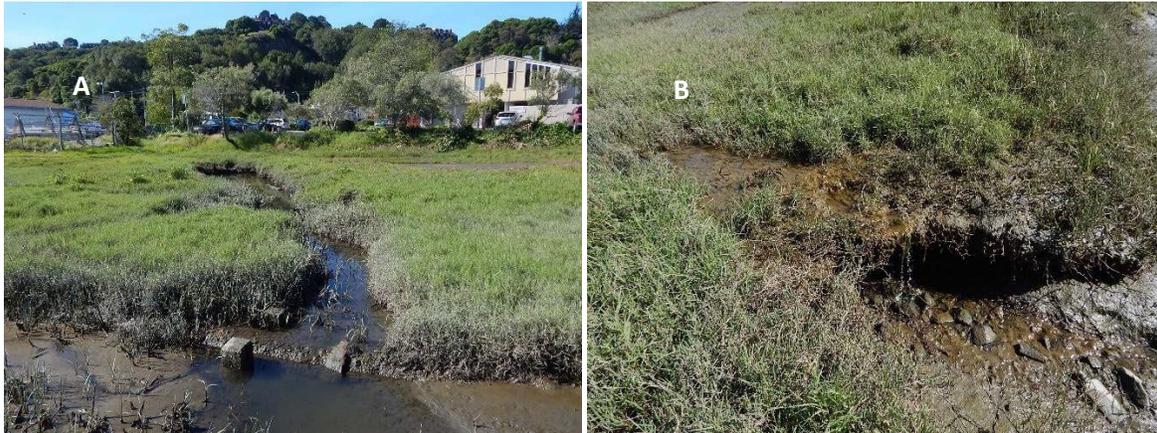
Figure 1.35. Old artificial fill and buried structures restrict eco-geomorphic development at South Bothin Marsh. (A) A buried pipeline exposed at the bed of a ditch acts as a grade control structure, preventing the ditch from achieving its equilibrium depth with its upstream tidal prism. (B) Resistant angular gravel in artificial fill along the north bank of Coyote Creek inhibits rapid channel incision and tidal creek evolution through the salt marsh surface (also see Figure 1.34 above). April 2017.

The ditch has cut down through the thin veneer of soft tidal sediment and into the compacted, rocky fill of the old levee. The ditch is slowly widening and deepening as it conveys more tidal prism, yet its rate of erosion is slowed by resistant gravel in the levee. It is, however, evidence of a tidal marsh channel evolution. April 2017.

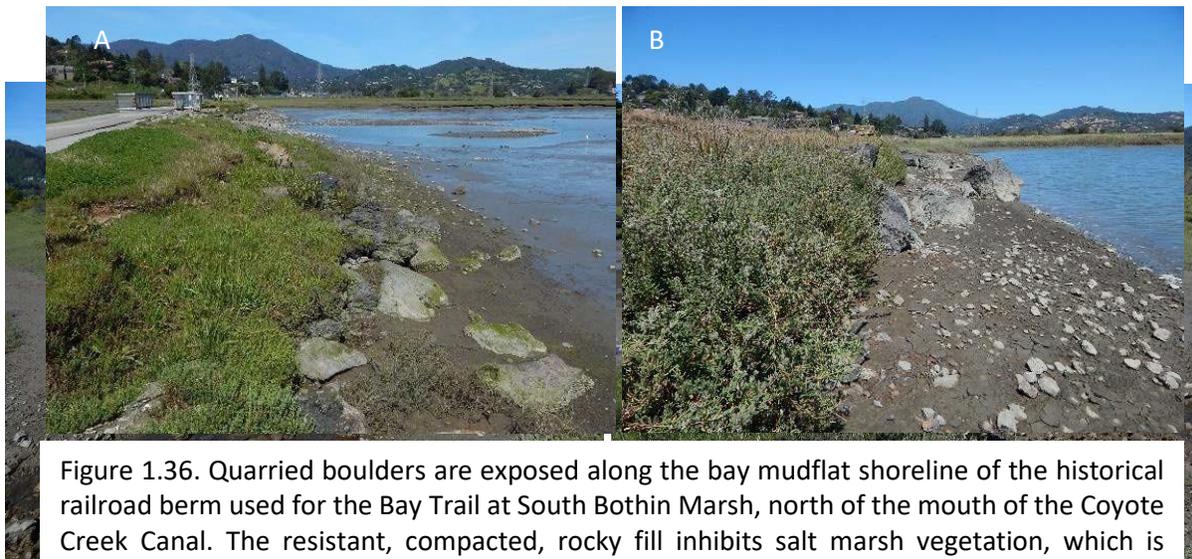
Figure 1.36. Quarried boulders are exposed along the bay mudflat shoreline of the historical railroad berm used for the Bay Trail at South Bothin Marsh, north of the mouth of the Coyote Creek Canal. The resistant, compacted, rocky fill inhibits salt marsh vegetation, which is restricted to shallow, temporary soil pockets or veneers between the rocks. Wind-wave reflection concentrates wave energy and promotes erosion of the soils. The vegetation is unable to gain enough stature and cover to attenuate wave energy. April 2017

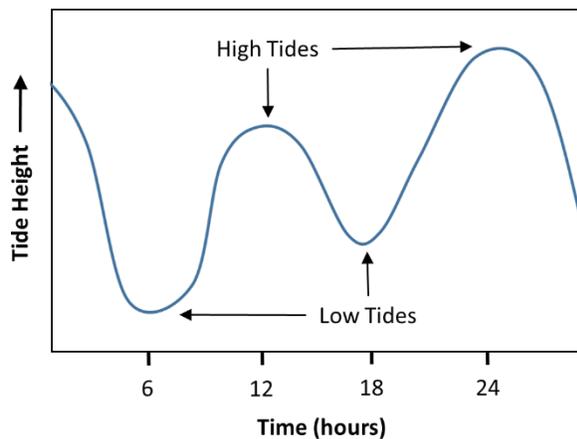
Figure 2.1. Diagram of the mixed semi-diurnal tide showing two high tides of different height and two low tides of different height each lunar day.

San Francisco Bay experiences a mixed diurnal tide, meaning there are two high tides and two low tides each lunar day, with the two low tides usually having different heights, and the two high tides also having different heights (Figure 2.1).

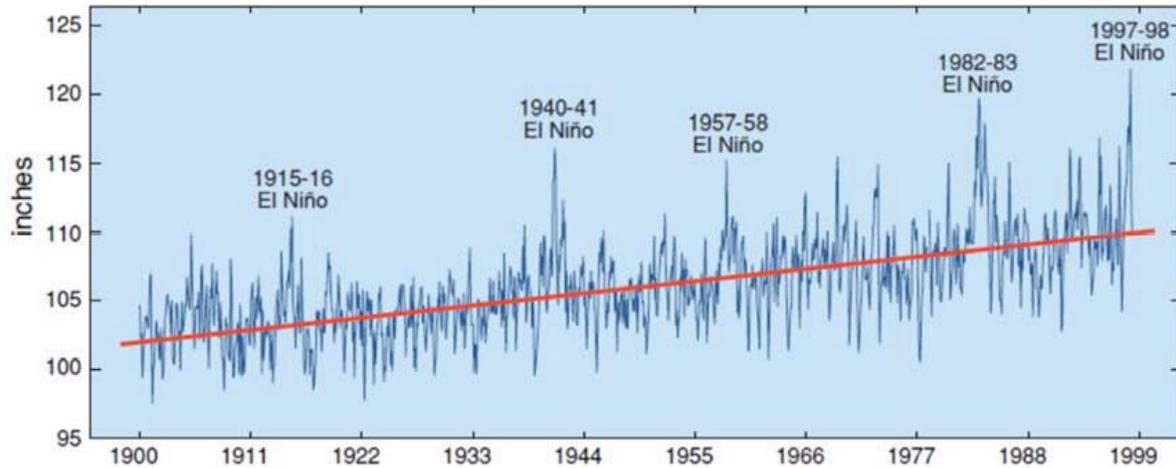
Figure 2.3. Sea level data from the Fort Point Tide Station 9414290 accounting for the historical shift in the local datum. Note the correspondence between extreme high tides and El Niño events (USGS 1999).

of tide height observations beginning in 1854 for the NOAA Tide Station at Fort Point (Figure 2.3). These data reveal an average rate of sea level rise just inside the Golden Gate of about 0.08 inches per year (about 8 inches per century). Short-term processes, including Pacific Basin climate fluctuations (e.g., El Niño Southern Oscillation), perigean high tides (i.e.; “King Tides”), and winter storms can produce significantly higher water levels than sea level rise alone (USGS 1999), and can cause actual sea levels to be significantly higher than predicted (Figure 2.4).
