Bothin Marsh Geomorphology, Ecology, And Conservation Options

Marin County Open Space District

January 2018

This report was produced on behalf of the Marin County Parks based on review of the science related to restoration and protection of tidal marshes in upper Richardson Bay, Marin County, California.

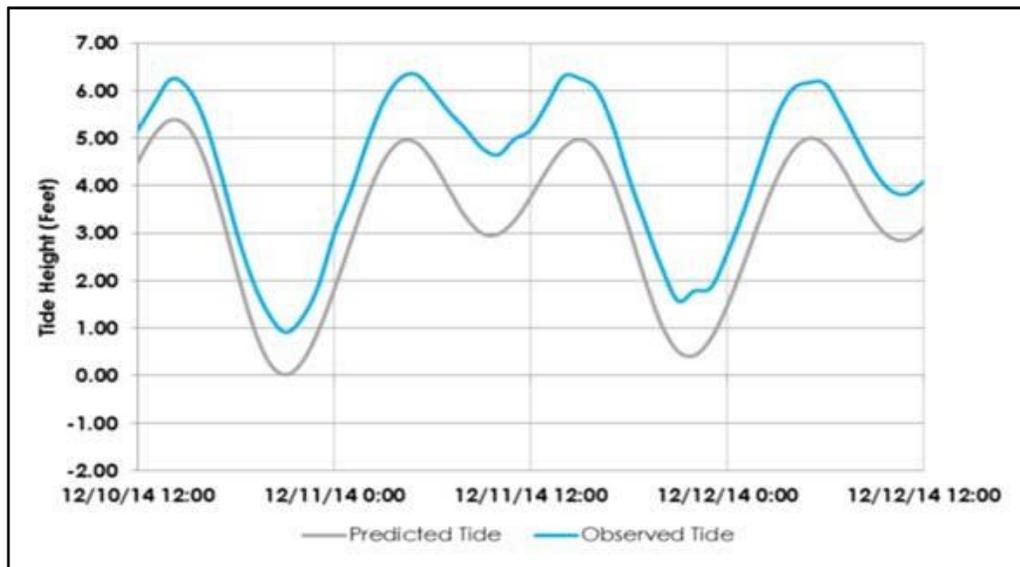
Figure 2.4. Predicted versus observed tide heights showing effect of storm surge on December 11, 2014 (BCDC 2016).

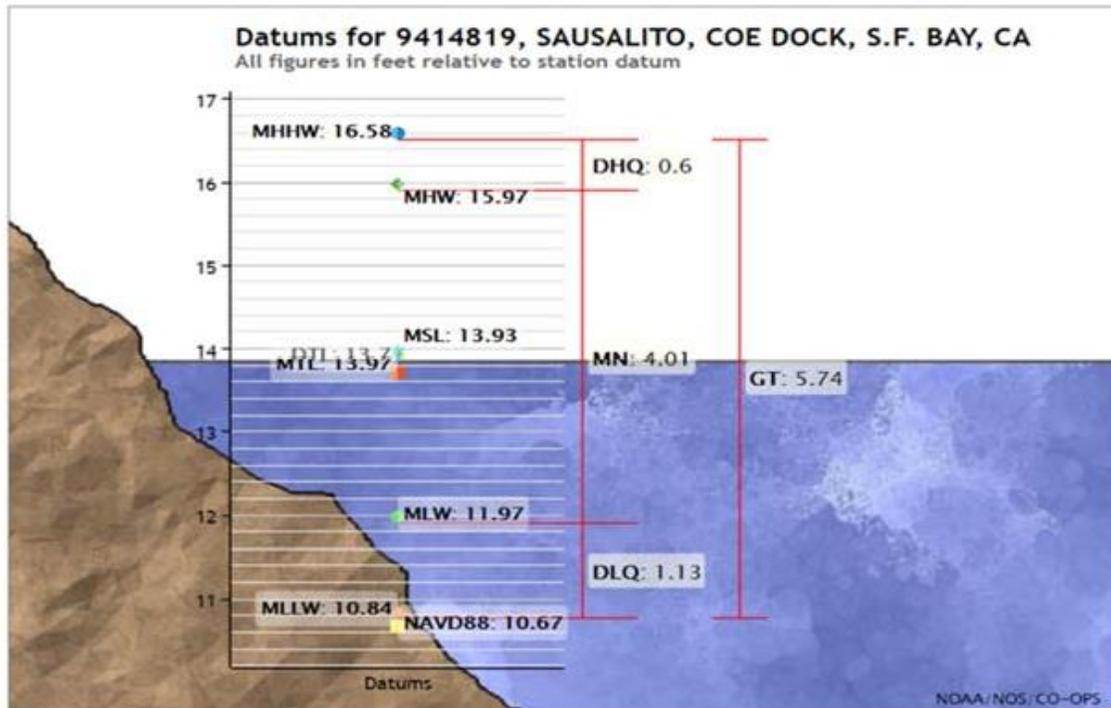
Figure 2.6. Tidal datums and other tidal statistics for the NOAA tidal station closest to the Bothin Marsh Complex, Station 9414819.

conventional zero tide datum for the U.S. West Coast (Figure 2.6). MHHW is 5.74 feet above MLLW, and 5.91 feet above NAVD88. For general purposes, tidal elevations at the COE Dock Station relative to NAVD88 are roughly the same elevation relative to MLLW. It is assumed that the correspondence between NAVD88 and MLLW observed for the COE Dock Station in Sausalito also exists for the foreshore (bayward margin) of Bothin Marsh. There are no long-term tide height data for Bothin Marsh or any other location near the upstream terminus of Richardson Bay.

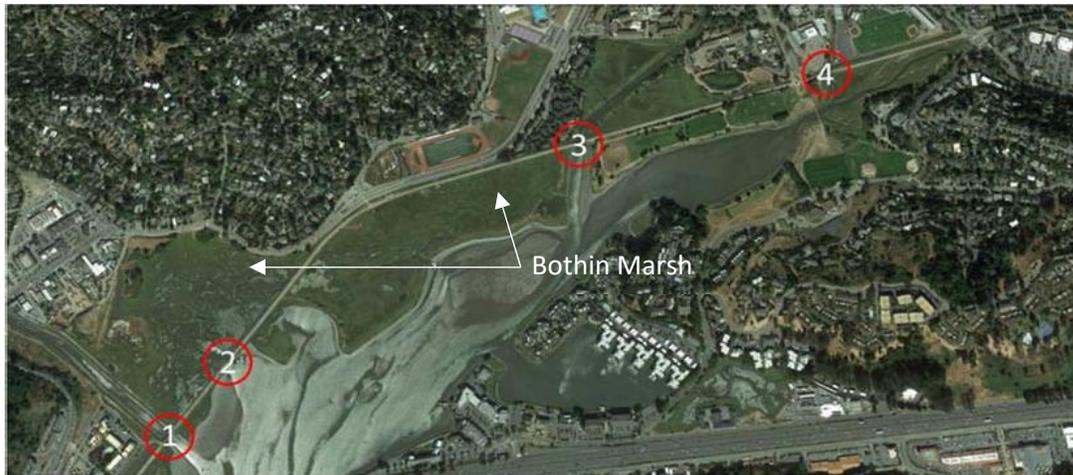
Figure 2.9 and Table 2.3. Locations of four bridges near Bothin Marsh and the associated preliminary forecasts of water surface elevation in feet relative to NAVD88, due to the combined effects of sea level rise, rainstorm discharge, and King Tide. The 50-year storm values were provided by FEMA. King Tide values were evidently taken from the nearest NOAA Tide Station (COE Dock Station 9414819 in Sausalito). The forecasts for seal level rise were provided by NRC (NRC 2012), using the 66-inch value for 2100. Wave run-up was disregarded. All elevations are relative to NAVD88, which equals MLLW minus 0.17 feet.

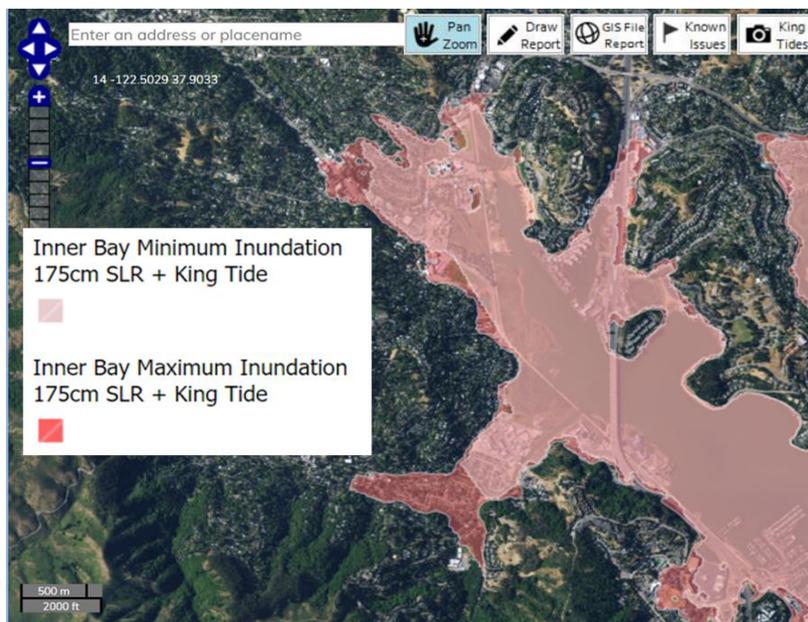
Figure 2.10. Screenshot from the OCOF website showing estimated future inland extend of tidal flooding due to about 69 inches of sea level rise plus maximum predicted King Tide. Stream flow and wave run-up are disregarded. Note that the minimum predicted tidal inundation extends inland and upstream beyond the

For the purpose of illustration, OCOF was used to estimate the extent of future tidal flooding at Bothin Marsh (Figure 2.10). OCOF enables the user to choose among a fixed set of sea level rise scenarios, and to choose whether to address King Tides or wave run-up. A sea level rise forecast of 66 inches for 2100 is not available. The 68.4-inch (5.7 feet) scenario was selected instead, plus the maximum expected King Tide. The forecasts for the ongoing Bothin Marsh bridge study and the OCOF illustration therefore differ by a few inches (68.4 inches versus 66 inches). However, the OCOF provides a reasonable approximation of the extent of flooding for the 2100 conditions being considered in the bridge study. It should be noted that the OCOF illustration does not reflect any changes in landform or land use related to migration that might affect the future extent of flooding.

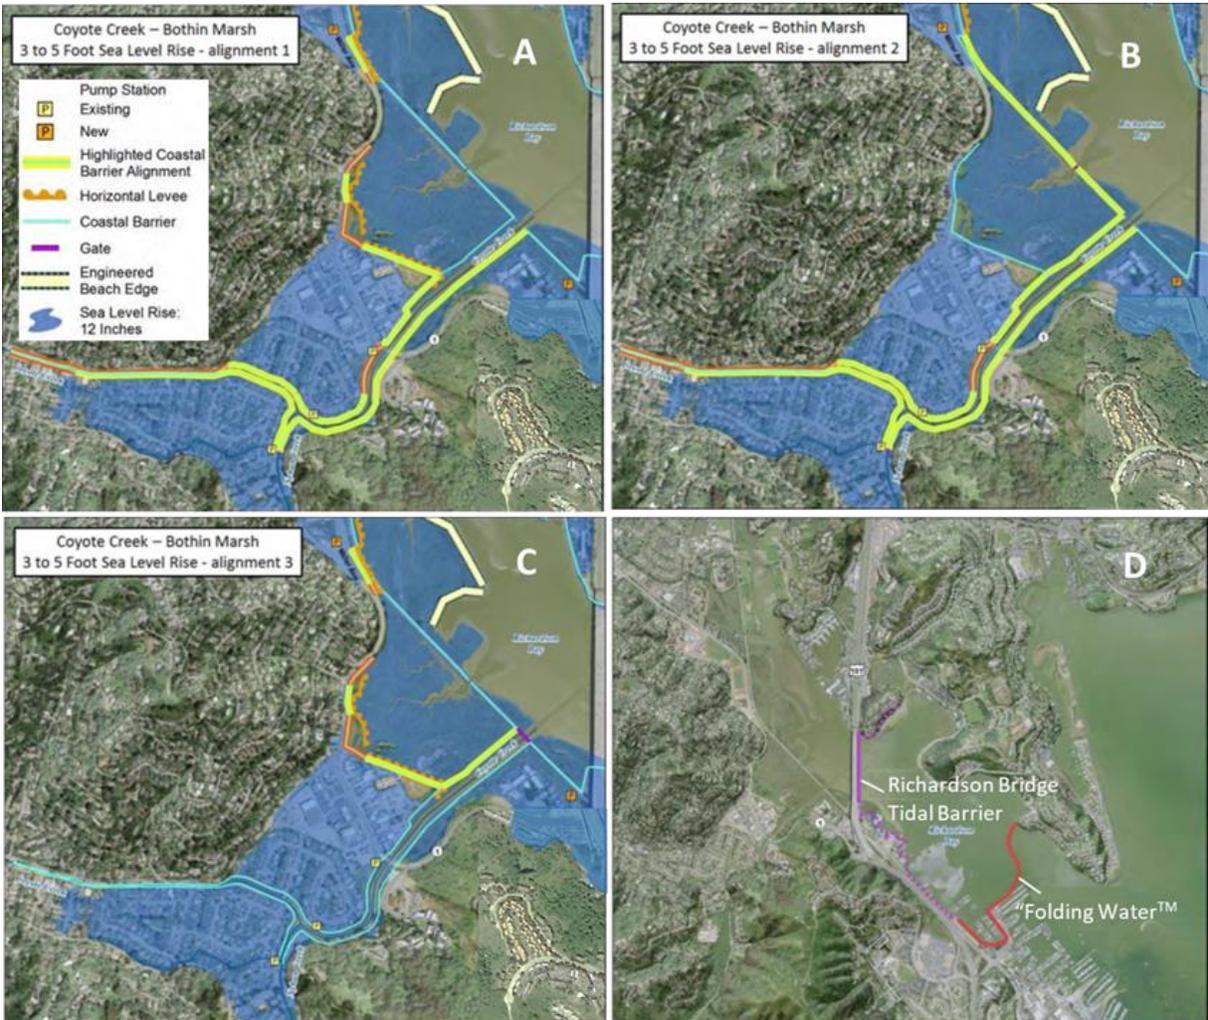
Figure 2.16. Example alternative alignments (A-C) for containment features at Bothin Marsh for a sea level rise of 3 - 5 feet NAVD88, plus (D) possible alignment of features affecting tidal containment throughout upper Richardson Bay (Leventhal 2015).

A variety of possible alignments of containment features were developed based on sets of reasonable assumptions about flood control needs (Figure 2.16). The alignments serve to illustrate an approach to land use planning and do not represent the findings of final engineering studies. It should be noted that the alternative alignments were developed without the benefit of more recent studies showing how containment in one area of an embayment can affect flood risks elsewhere in the same embayment (Holleman and Stacey 2014, Stacey 2017). The idea of preventing tidal excursion into upper Richardson Bay (see Figure 2.16D, and Kennedy 1957) probably has serious implications for flood risks in others parts of San Francisco Bay. Individual containment projects will need to be assessed in terms of their cumulative effects on sea level rise and tidal flooding at a variety of spatial scales.

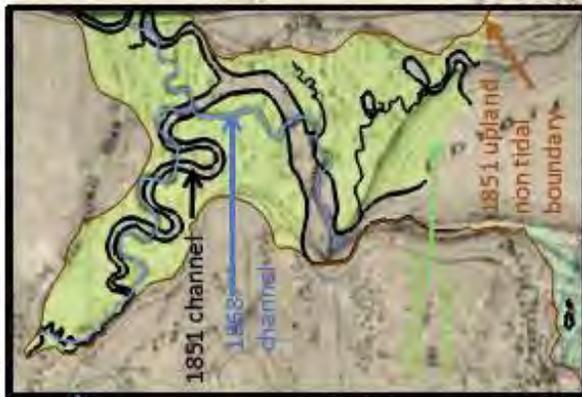
Ref
12

Detail showing comparison of 1868 channel position and sinuosity to 1851. Note the 1868 map appears to be a conceptualized channel and shoreline. A better survey was done in 1870 of the marsh shoreline. The 1851 marsh boundary is shown in green with the brown line representing the upland non-tidal boundary.

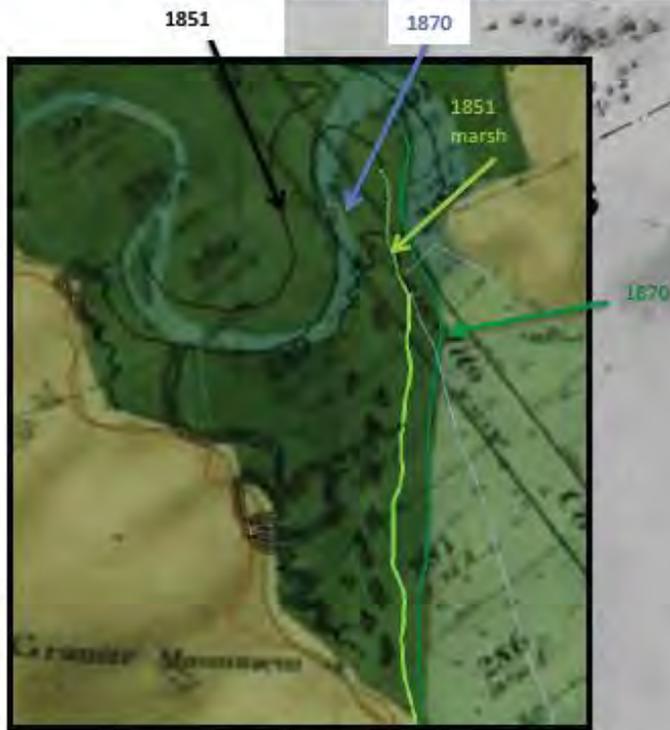
Ref
18

Note in the detail below that the 1870 channel has become much narrower than it was in 1851.

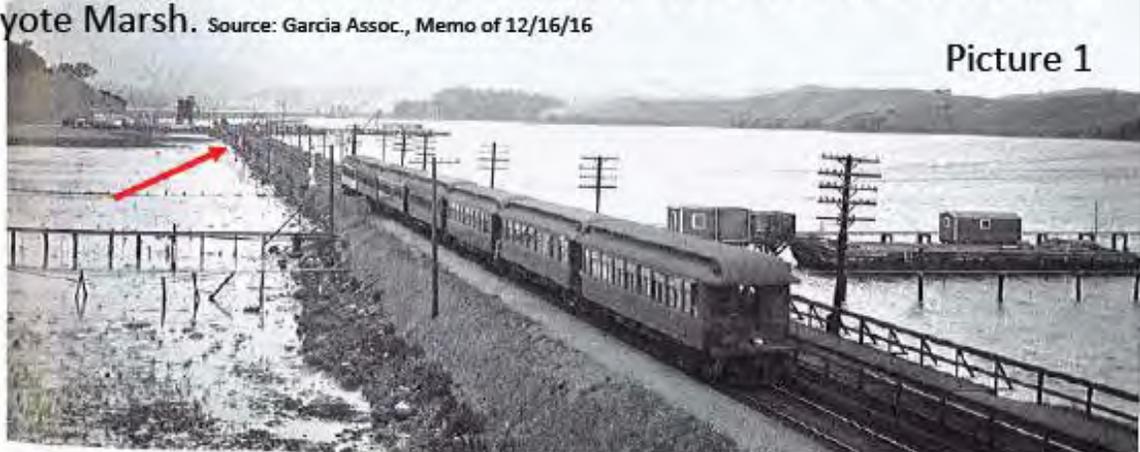
Picture 1

Upper photo is looking northward from Sausalito at a RR levee along Sausalito south of Bothin Marsh. It looks like the drawbridge of the Redwood Bridge of Hwy 1 can be seen in the distant background. Note how high the RR levee is with new fill for the double track. By 2017 in Bothin Marsh sediment has filled substantially to a greater height along both sides of the RR. The red arrow is presumed to be pointing at an outlet beneath the tracks.

The lower photo shows Almonte Marsh to either side of the tracks while looking northward where the Mill Valley branch splits from the San Rafael Branch

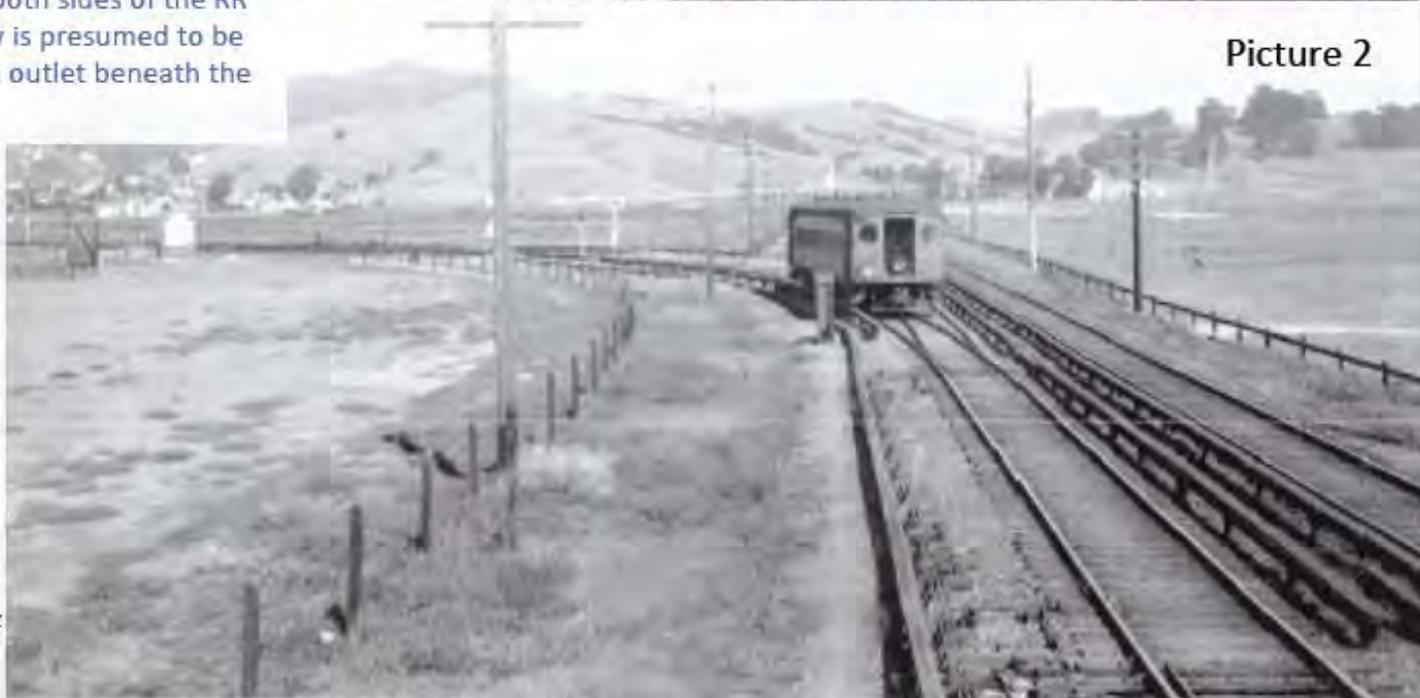
Picture 2

Circa 1898, looking northward along the Mill Valley branch of the NWPRR just beyond the intersection with the San Rafael branch that veers eastward and future Tam Valley High School location, which would be to the southwest. All portions of the tidal marshlands in this photo are bounded and influenced by an altered tidal prism from the railroad berms.

<p>Picture 2 of Image Ref #35 shows the junction of the Mill Valley and San Rafael rail lines along Almonte Marsh. The marsh along the west side of the Mill Valley branch appears dryer, perhaps due to the muted tides caused by the Railroad levee constructed along the eastern foreshore of the marsh in 1883.</p>
1898	36, 37		<p>The Mill Valley Branch of the rail line pictured in Image Ref #36 was taken in 1898 and shows sparse development in the background hills. It seems likely that the previous undated picture 2 photo of Image Ref #35 post-dates Image Ref #36 because it shows much more hillside development. The Mill Valley branch further dissected Almonte Marsh, restricting tidal flow to the marshlands on the western side of the tracks to small culverts beneath the railroad levee. This further reduction in tidal prism and resulting poor drainage caused the former channels on the west side of the tracks to become pannes or potholes. Much of the marsh vegetation in the backshores of Almonte Marsh during this time appears to be dominated by pickleweed or other low-growing, salt-tolerant vegetation.</p> <p>Image Ref #37 shows what appears to be a narrow channel in the mudflats connected to the inlet to the Coyote Creek Embayment at the recently shortened trestle. This image also shows an area of light shading at the flatlands between Coyote Creek and Tennessee Creek. The shading is consistent with reflection off standing water. The area may be ponded due to flooding or irrigation. The tides are low in this image, suggesting that any flooding upstream is not tidal.</p> <p>The abandoned 4000-ft-long railroad trestle across Richardson’s Bay between Strawberry Point and Sausalito can be seen very faintly in the background of Image Ref #37.</p>

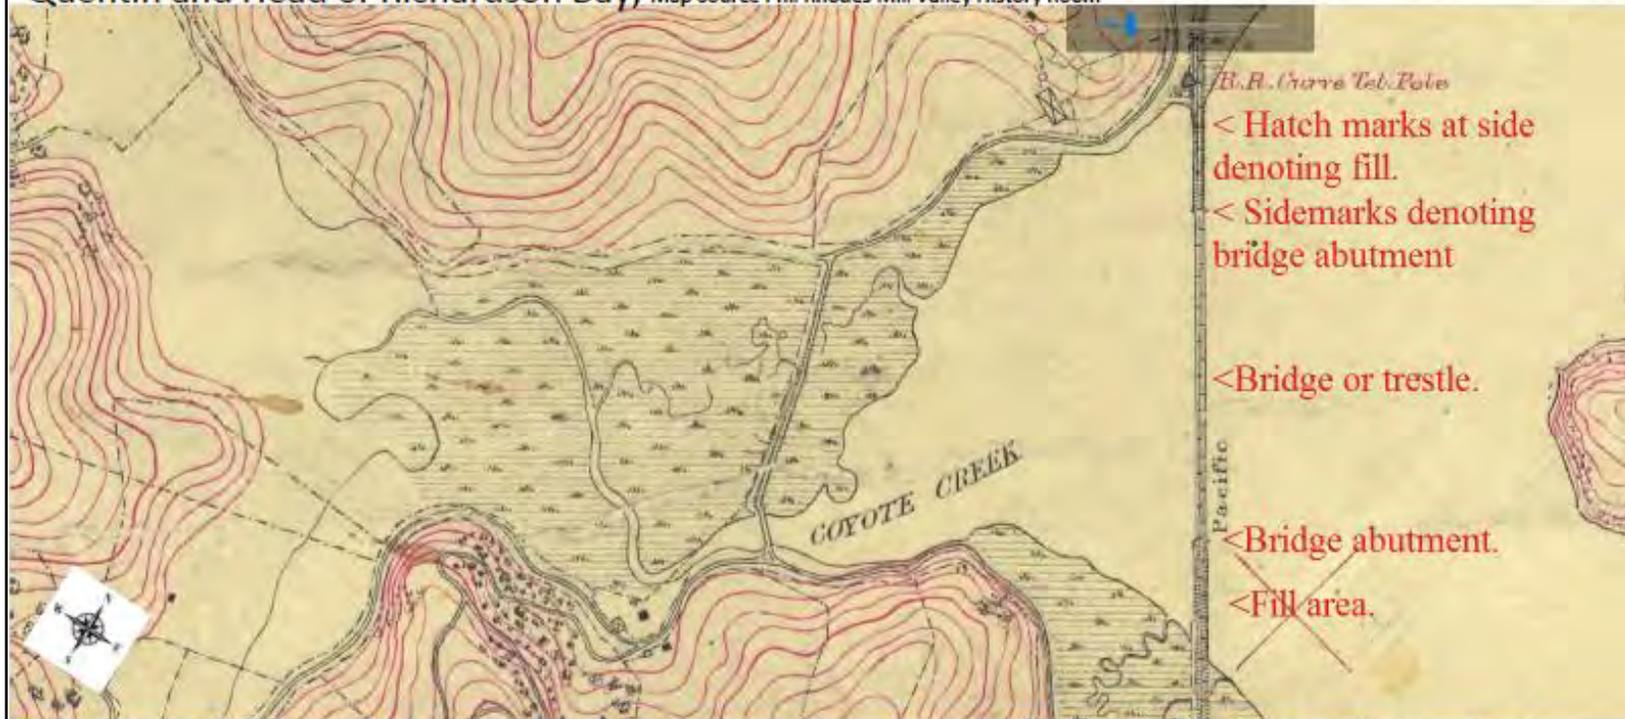
1899, Detail of T-sheet 02485 USCGS, San Francisco Bay, California, City Point to Point San Quentin and Head of Richardson Bay, Map Source Phil Rhodes Mill Valley History Room

Railroad trestle is here depicted in detail. Outside hatch marks typically denote fill. Bridge abutments are denoted with curving outside lines that bend away from the span. These are clearly evident on this map. While there is no certainty this 1899 map is entirely correct in its depiction of the rail line here, Rhodes (Mill Valley Library History Room) considers it unlikely that the surveyor and drafter of this map would have gotten such key details on a waterway wrong. Source: 1899 T-sheet from P. Rhodes, email 4/25/2017. Historians from the NWPRR Society state that the trestle was replaced with a berm in 1894 (verbal communication to L. Collins). This seems consistent with information developed for this report. The length of the original trestle over the Coyote Creek Embayment appears to have been about 1310 feet long while the total amount of berm extending across the bay from the 1899 shoreline to the trestle was about 850 feet.

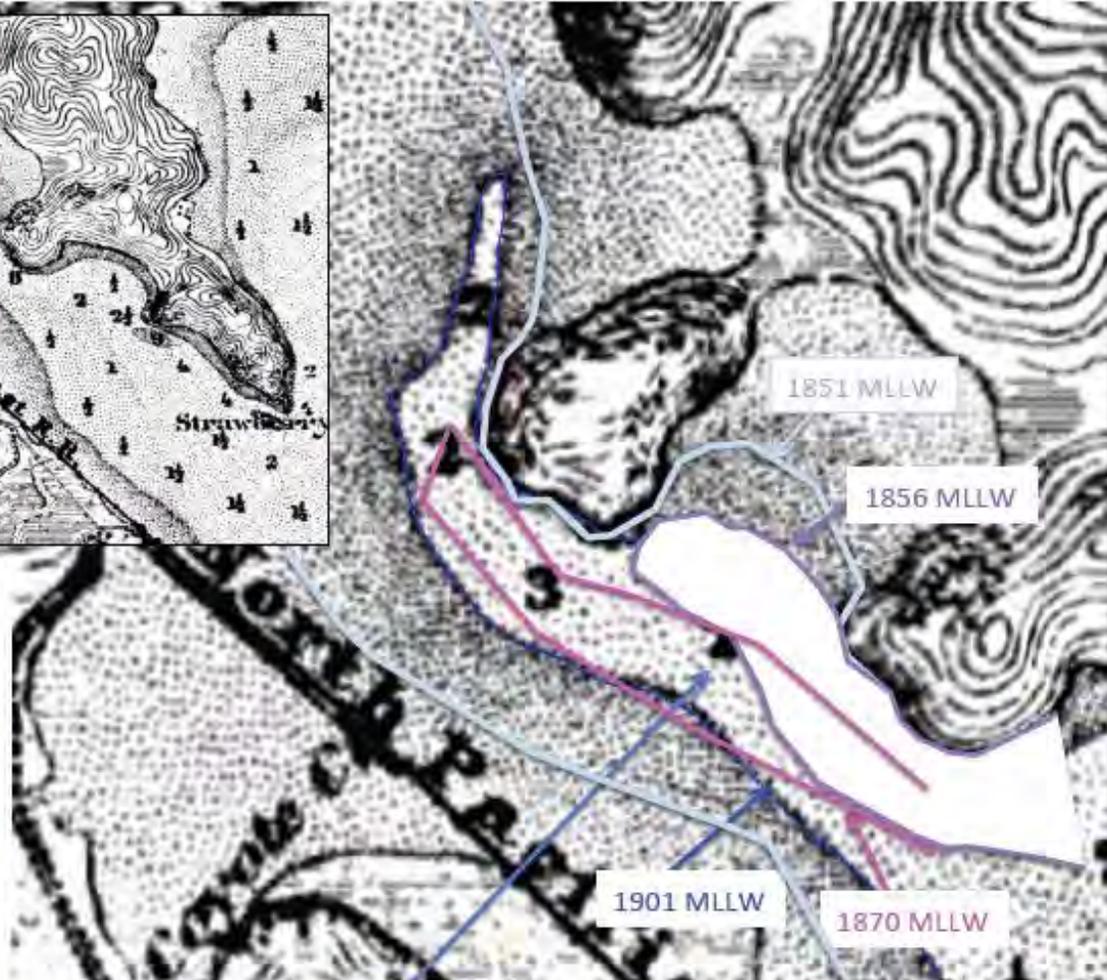
Ref 44 Note - Soundings are in feet above MLLW. Shallow mudflats continue to be more extensive than they were in 1851 (light blue line), but following the extensive sedimentation in 1856 (purple line), the MLLW boundary has been progressively expanding and deepening landward since 1870 (pink line).

Note – older mapping was used on this chart for the marshes and channels and therefore does not represent landscape conditions other than bathymetry relative to 1901.

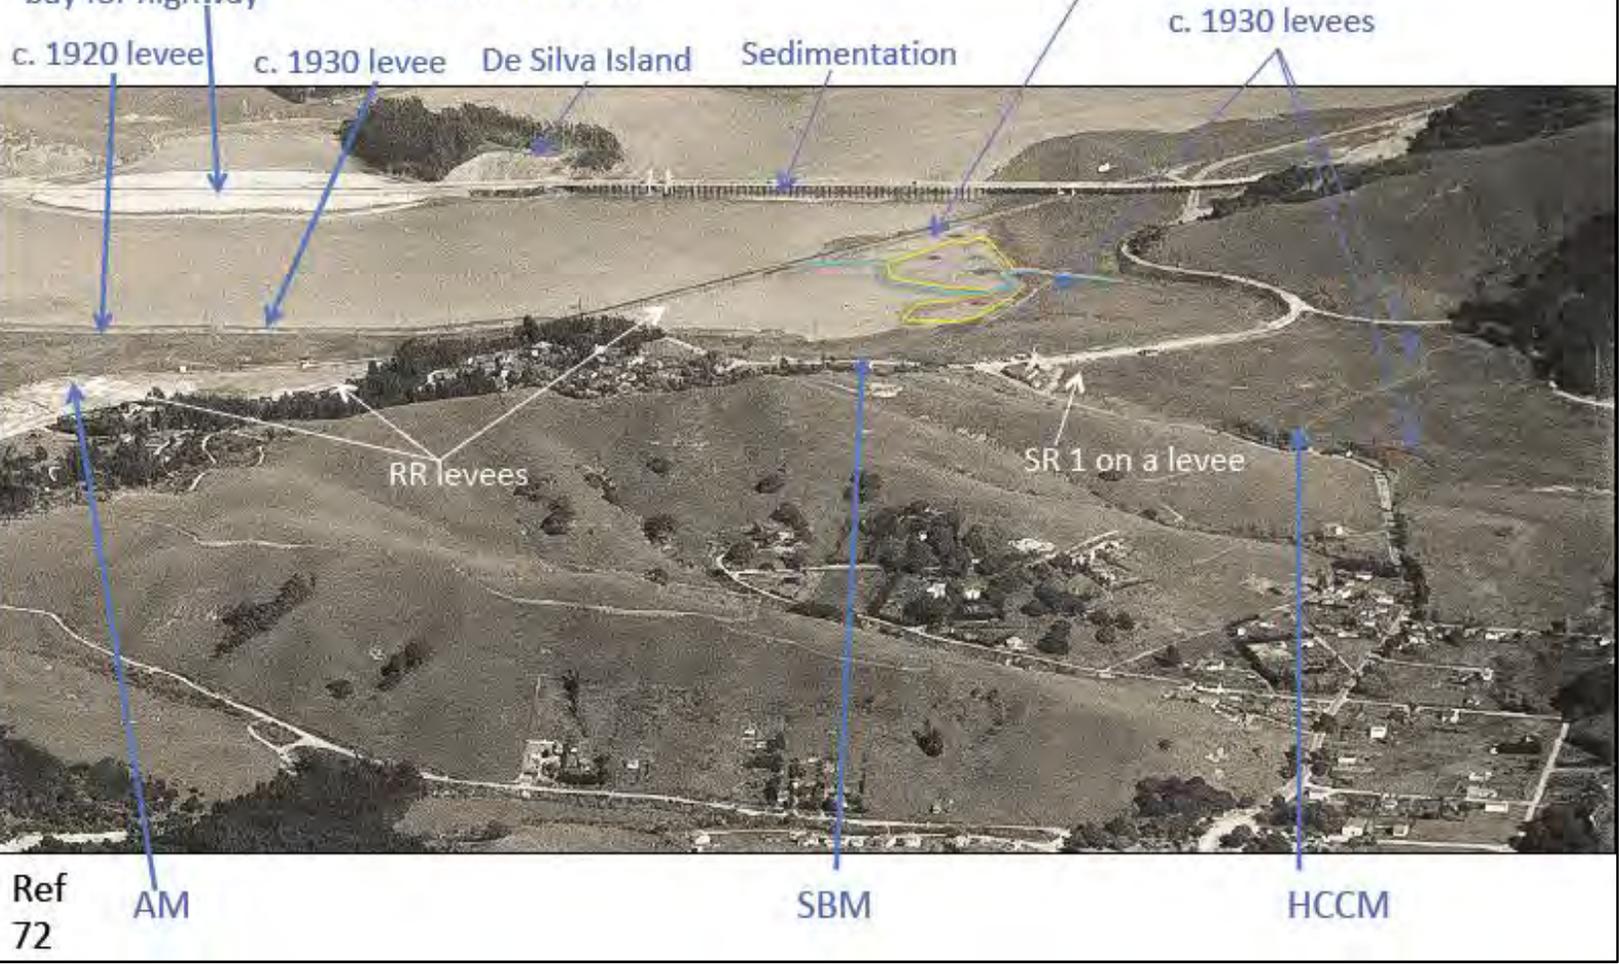
The Coyote Creek tidal (turquoise line) channel has significant sinuosity within its delta fan (yellow line) that is forming at the channel mouth.
Artificial fill placed in bay for highway

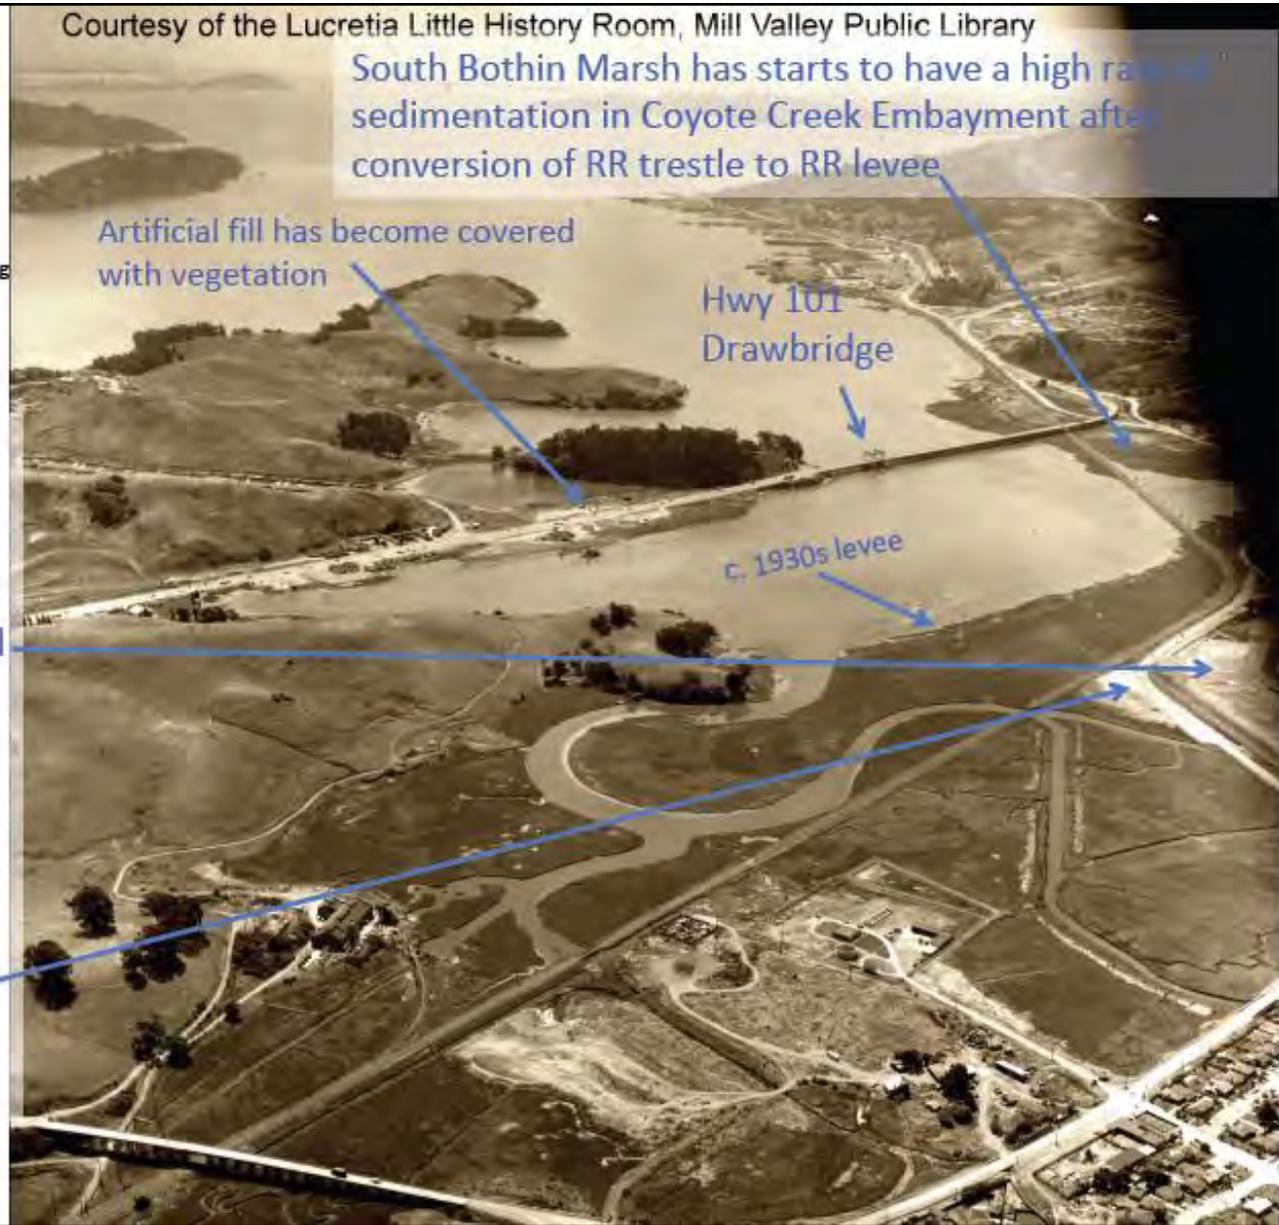
Ref
78

This later c. 1931 sports field is constructed to south of the earlier 1923 track. Artificial fill has been placed over much of the former Almonte Marsh on the west side of Mill Valley RR branch and in the small triangle between the two branches.

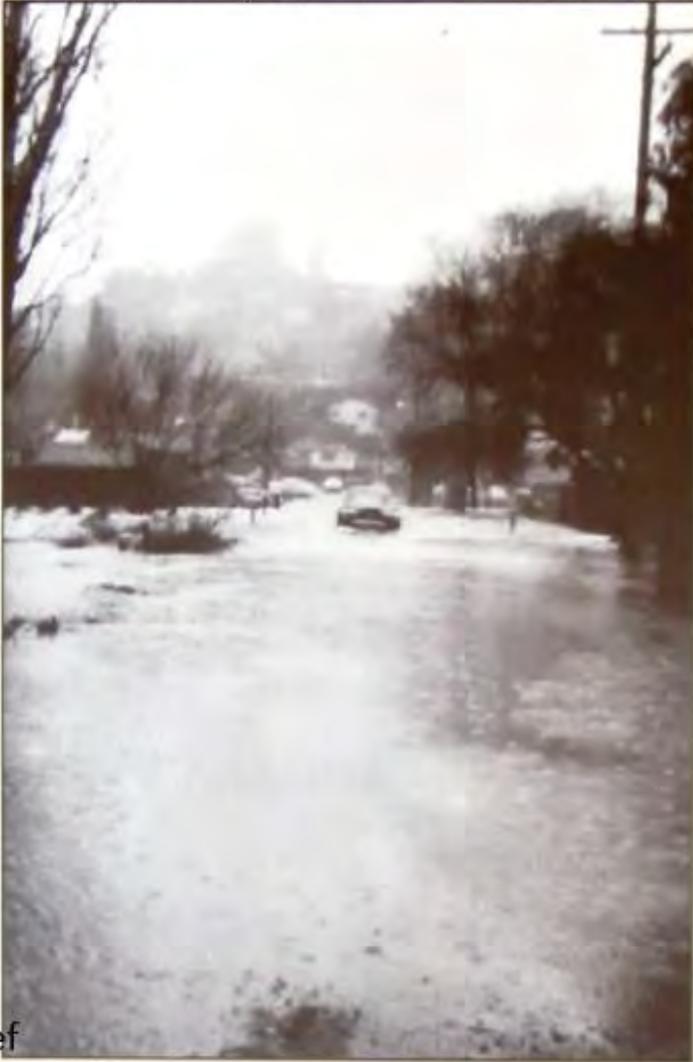
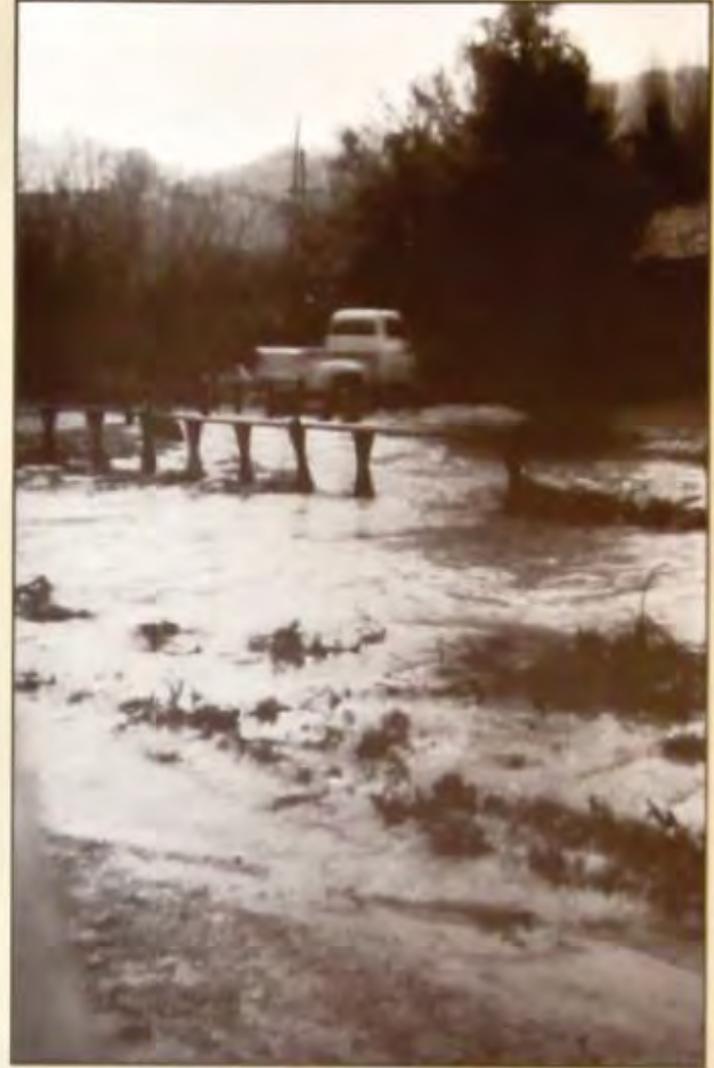
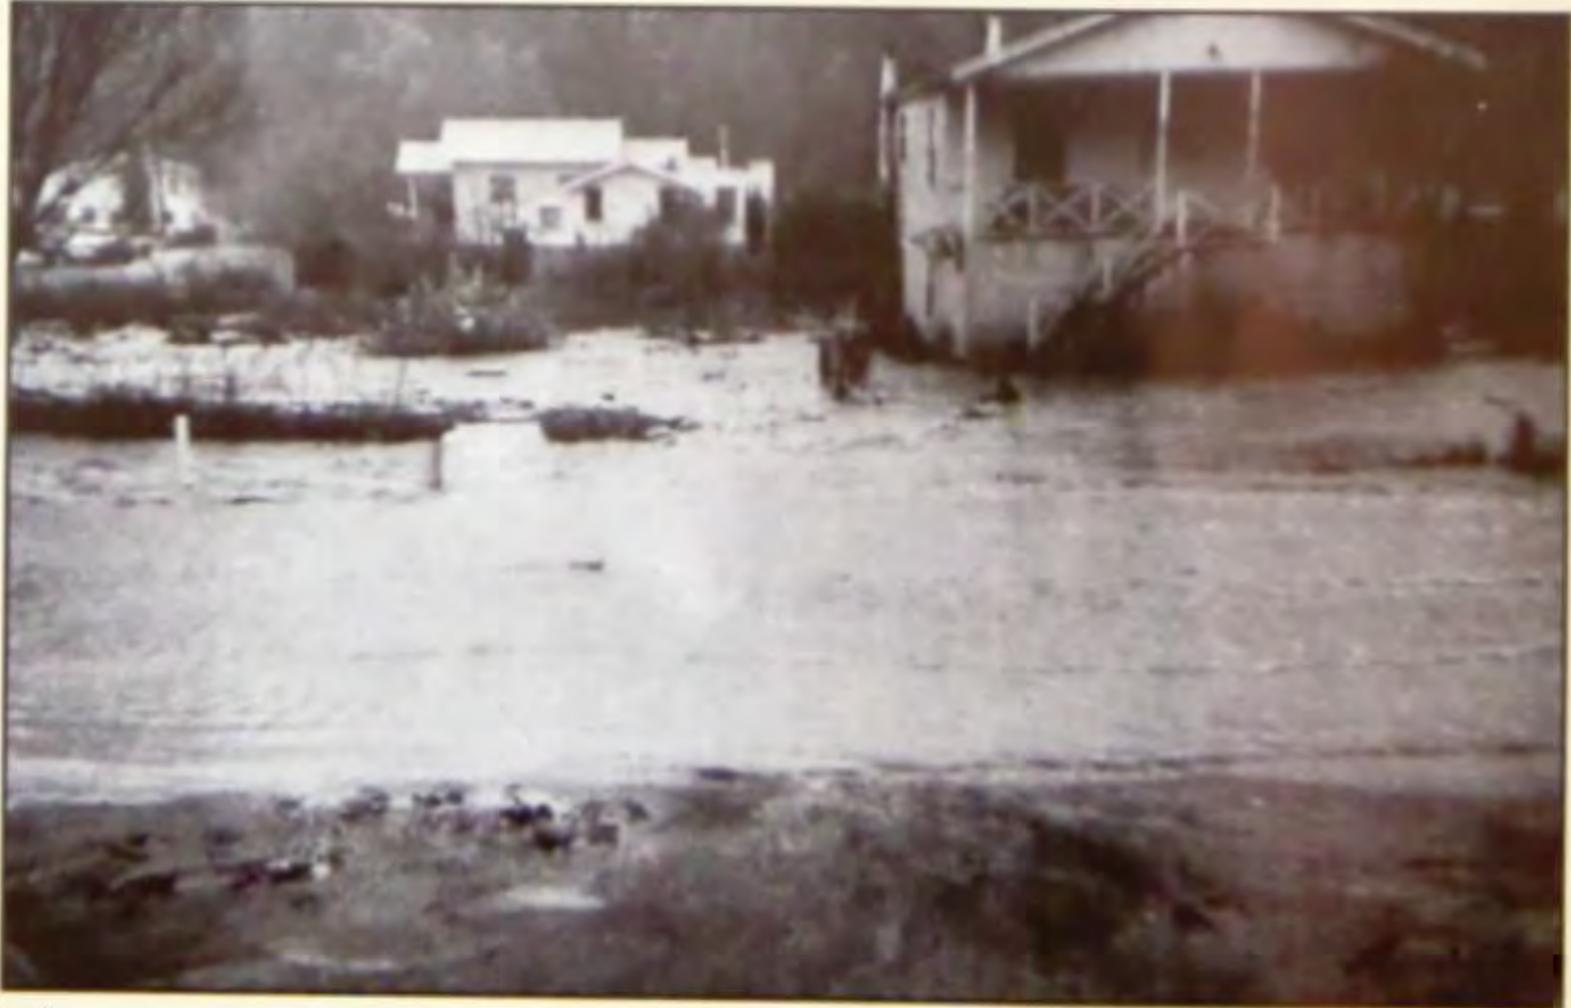
Ref
82

MAIN ST. (LAUREL) TOWARDS SHORELINE

SHORELINE BETWEEN PINE & SPRUCE

SHORELINE BETWEEN POPLAR & PINE ST.

Dec 1955	82 83	Significant flooding throughout the Bay Area due to intense rain	<p>Flood at Arroyo Corte Madera del Presidio was caused by 9 inches of rainfall over the watershed that resulted in a peak discharge of 1400 cfs at the Camino Alto Bridge (USACE 1968). Flooding was widespread and ultimately led to the start of many flood control projects that straightened and diverted channels throughout Marin County.</p>

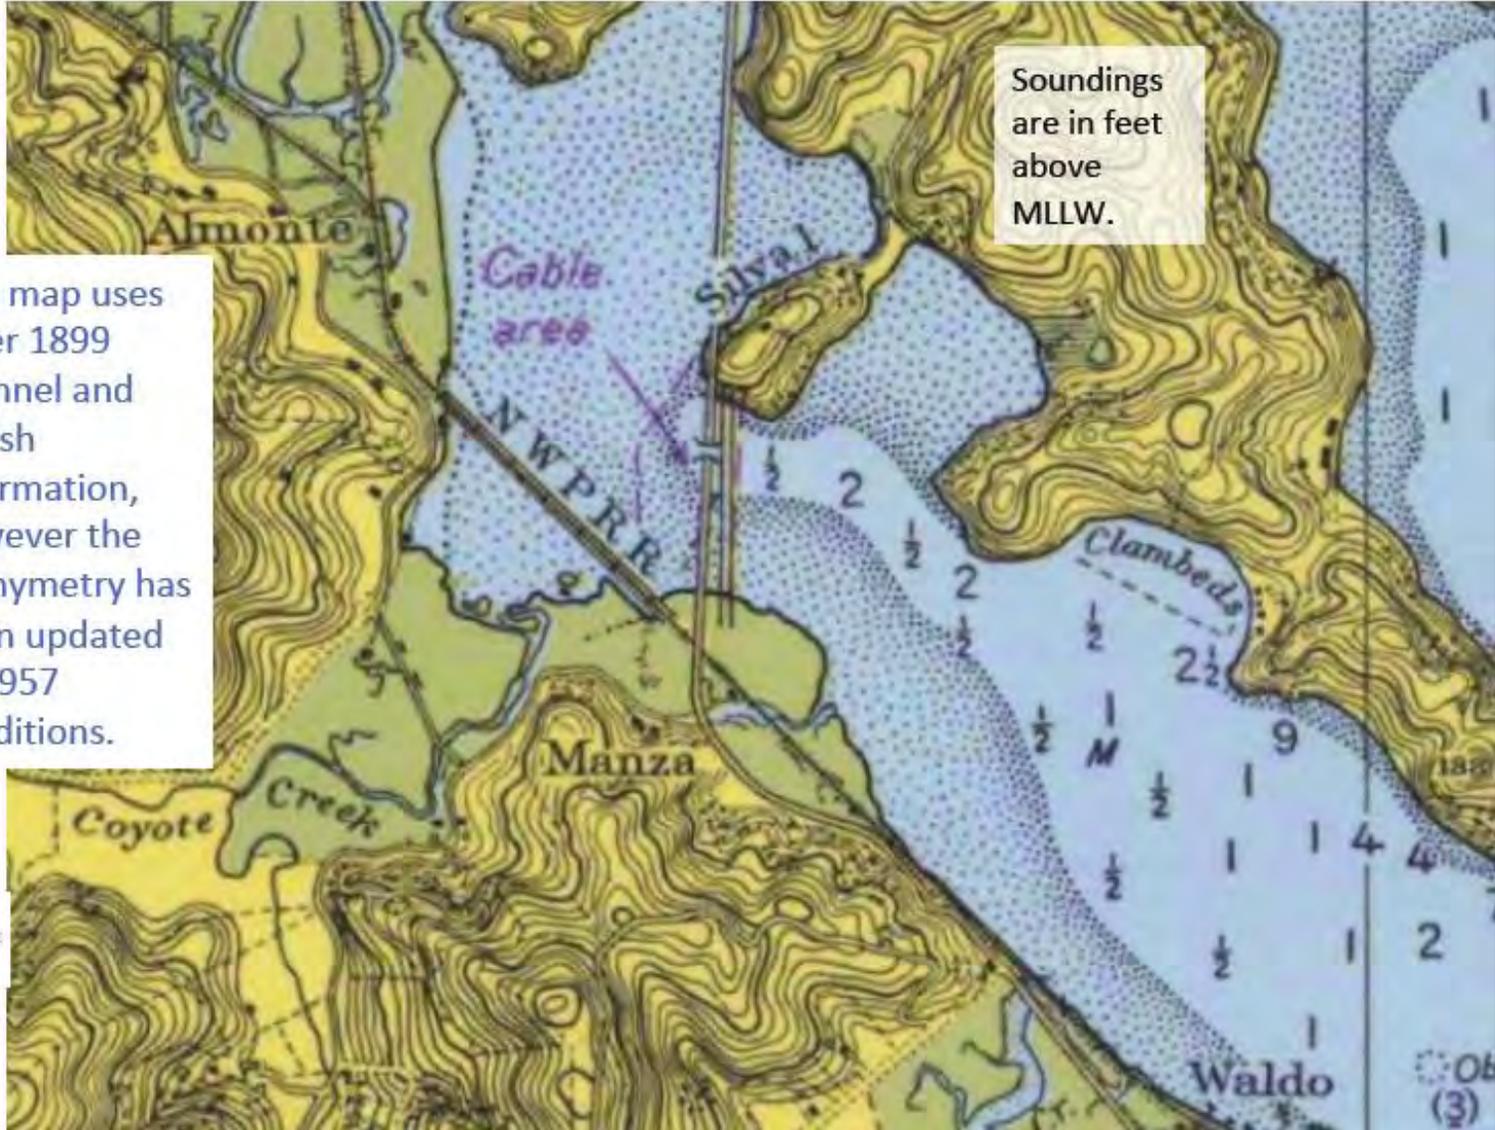
This map shows the changing conditions of the MLLW boundary. It shows that following 1851 (light lavender line) sedimentation in the bay pushed the 1856 boundary significantly southward (violet line). This might have been related to the influx of hydraulic mining sediment from the Sierra and local logging and ranching activities. By 1901 the shallow bay deepens northward (navy blue line), but by 1956 it shallows again, nearly approaching the 1856 boundary of MLLW. The latter period of shallowing might relate to loss of tidal prism from marsh reclamation and bay filling, as well as increased sediment supply from grading for urban development, channel diversion and channelization, and 1956 record flooding.

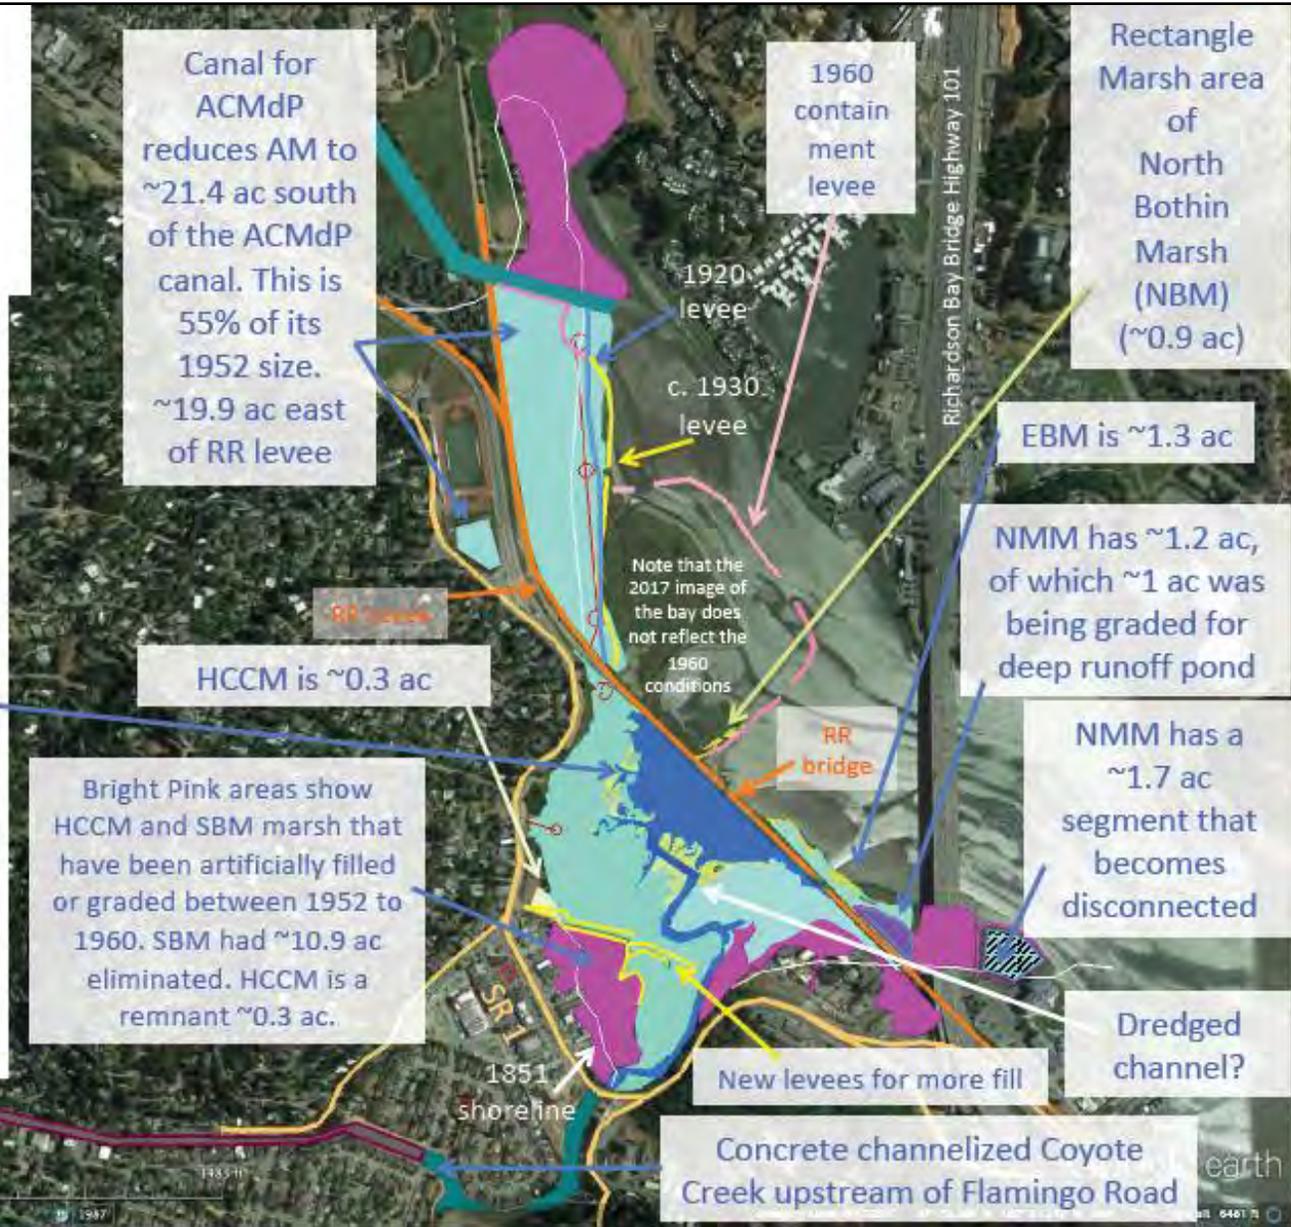
Between 1952 and 1960 as interpreted from earlier and later aerial photos and from the 1960 oblique photograph in Image Ref #87, SBM decreased in size from ~35.4 ac to ~28.0 ac. This included some progradation into the embayment (light green) but also loss of marsh from grading and filling. SBM became 79% of its maximum size in 1952. Coyote Creek Embayment also decreased from ~12.0 ac to ~10 ac, becoming 21% of its original size.

Canal for ACMdP reduces AM to ~21.4 ac south of the ACMdP canal. This is 55% of its 1952 size. ~19.9 ac east of RR levee

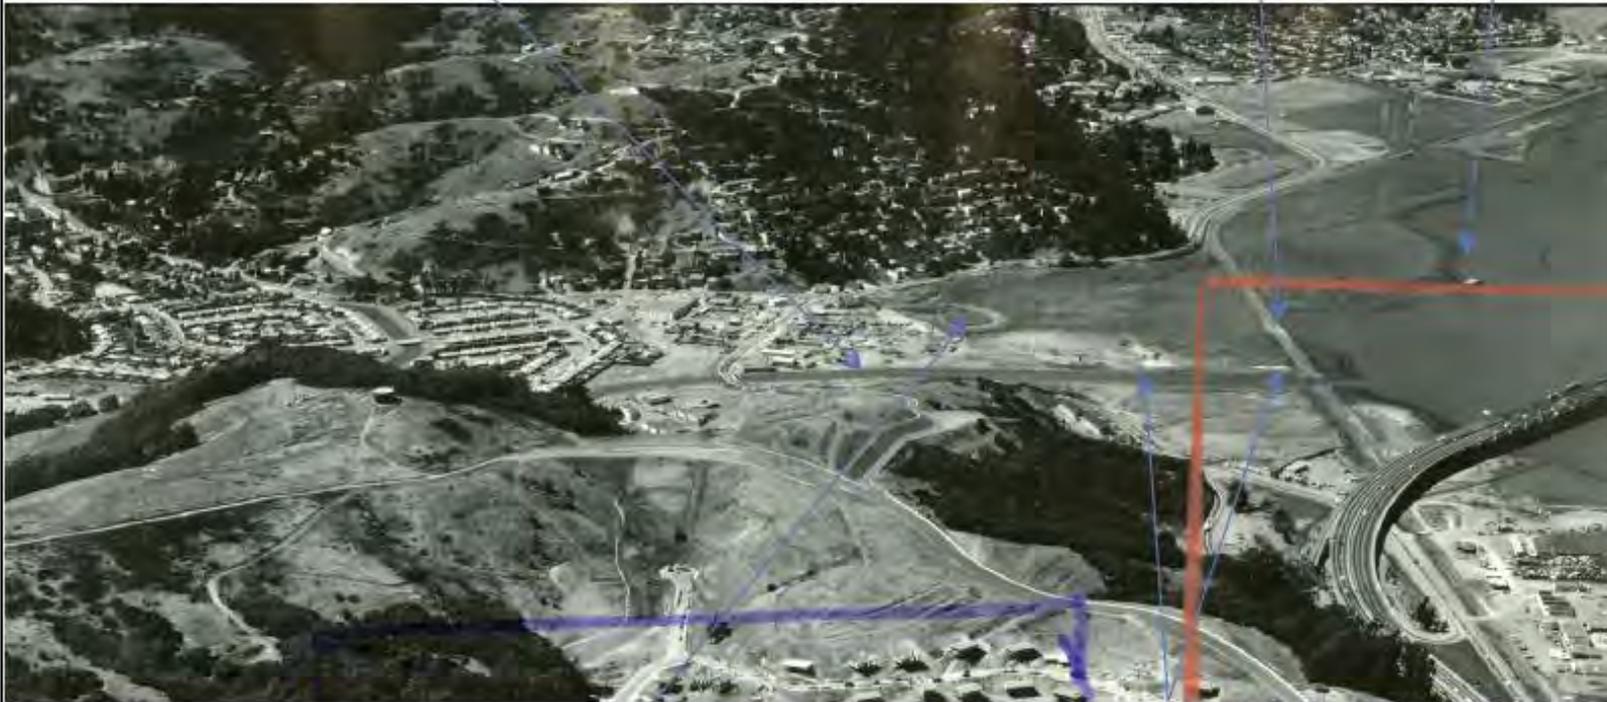
Ref
92

Artificial fill placed for narrowing the opening of Coyote Creek Embayment

New interior containment cell levee under construction (dredge in picture).

Artificial fill placed c. 1961?

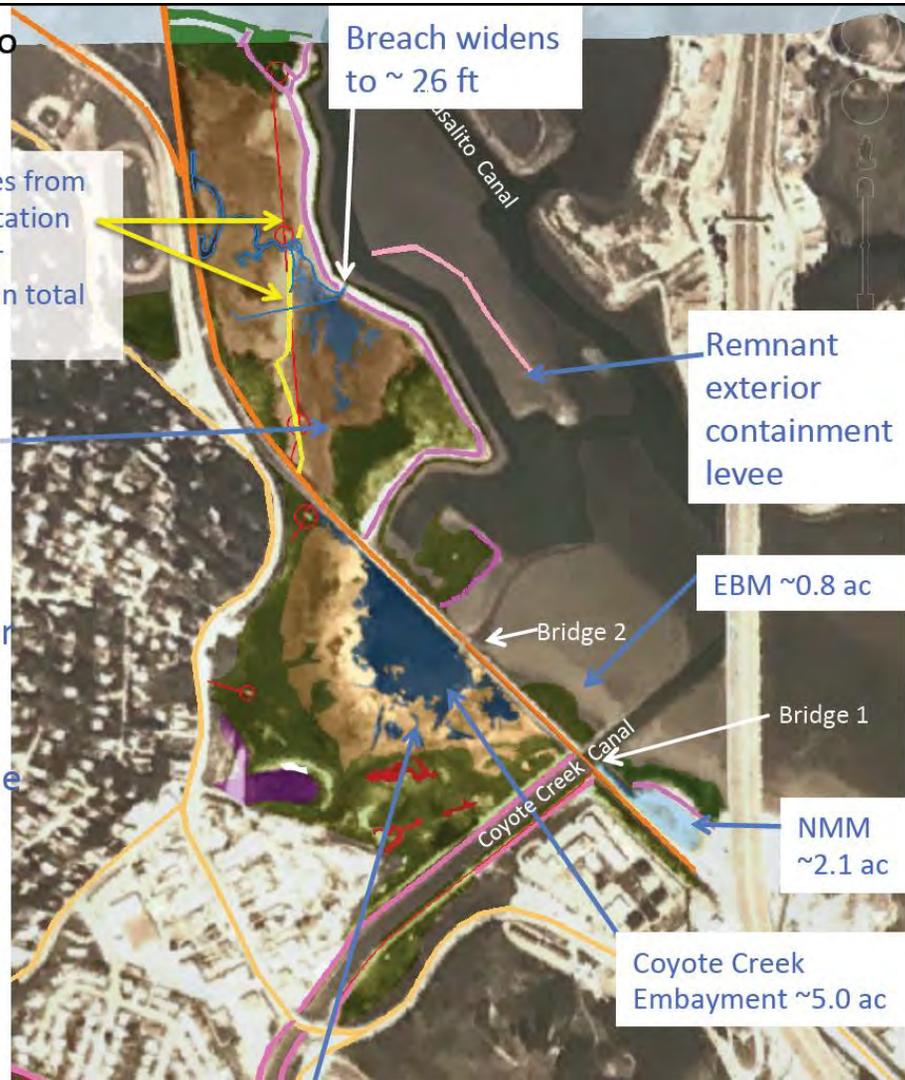
Ref
109

High marsh forming NBM on dredge spoils that were placed on former mudflats of Richardson Bay. NBM ~14.0 ac (4.4 ac subject to desiccation, ~ 1.7 ac inner bay, ~4.9 vegetated, ~2.1 ac Rectangle Marsh, ~0.9 ac outer levee)

Breach of western edge of the former "inner berm" levee provides tidal connection to NBM but still very limited tidal connection to AM due to c. 1930 levee. A portion of the inner mud flat was deep enough that it maintained an open water embayment whereas much of the area that would previously become desiccated was now subject to diurnal tides.

SBM ~28.1 ac It has ~8.9 ac transitional ecotone (buff color) with low areas subject to ponding interspersed with patchy mud flats interspersed with sparse vegetation and that was subject to desiccation. There was ~19.2 ac upper ecotone marsh.
