Bothin Marsh Geomorphology, Ecology, And Conservation Options

Marin County Open Space District

January 2018

This report was produced on behalf of the Marin County Parks based on review of the science related to restoration and protection of tidal marshes in upper Richardson Bay, Marin County, California.

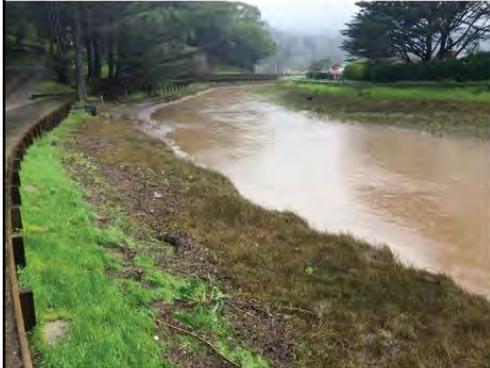
Sediment-rich water in Coyote Creek

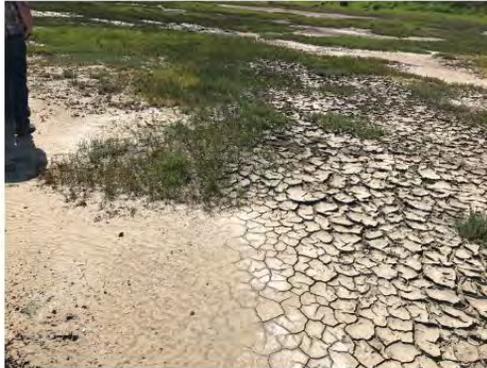
Desiccated backshore areas affected by muted tides

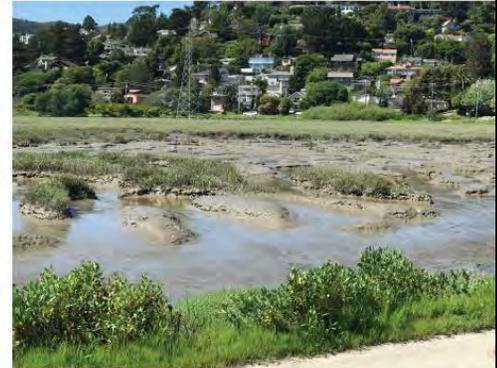
Channels deepening and erosion in the mudflats of the Coyote Creek Embayment

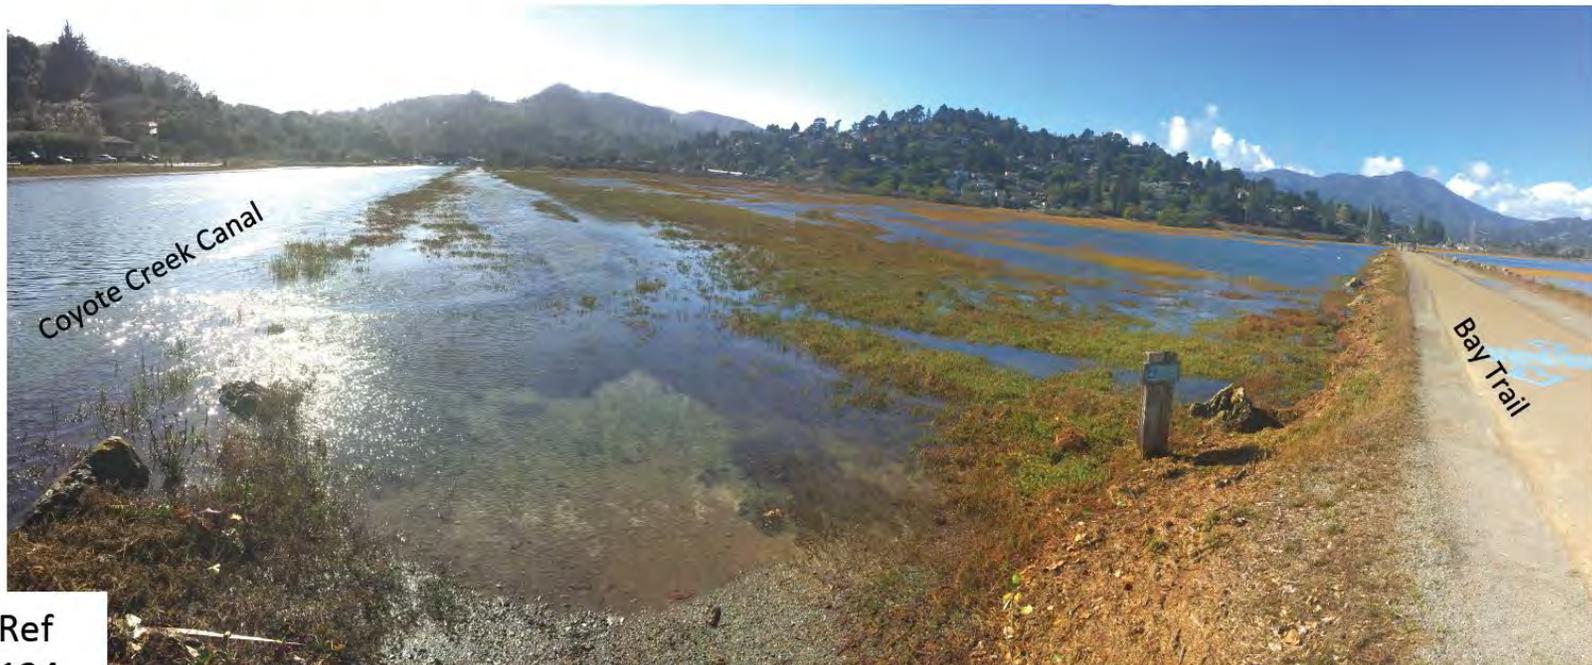
Ref
124

Looking northwest at high tide flowing from Coyote Creek Canal into the South eastern corner of Coyote Creek Embayment.

2017	123, 124, 125	Evidence of loss of high elevation marsh within SBM	<p>The photograph in Ref Image #123 show a very high tide where water is pouring out of South Bothin Marsh over the low north bank levee of the Coyote Creek Canal. This represents what will become an increasing condition with sea level rise, and will likely change much of the tidal dynamics of the marsh. This photo shows that if Coyote Creek were at a very large flood</p>

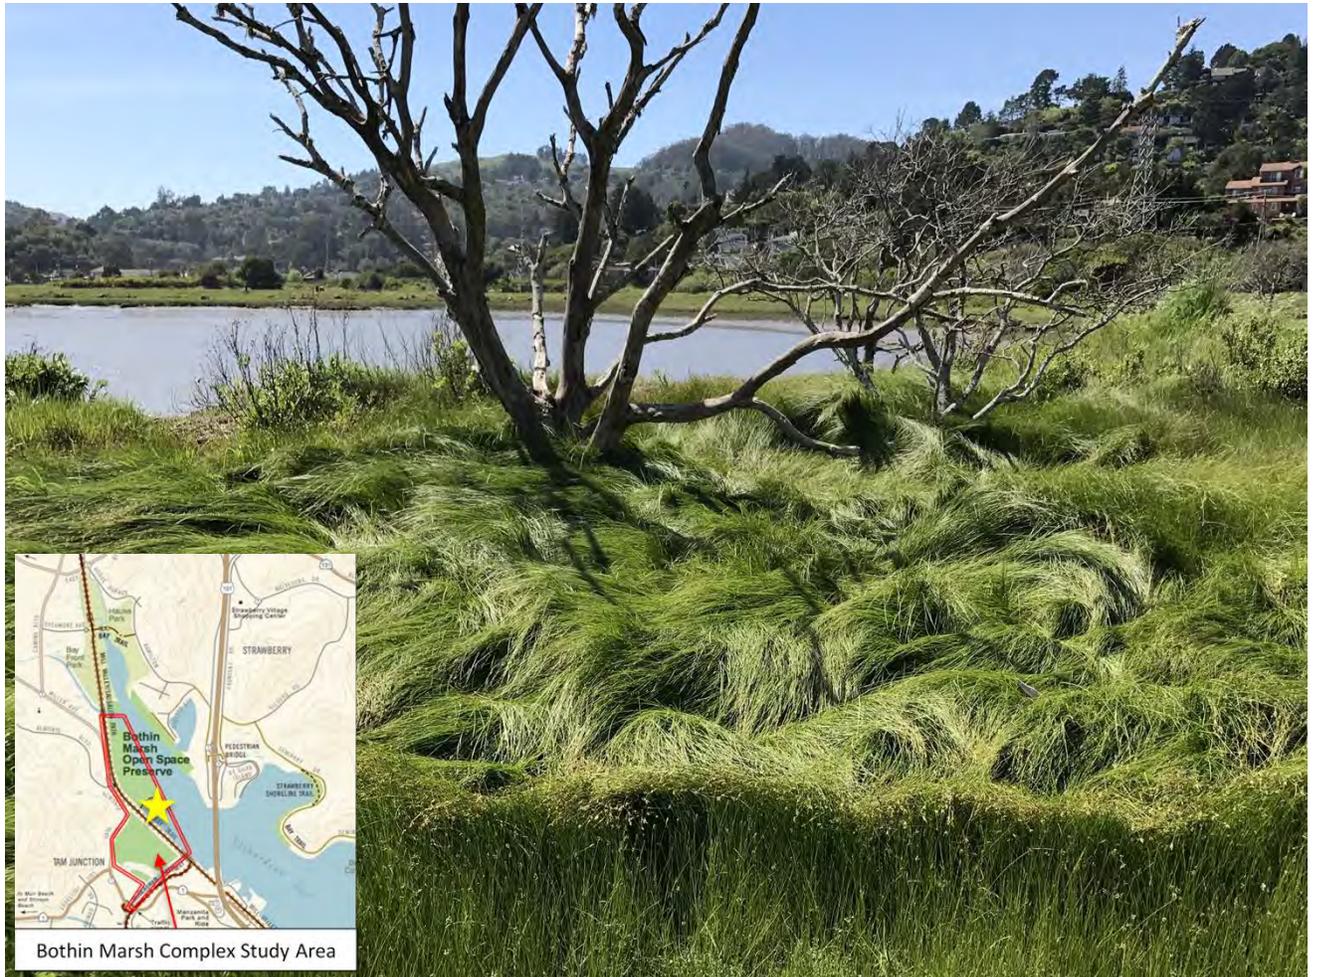
Chapter 3 final figure. South-facing view of native brackish tidal marsh vegetation with shallow roots flourishing on the leached sediments at the top of an historical unnatural levee along the southeastern foreshore of North Bothin Marsh, beneath planted shrubbery killed by salt water intrusion into its deeper root zone, due to sea level rise.

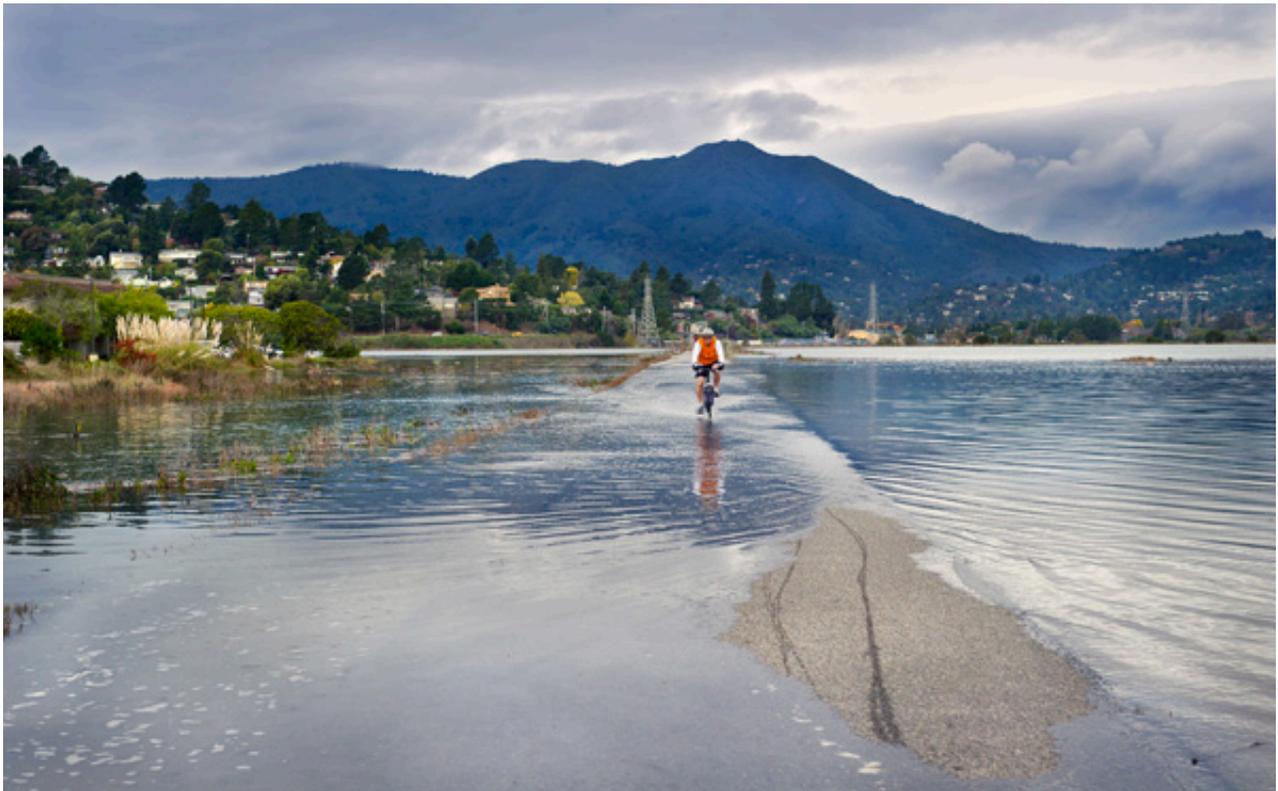
Figure 6.4. Flooding of the Bay Trail at South Bothin Marsh during spring 2012. Photo courtesy Tim Porter (<http://www.timporter.com/seconddraft/?tag=bothin-marsh>).

- *Are tidal flows across the Bay Trail impacting its structural integrity or maintenance needs?* Reviews conducted for this report revealed multiple references to tidal flooding of the Bay Trail within the Bothin Marsh Complex. However, no studies of the effects of the flooding on the Bay Trail or its levee were found. A study is needed, if an adequate one does not exist, to determine the timeframe for future repairs and preventive measures. The timeframe will determine when preventive measures should be integrated into mid-term or long-term adaptation strategies.
