PHOENIX LAKE LOG CABIN RENOVATION

BASIS OF DESIGN REPORT

THE MARIN MUNICIPAL WATER DISTRICT

**PHOENIX LAKE LOG CABIN
MARIN MUNICIPAL WATER DISTRICT
BASIS OF DESIGN REPORT**

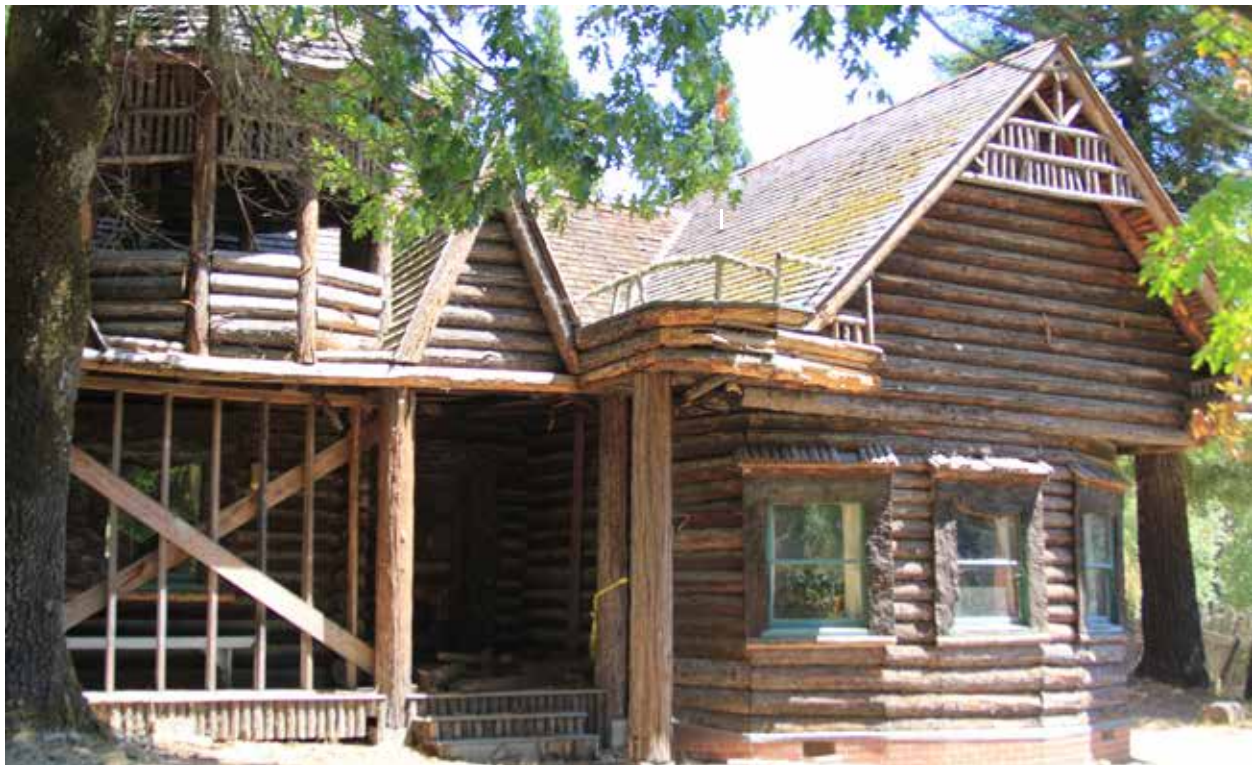
Phoenix Lake Log Cabin – Front (south), 2016

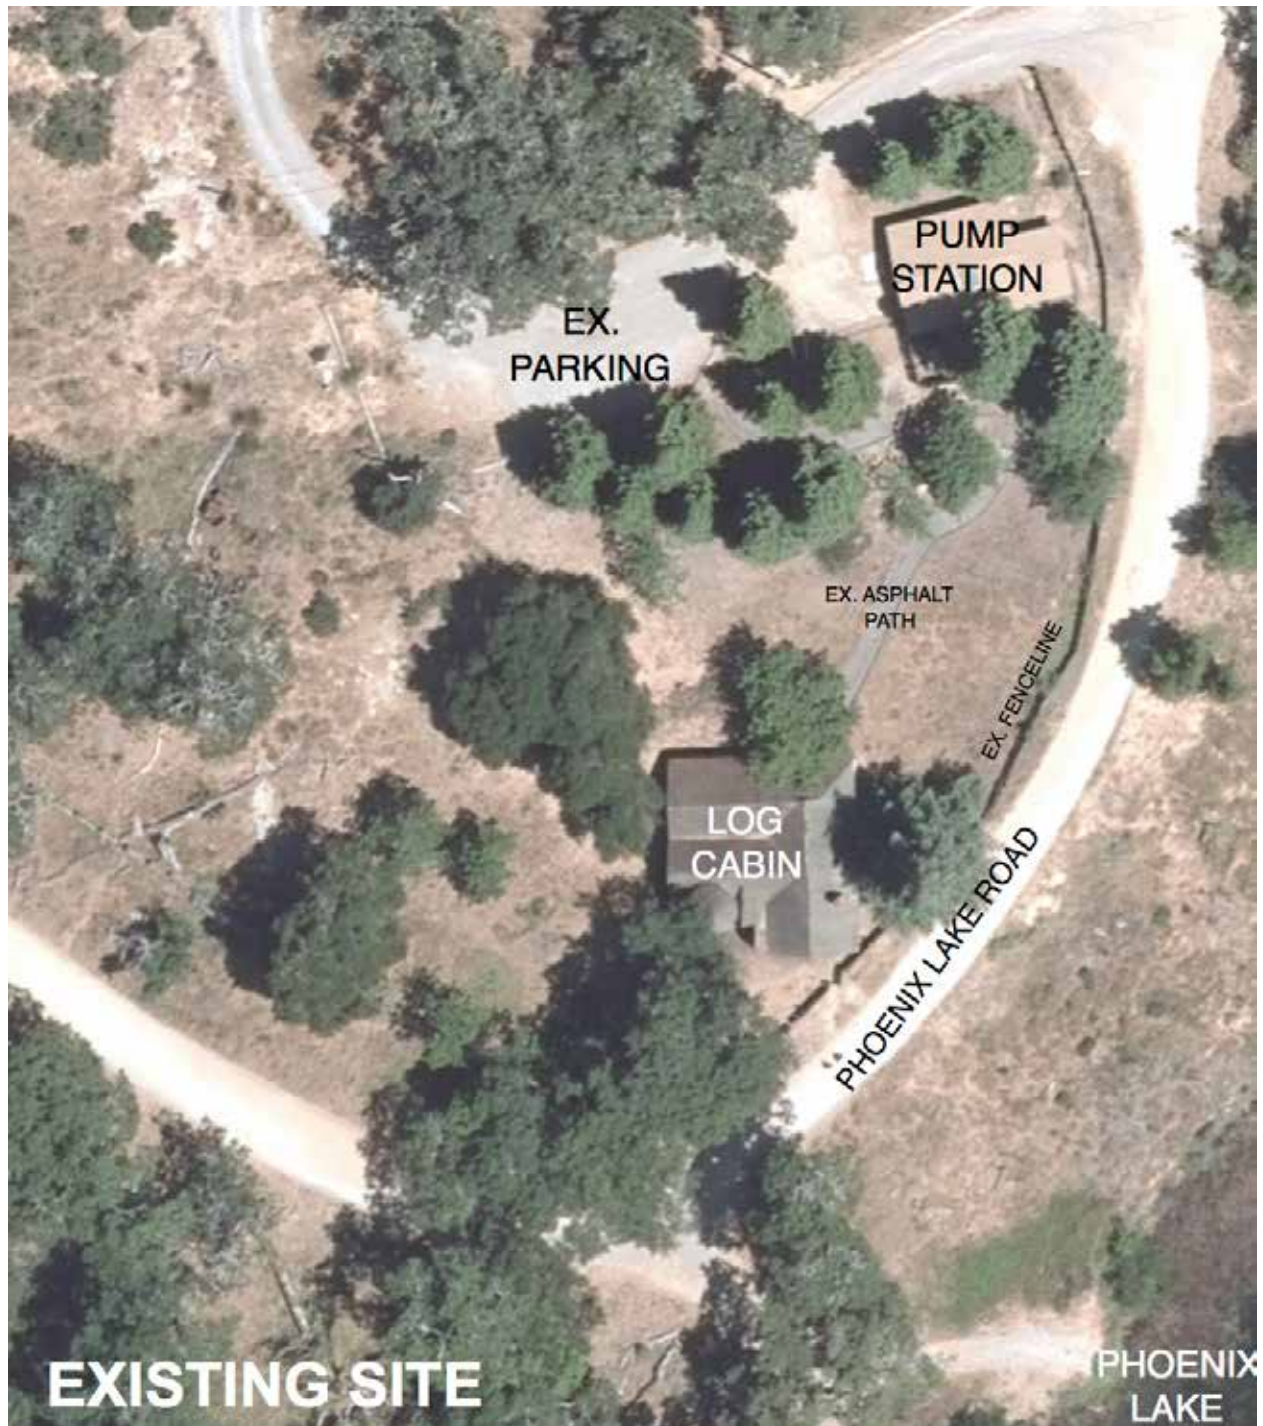
Phoenix Lake Log Cabin – Existing Site Plan (north is up)

Specific site conditions are limited since the Cabin is essentially freestanding and has no specifically related outdoor areas with the exception of parking and an entry path. The parking is located along the driveway above and to the north. The asphalt-paved entry path descends the slope in a meander, arriving at the rear porch. Both parking and entry pathway are improved to no more than a basic extent — the parking is unpaved and circumstantial, and the path while paved is makeshift.

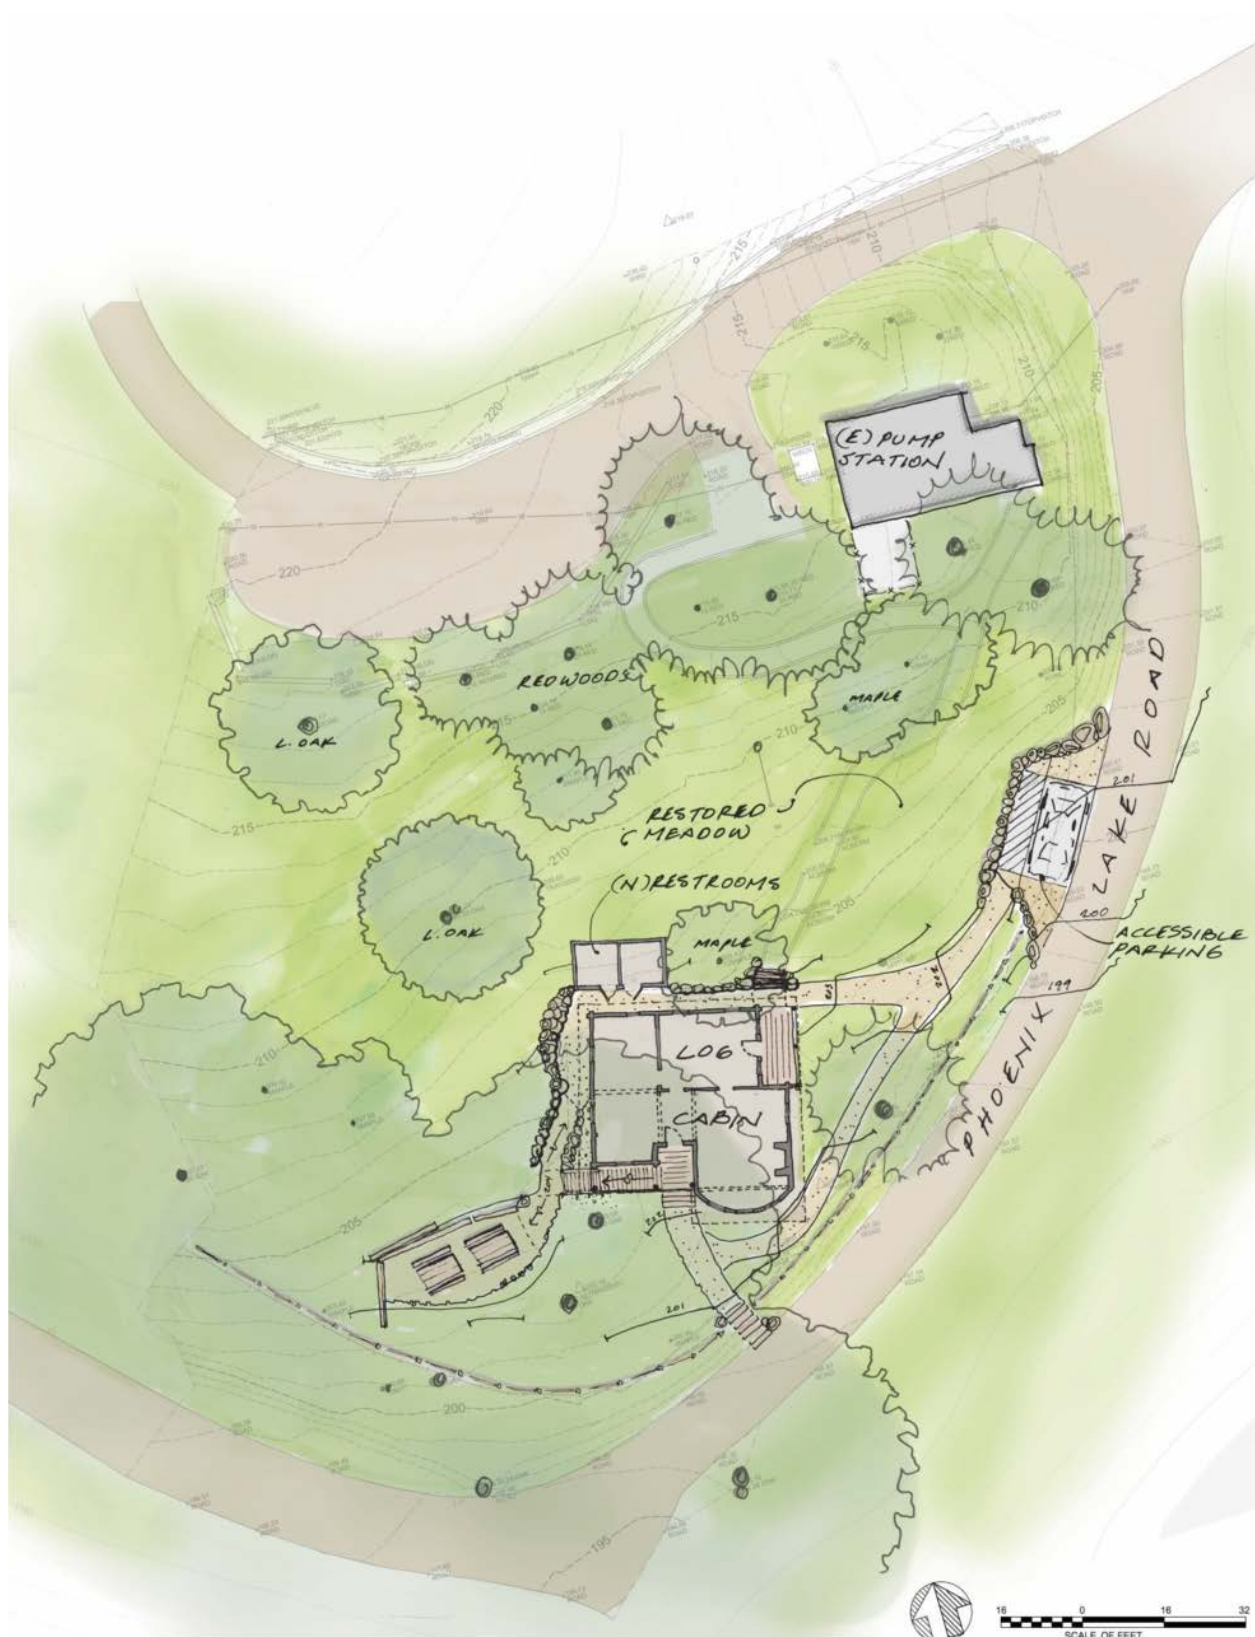
1 REHABILITATION
1/16" = 1' - 0"

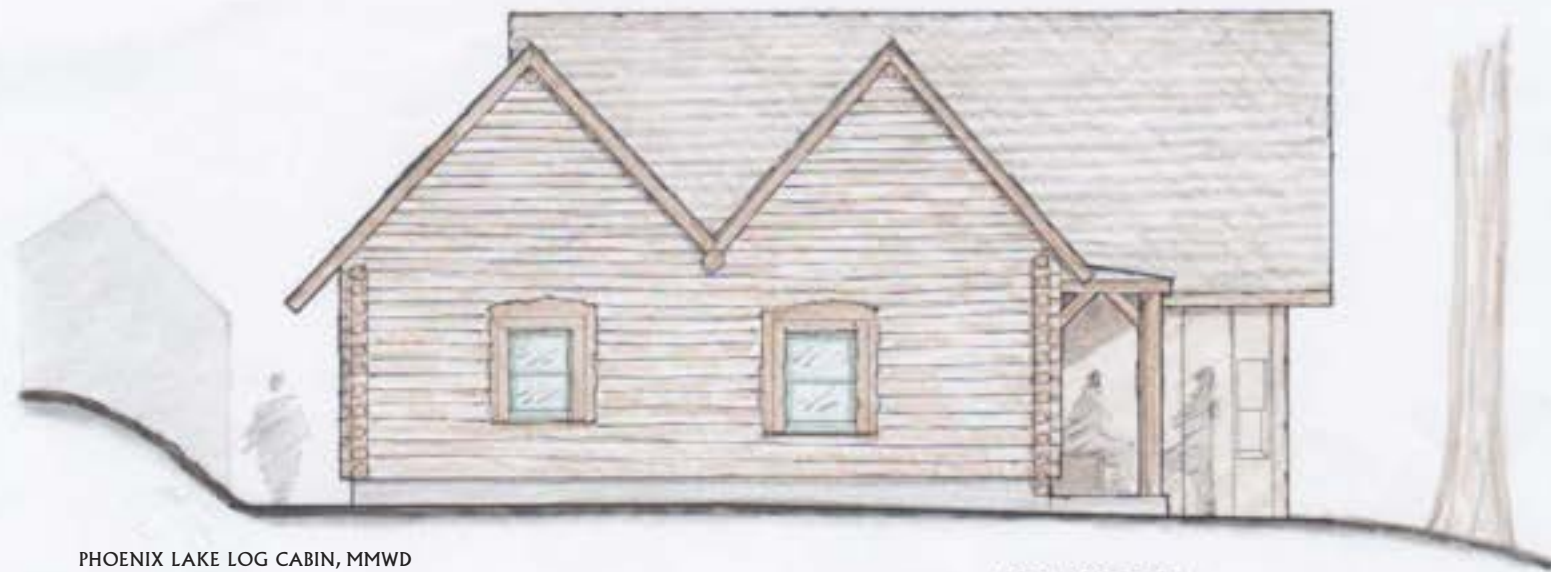
NORTH SIDE ELEV.
1/8" = 1'-0"

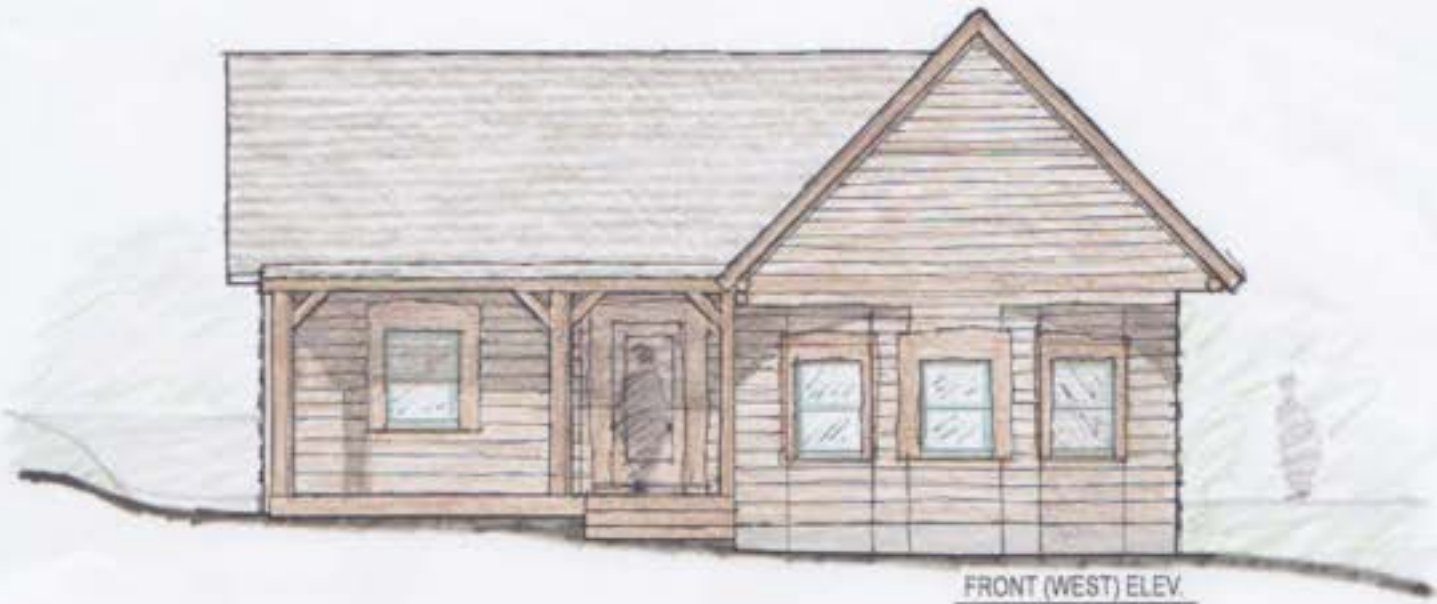
FRONT (WEST) ELEV.
1/8" = 1'-0"

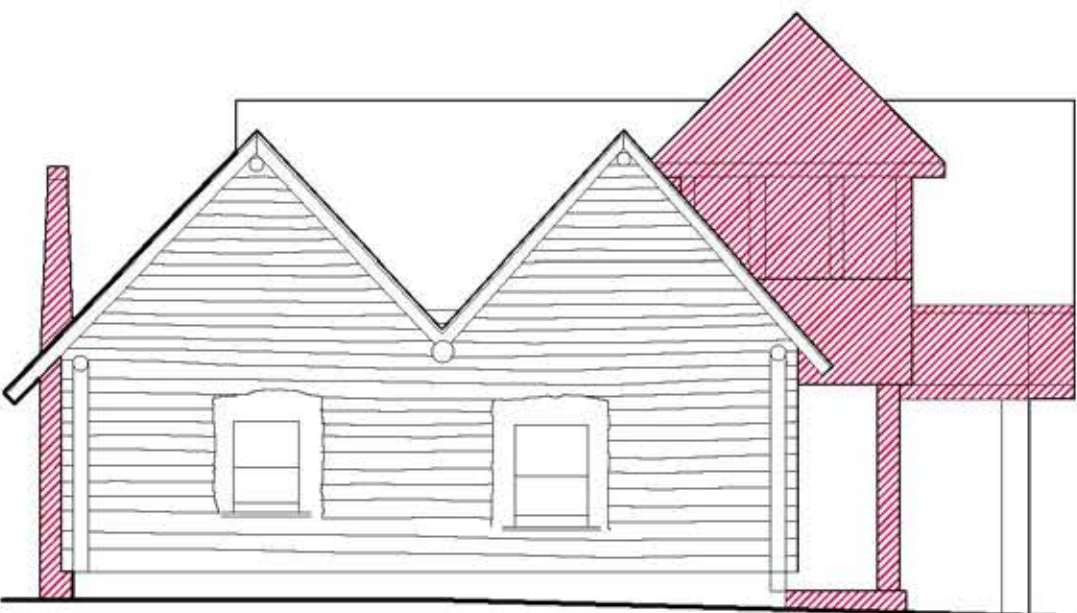
NORTH SIDE ELEV.
1/8" = 1'-0"

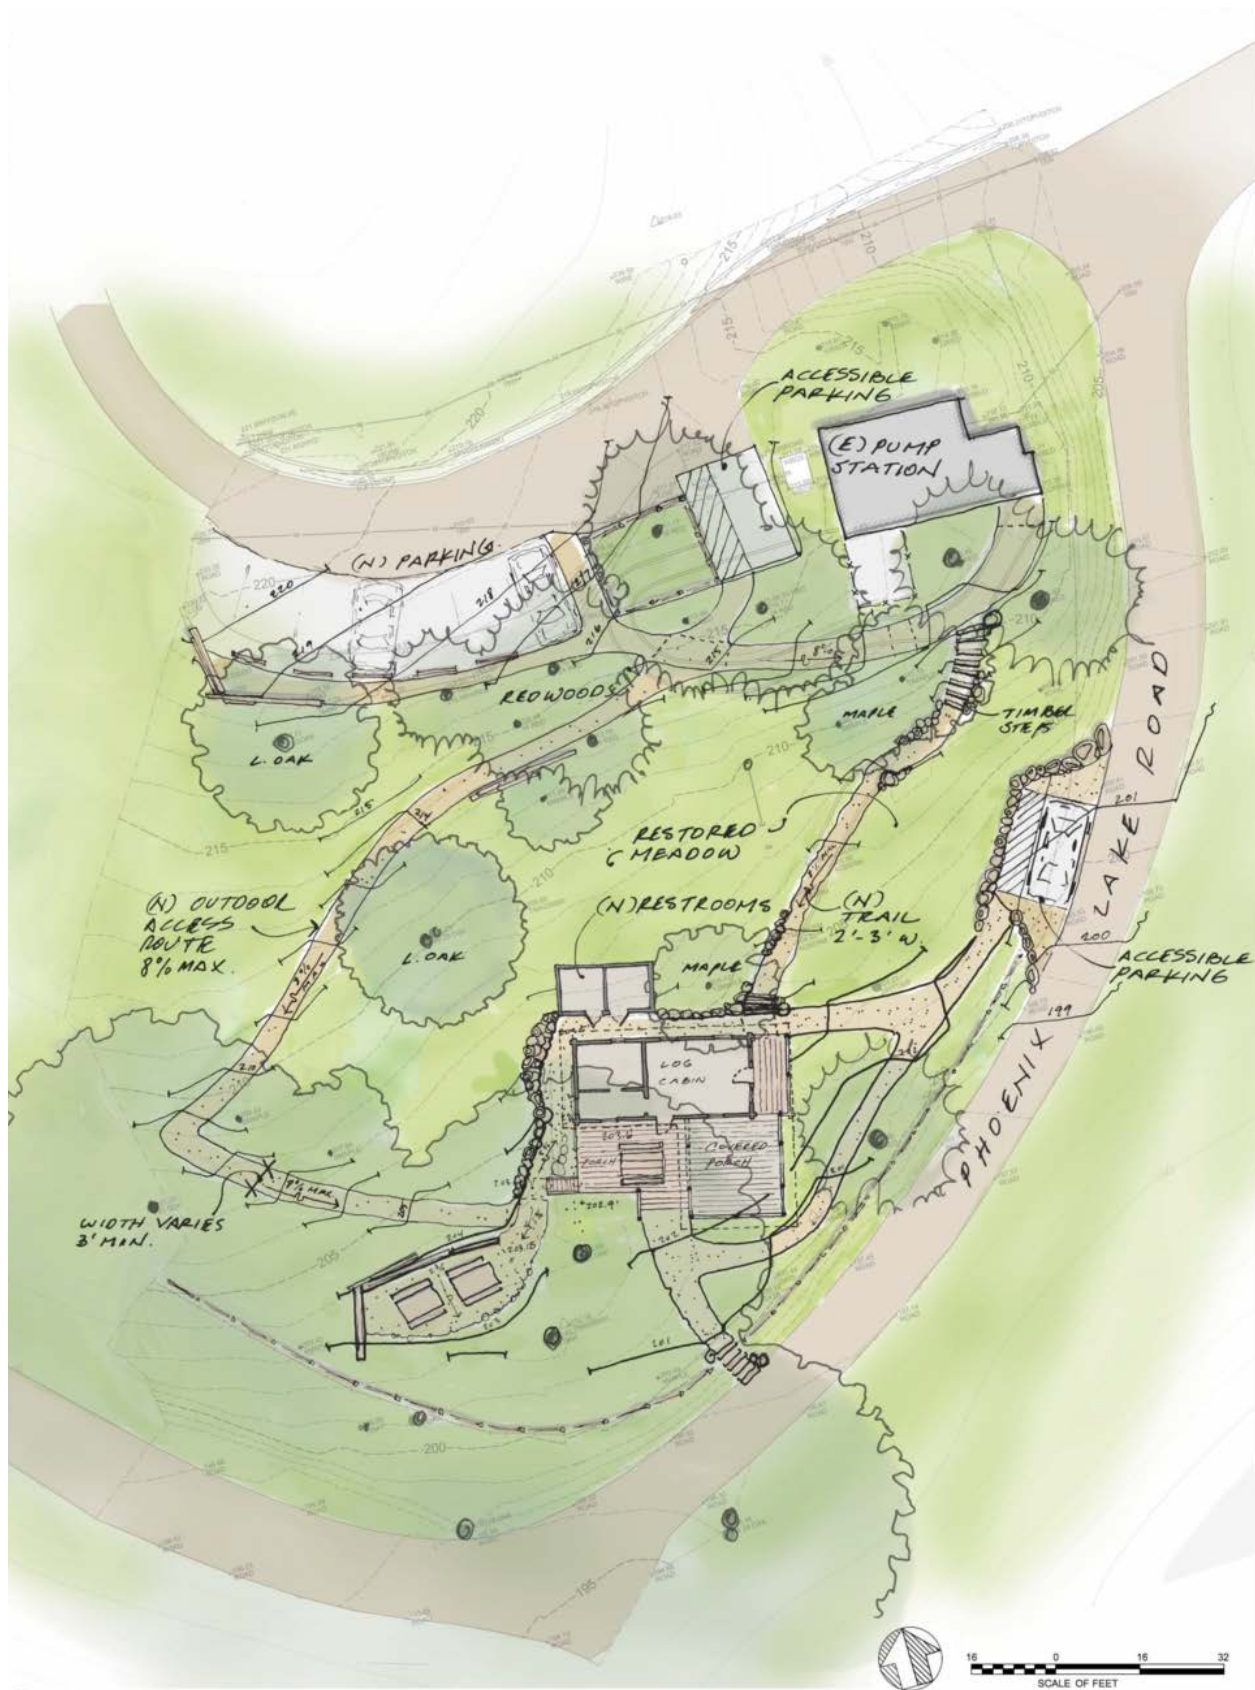
2 PARTIAL RETENTION AND REHABILITATION
1/16" = 1'-0"

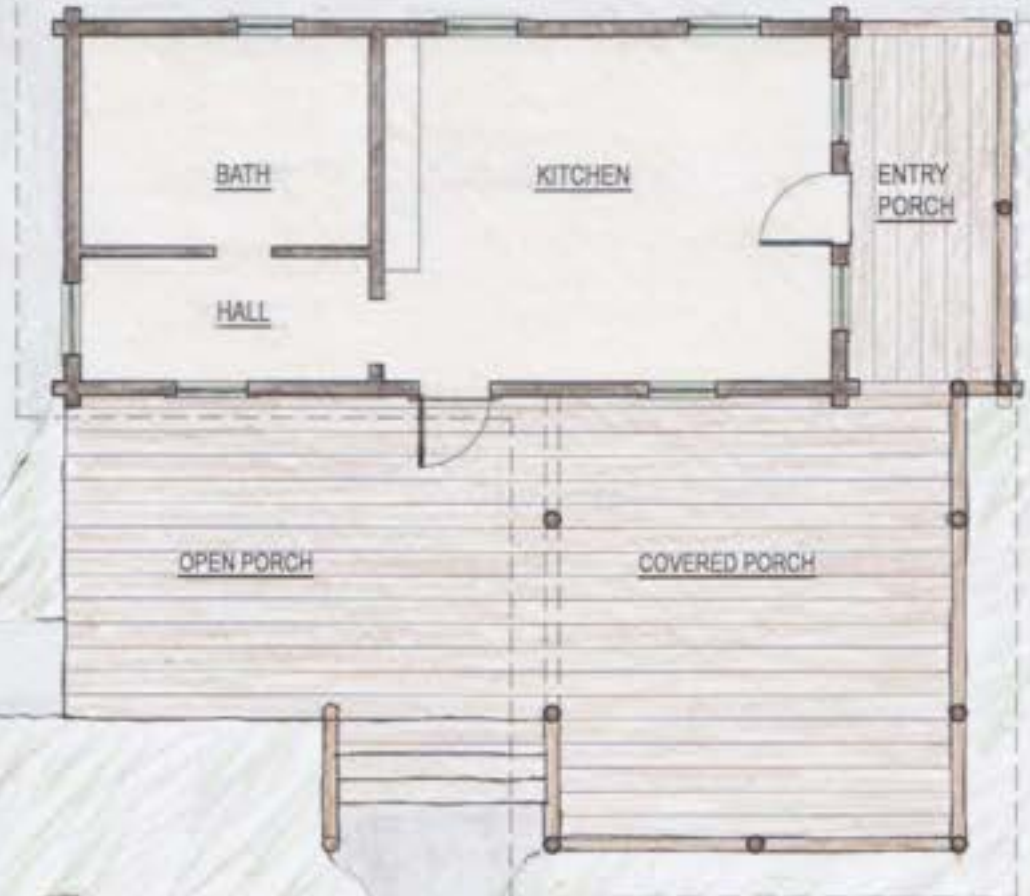
FLOOR PLAN

1/8" = 1'-0"

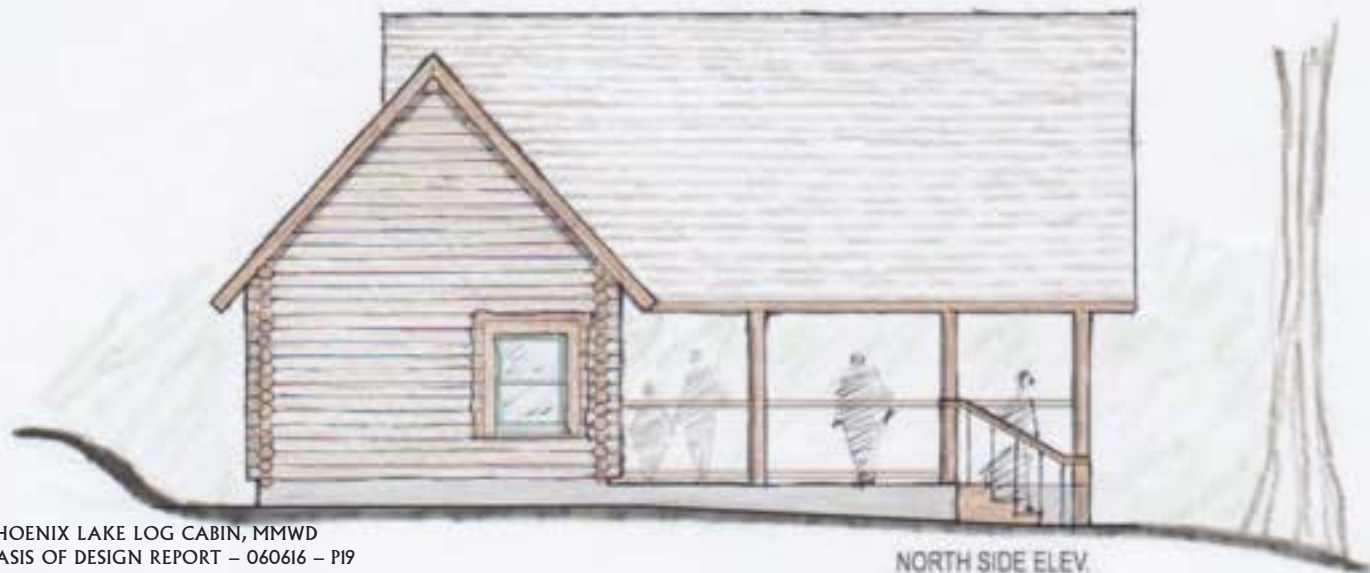
NORTH SIDE ELEV.

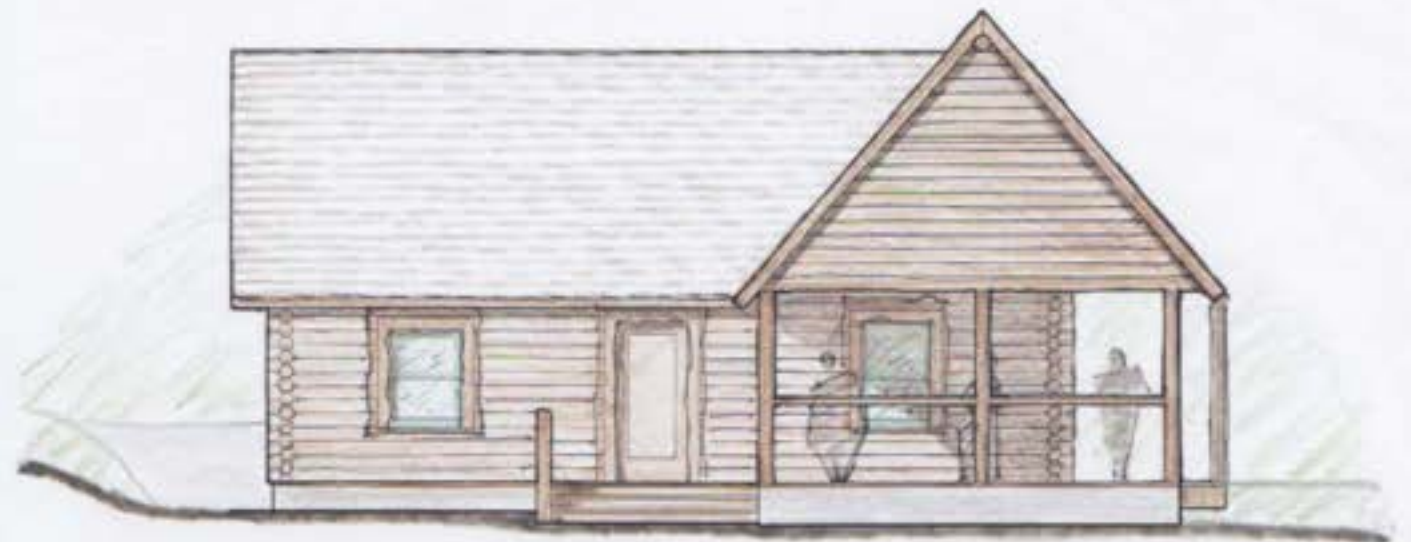
FRONT (WEST) ELEV.

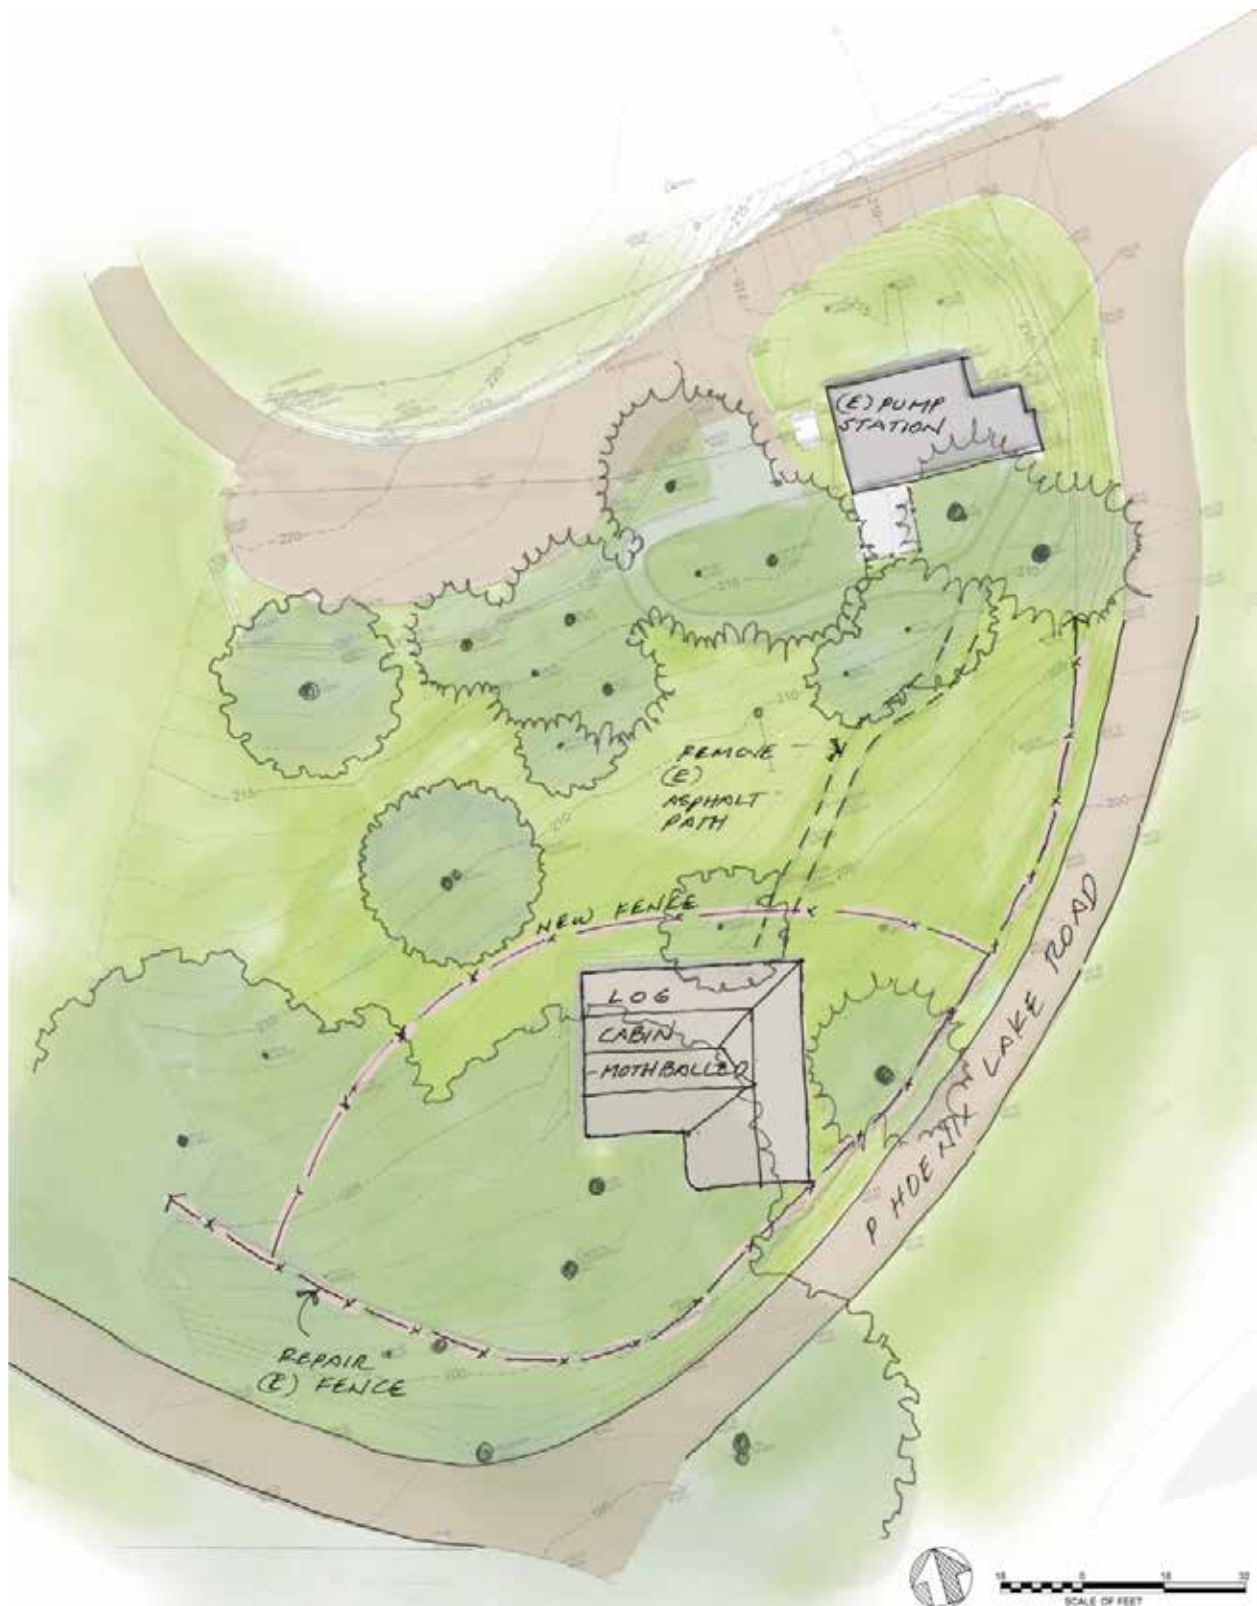
1 MOTHBALL THE FACILITY
1/16" = 1'-0"

BUILDING Alterations and Improvements – MOTHBALLING

1. Remove damaged exterior structure and ornamentation.
2. Remove and salvage front door.
3. Undertake pest control.
4. Secure building exterior, including patching openings; blocking up doors and windows (with plywood); repairing roof and roof drainage assemblies; applying bird control netting at walls and eaves.
5. Periodically inspect and maintain mothballing, including inspecting and airing-out interior.

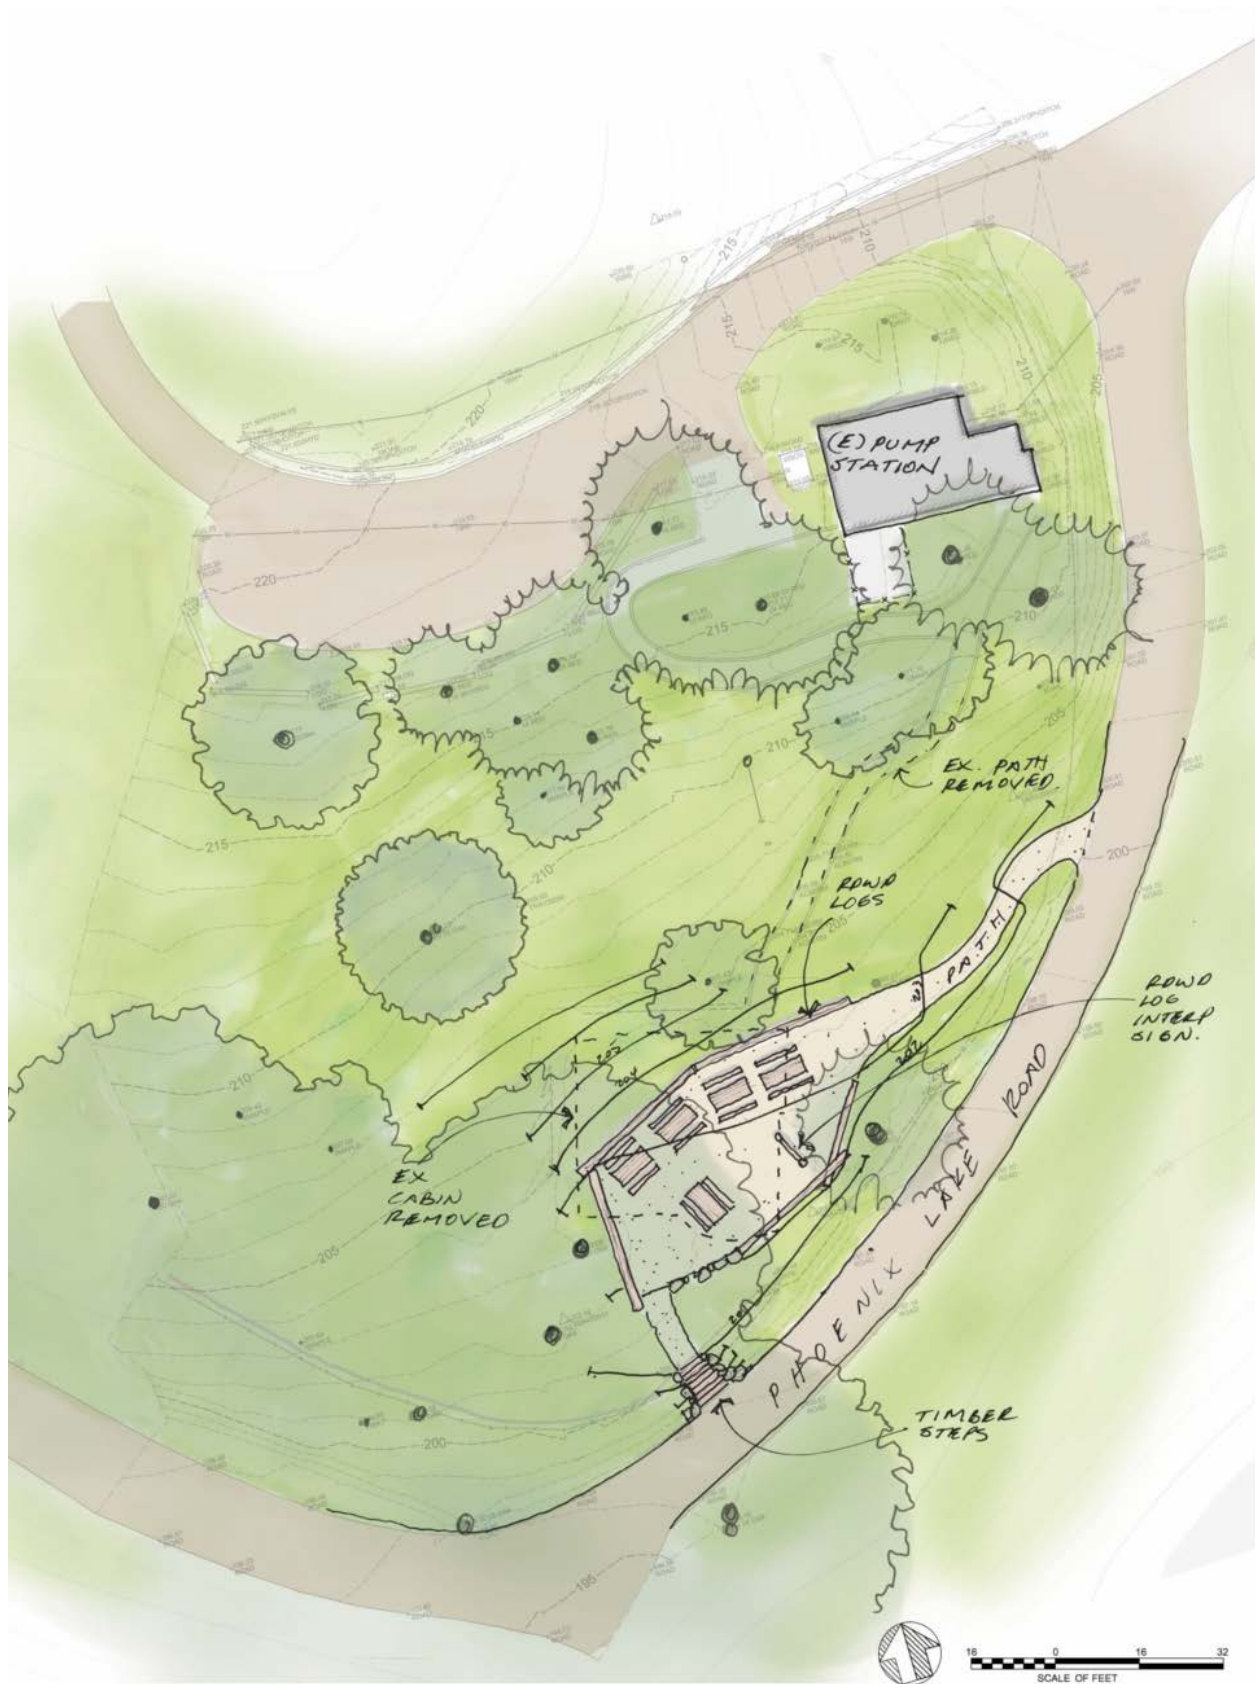
2 REMOVAL OF BUILDING & MEMORIALIZE SITE
 1/16" = 1' - 0"

Design Program – Public use and enjoyment of the site through basic improvements and re-use of the building pad area to create space for public gathering and picnicking. Work will include site restoration with locally native plants and expansion of public view of the site.

1. Create open terrace for picnicking and gathering.
2. Remove upper asphalt path, or replace with on-grade, sustainable trail alignment.
3. Install log edging with salvaged logs from cabin.
4. Install interpretive kiosk and water fountain.
5. Install new, accessible paving, resin modified compacted aggregate or similar.

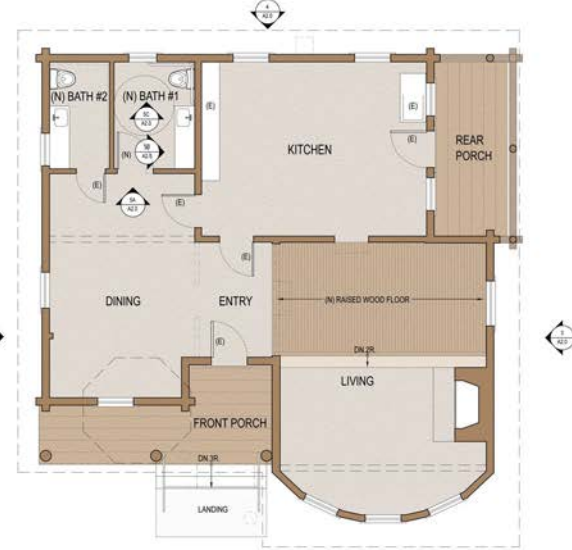
1 FULL REHABILITATION - BUILDING PLANS
1/8" = 1' - 0"

ROOF PLAN

FLOOR PLAN

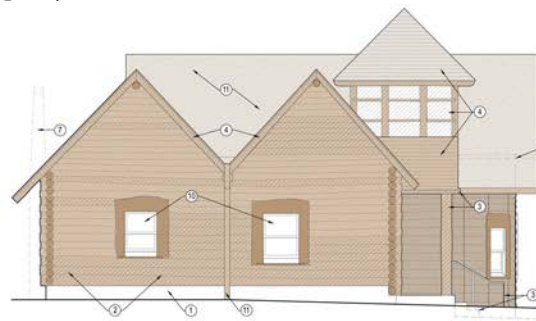
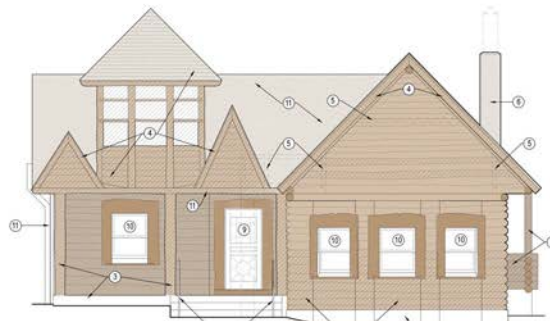
2 FULL REHABILITATION - BUILDING ELEVATIONS
1/8" = 1' - 0"

- 1 RETAIN AND REPAIR EXISTING FOUNDATIONS, INCLUDING REPLACEMENT OF MISSING AND DAMAGED FACE BRICKS, VENTILATION AND FLASHING ASSEMBLIES
- 2 REPAIR AND SELECTIVELY REMOVE AND REPLACE STRUCTURALLY DAMAGED LOGS.

- 3 REMOVE AND REPLACE FRONT PORCH TO MATCH EXISTING, EXCEPT ALTER SPACING OF THE CENTRAL PORCH POST AS PART OF THE RECONSTRUCTION OF THE CUPOLA. CONSTRUCT NEW WOOD STEPS AND HANDRAILS W/ CONCRETE LANDING.

- 4 REMOVE AND RECONSTRUCT FRONT PORCH ROOFS AND CUPOLA. WHILE THE INTENT IS TO REPLACE THE EXISTING CUPOLA TO VISUALLY MATCH THE EXISTING UNPEELED REDWOOD LOG CONSTRUCTION, ALTERNATIVELY, PEELED AND TREATED REDWOOD LOGS MAY BE SUBSTITUTED, AND THE NEW SUPPORT STRUCTURE MAY REQUIRE ADDITIONAL WOOD OR METAL FRAMING TO BE CONCEALED ALONG WITH NEW FOUNDATION WORK.

- 7 REMOVE EXISTING REAR CHIMNEY AND REPAIR OR REPLACE UNDERLYING LOGS.
- 8 REPAIR AND REBUILD EXISTING REAR PORCH WITH NEW LOG POST AND RAIL WORK AND NEW DECKING. WHILE THE INTENT IS TO REPLACE TO MATCH THE EXISTING UNPEELED LOG CONSTRUCTION, ALTERNATIVELY, UNPEELED LOGS MAY BE SUBSTITUTED.

- 9 RETAIN AND RESTORE EXISTING WOOD DOORS AND BURLWOOD CASINGS.
- 10 REMOVE, RESTORE, REFINISH AND REINSTALL EXISTING WOOD WINDOW SASHES AND SILLS, OR SELECTIVELY REPLACE TO MATCH. REPLACE SPLIT LOG WINDOW SILLS WHERE DAMAGED OR MISSING. RETAIN AND RESTORE EXISTING BURLWOOD CASINGS.

- 11 REPLACE WOOD SHINGLE ROOFING AND ROOF DRAINAGE (FLASHING) ASSEMBLIES TO MATCH EXISTING. ADD GUTTERS AND DOWNSPOUTS AS INDICATED.

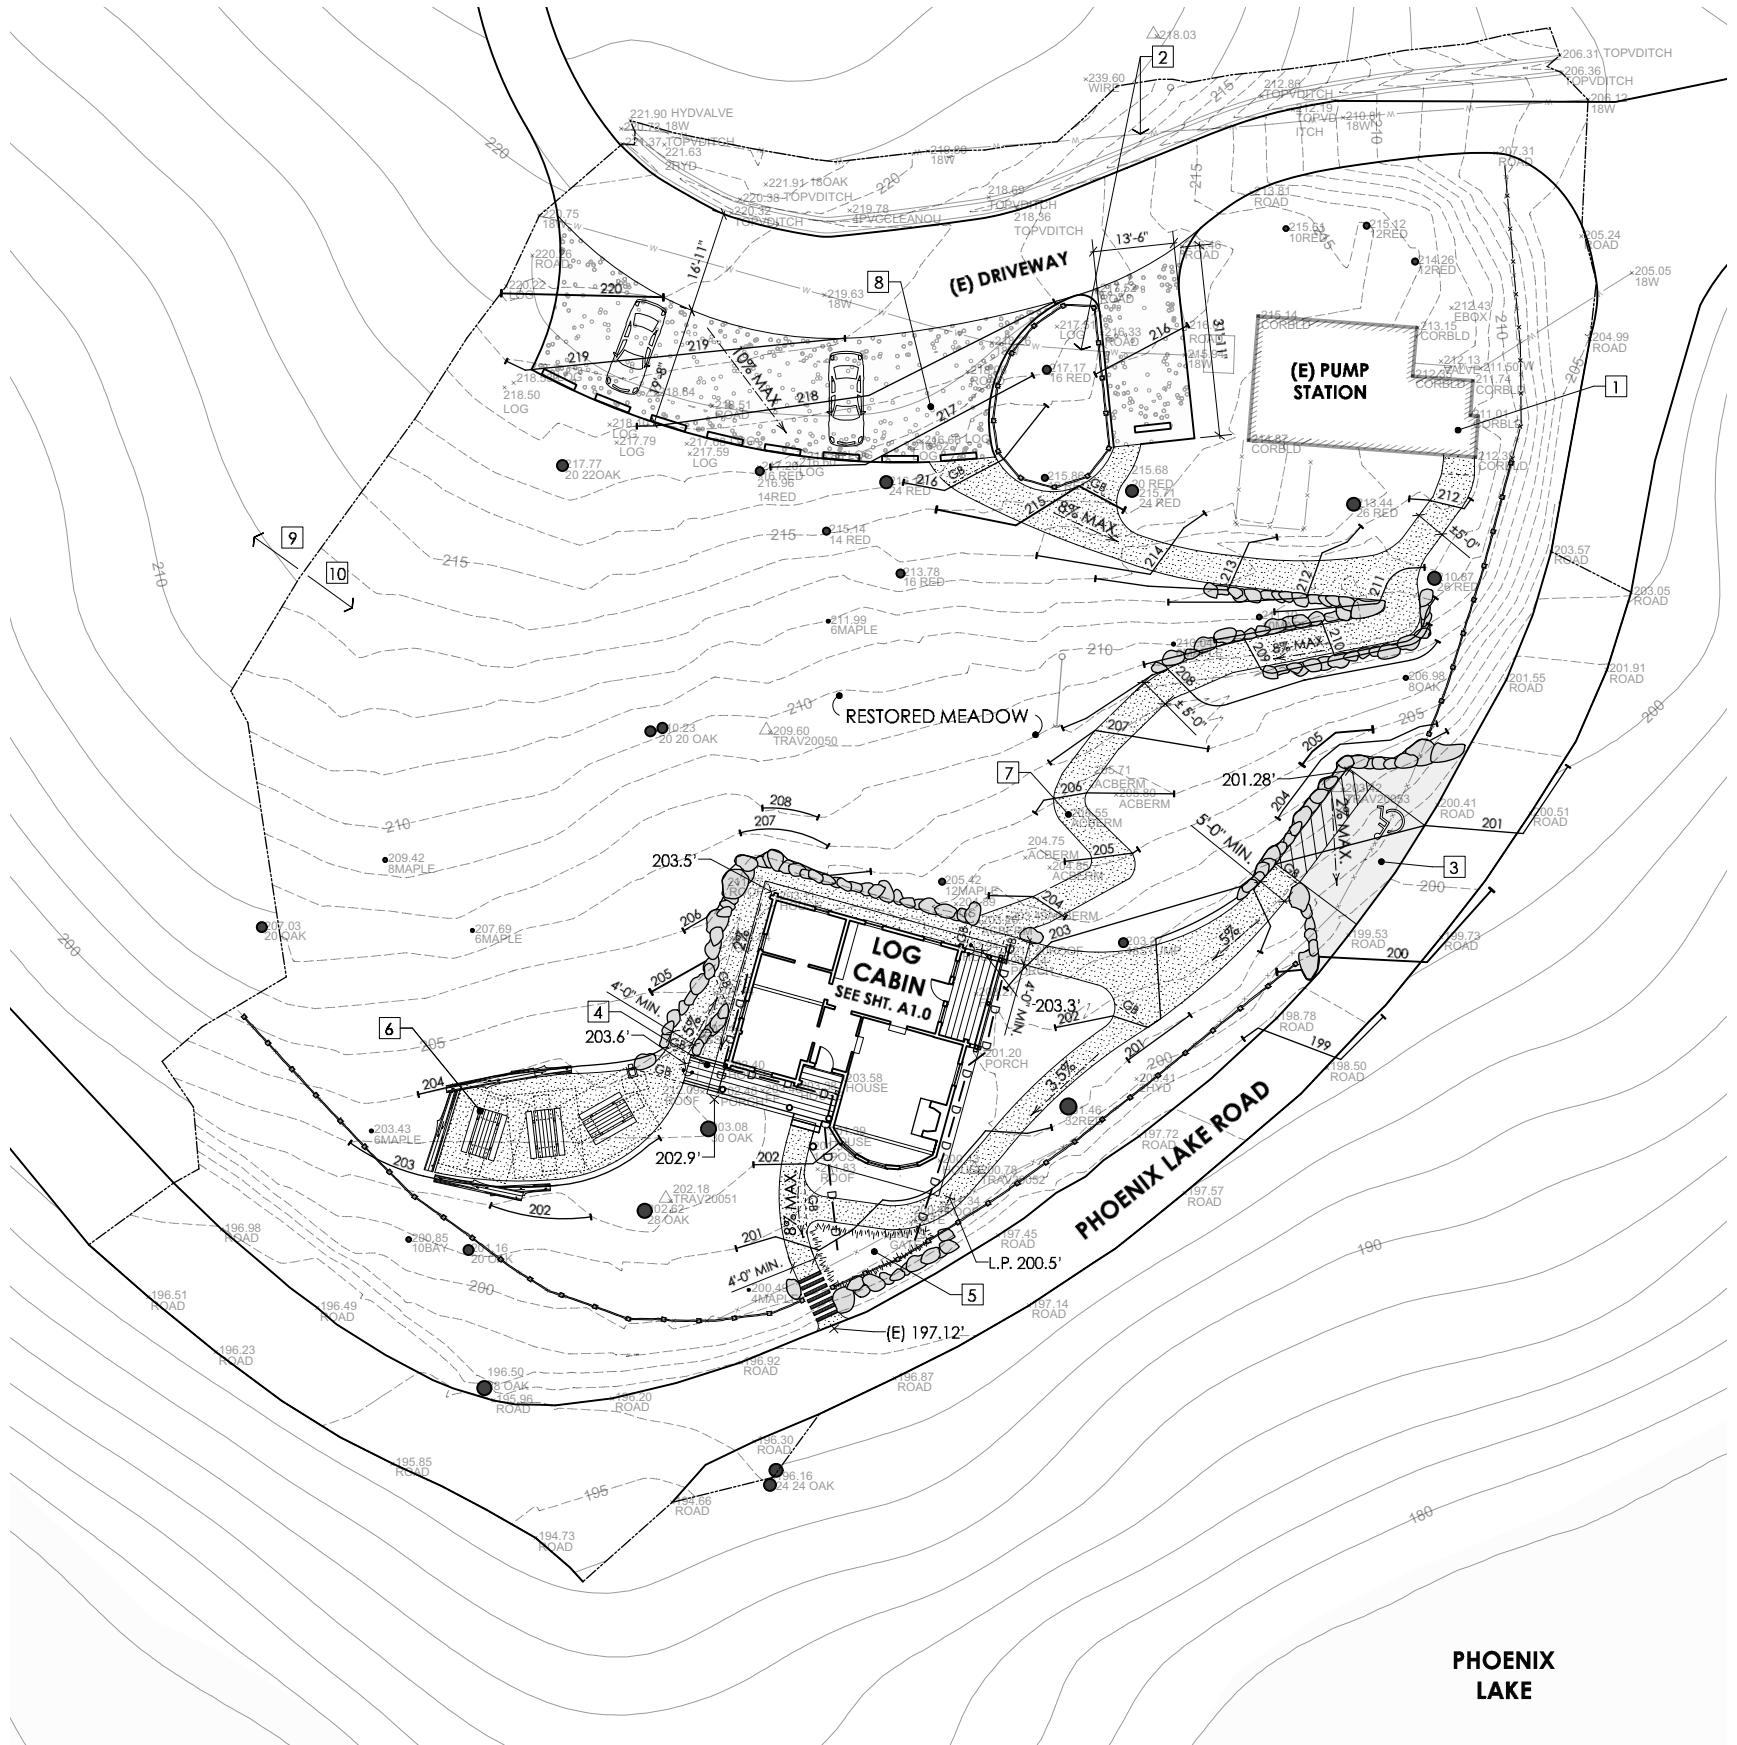
1 SITE PLAN
L1.1 1/16" = 1'-0"

| 4" DRAINLINE FROM DOWNSPOUTS | |
